AVIATION INVESTIGATION REPORT

A03P0199

COLLISION WITH TERRAIN

CESSNA 172 C-GDPD

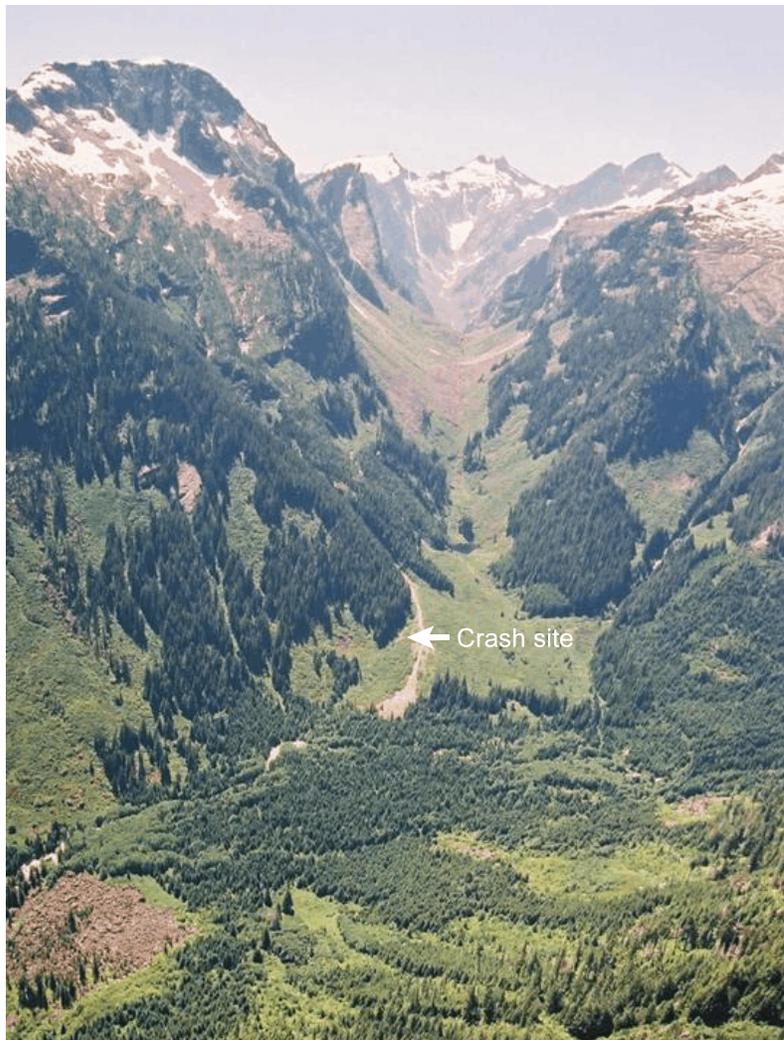
During impact, the left wing, engine, firewall, and nose landing gear detached from the fuselage and the battery was ejected from the aircraft. Pieces of the left wingtip and navigation light were found embedded in the ground 130 feet west of the main wreckage and at approximately the same elevation. A series of impact marks and aircraft parts extended horizontally across the hillside between the wingtip pieces and the main wreckage. A section of propeller blade tip found near the beginning of the wreckage trail exhibited leading-edge damage, chordwise scratching, and torsional damage indicative of applied power. The propeller fractured 20 inches inboard from the tip; the cause was overload. The ELT remained attached to the aft fuselage wall via its mount, but the antenna

Photo 1. Aerial photograph of crash site, facing southwest

connection and the function switch at the forward end of the ELT were damaged when the fuselage was crushed. Although a substantial amount of avgas and engine oil was spilled at the accident site, there was no fire.
