**AVIATION INVESTIGATION REPORT
A07W0128**

COLLISION AT TAKE-OFF

**LIARD AIR LIMITED
DE HAVILLAND DHC-6 100 TWIN OTTER, C-FAWC**

**MUNCHO LAKE, BRITISH COLUMBIA
08 JULY 2007**

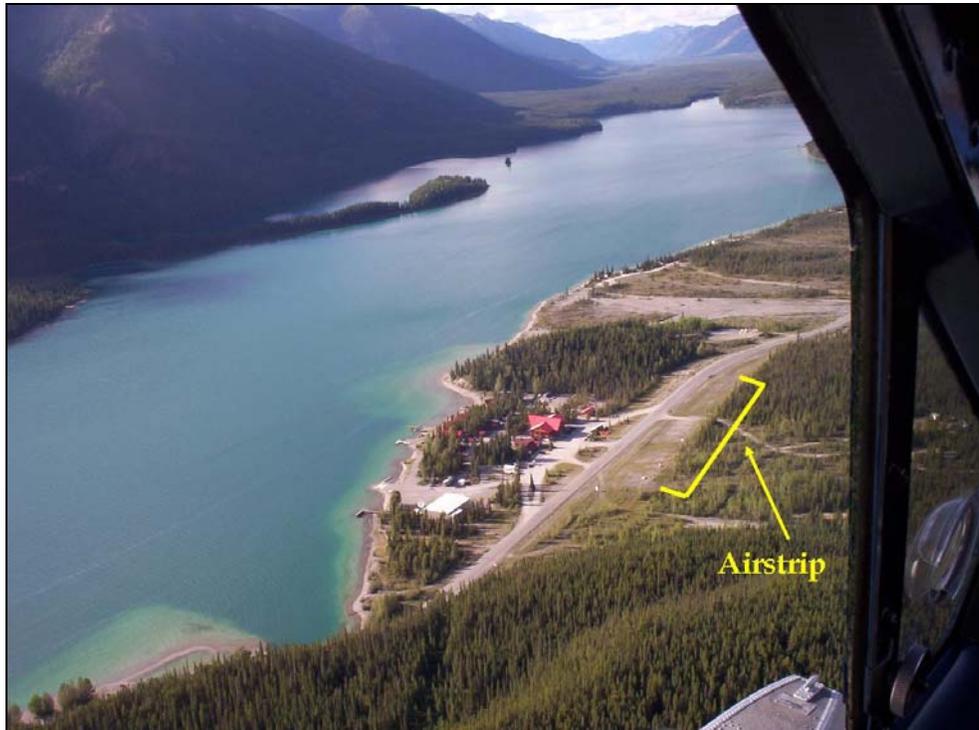
The lodge airstrip was maintained by Liard Air (see Photo 1 – Lodge Airstrip). The southeast threshold was unmarked and indistinct, and approximately the first 100 feet of the surface forward of the southeast threshold was covered with grass and short brush. There were no windsocks on the airstrip and flight crews relied on the flags flying on tall poles in front of the lodge as wind indicators. The owner of Liard Air considered the airstrip to be 900 feet long. The

Photo 1. Lodge airstrip in direction of take-off.

airstrip had never been professionally surveyed to determine its exact length or slope.
