AVIATION INVESTIGATION REPORT

A09O0207

COLLISION WITH TERRAIN

ROBINSON R22 ALPHA (HELICOPTER) N97CP

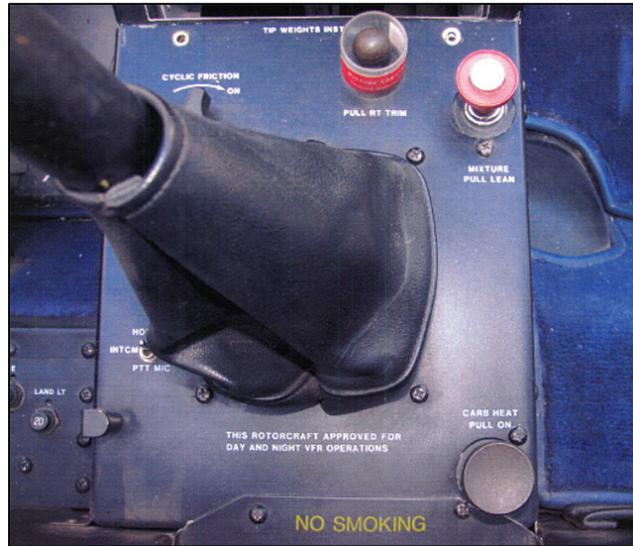
The fuel mixture and carburetor heat controls are located on the centre pedestal in close proximity to each other. To aid in identification, the control knobs are shaped differently. Furthermore, the fuel mixture control knob is red while the carburetor heat control knob is black (see Photo 1). To prevent the inadvertent deployment in flight, the manufacturer's checklist directs the pilot to place a removable cylindrical plastic guard over the mixture control knob before starting the engine (see Photo 2). This guard is not to be removed until engine shutdown when the mixture control knob is pulled to the idle cut-off position (see Photo 3). This plastic guard is not permanently attached to the control panel. While the plastic guard was found at the crash site, it could not be determined whether it was used at the time of the occurrence.

Photo 1. Centre pedestal with mixture control at upper right and carburetor heat control at lower right

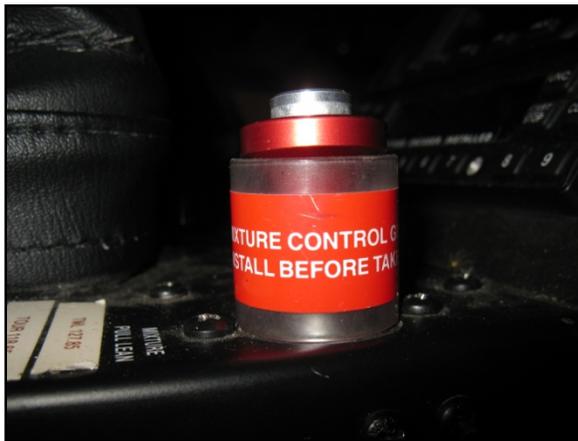
Photo 2. Mixture control pushed in to full rich with guard installed

the wrong control knob. In order for the pilot to be able to pull the mixture control knob to the idle-cut off position, it is likely that the plastic guard had not been placed over the mixture control knob as required.

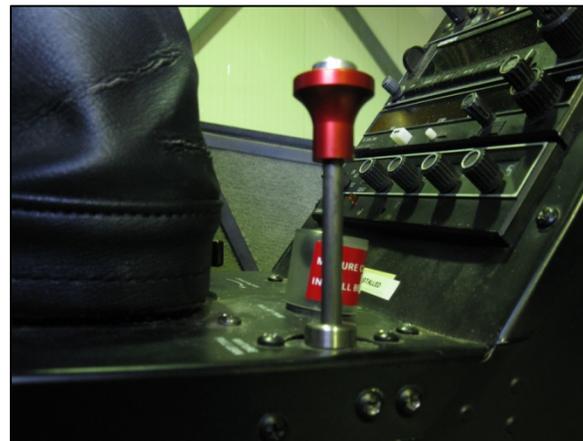
Photo 3. Mixture control pulled out to idle cut-off with guard removed

- The mixture control knob was pulled out and bent back. The mixture control is a push/pull control with a push button locking feature and therefore most likely did not move at impact.
- The carburetor heat control knob was fully in (cold). The carburetor heat control is a standard push/pull control with no locking feature and may have moved at impact.

While it was not possible to determine accurately the position of the carburetor heat control before impact, the mixture control knob was found out and bent. With the push button locking feature, it is unlikely that the mixture control moved during the impact. It was, therefore, likely in the idle cut-off position at impact.
