**AVIATION INVESTIGATION REPORT
A11O0098**

RUNWAY EXCURSION

**SKYCHARTER LTD.
DASSAULT FALCON 10 C-GRIS
TORONTO/BUTTONVILLE MUNICIPAL AIRPORT,
ONTARIO
17 JUNE 2011**

Report Number A11O0098

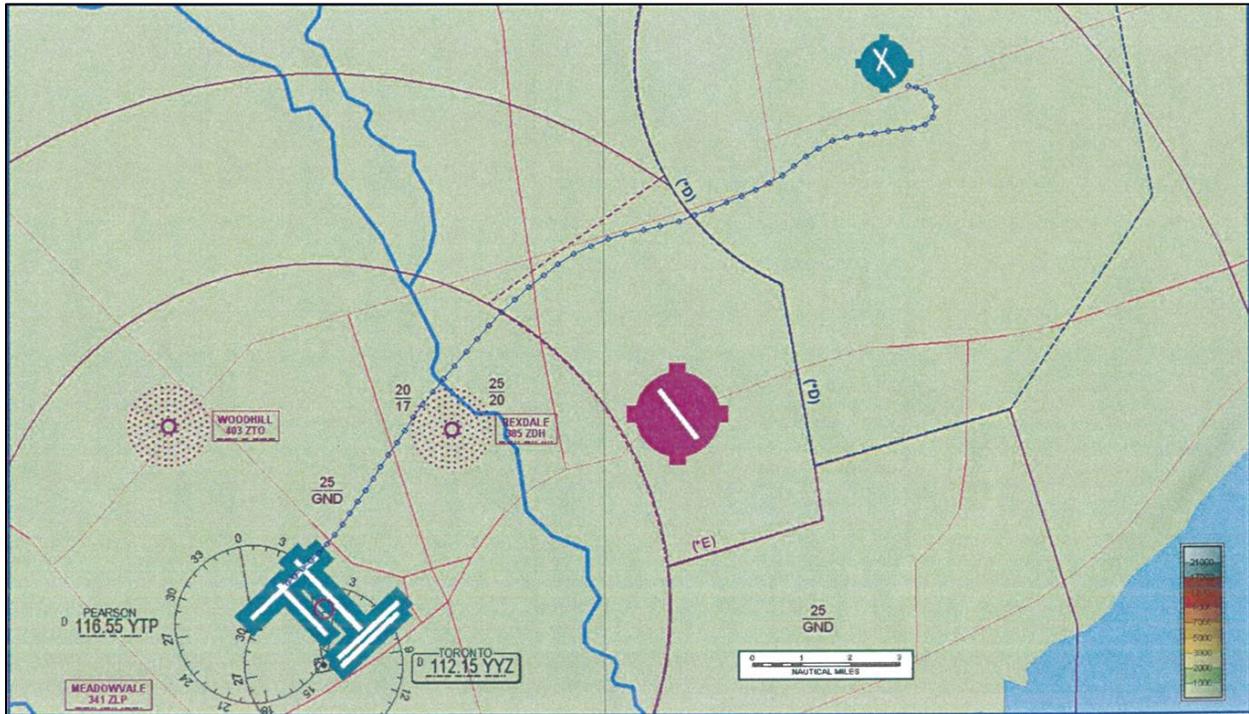
Figure 1. Radar plot of aircraft flight path

At 1503:40, 1.6 nm from the threshold, with a ground speed of 220 knots and descending through 1900 feet asl, the aircraft turned right to widen the left base (Figure 1).

At 1503:53, the Toronto ACC controller instructed the aircraft to switch to the CYKZ tower frequency. The captain commanded flaps, and the FO read back the Toronto ACC controller's request. The FO contacted the CYKZ tower controller with the flight identification and position on left base for Runway 33. The CYKZ tower controller provided altimeter information and cleared the aircraft to land on Runway 33. At this time, the aircraft was descending through 1400 feet asl with a ground speed of 210 knots, and was located approximately 0.3 nm from the inbound track to Runway 33. The aircraft leveled out from the right turn and was heading in an eastward direction. It flew through the inbound track at a transverse angle of about 120° at approximately 1 nm final. In an attempt to regain the runway centreline, the aircraft banked left, exceeding 30° of bank. The aircraft overflowed the runway centreline by approximately 0.3 nm.

ATC requested that the flight crew keep the circuit tight. Because of its excessive speed, however, the aircraft overshot the final approach track. The radar display indicated that the

aircraft transitioned through the final approach course at approximately 140 knots. Consequently, a left turn was performed exceeding 30° of bank, well above the SOP limit and outside the FSF criteria for a stabilized approach. The distance to the runway threshold continued to reduce quickly, and manoeuvres to regain runway heading became more aggressive and non-standard.

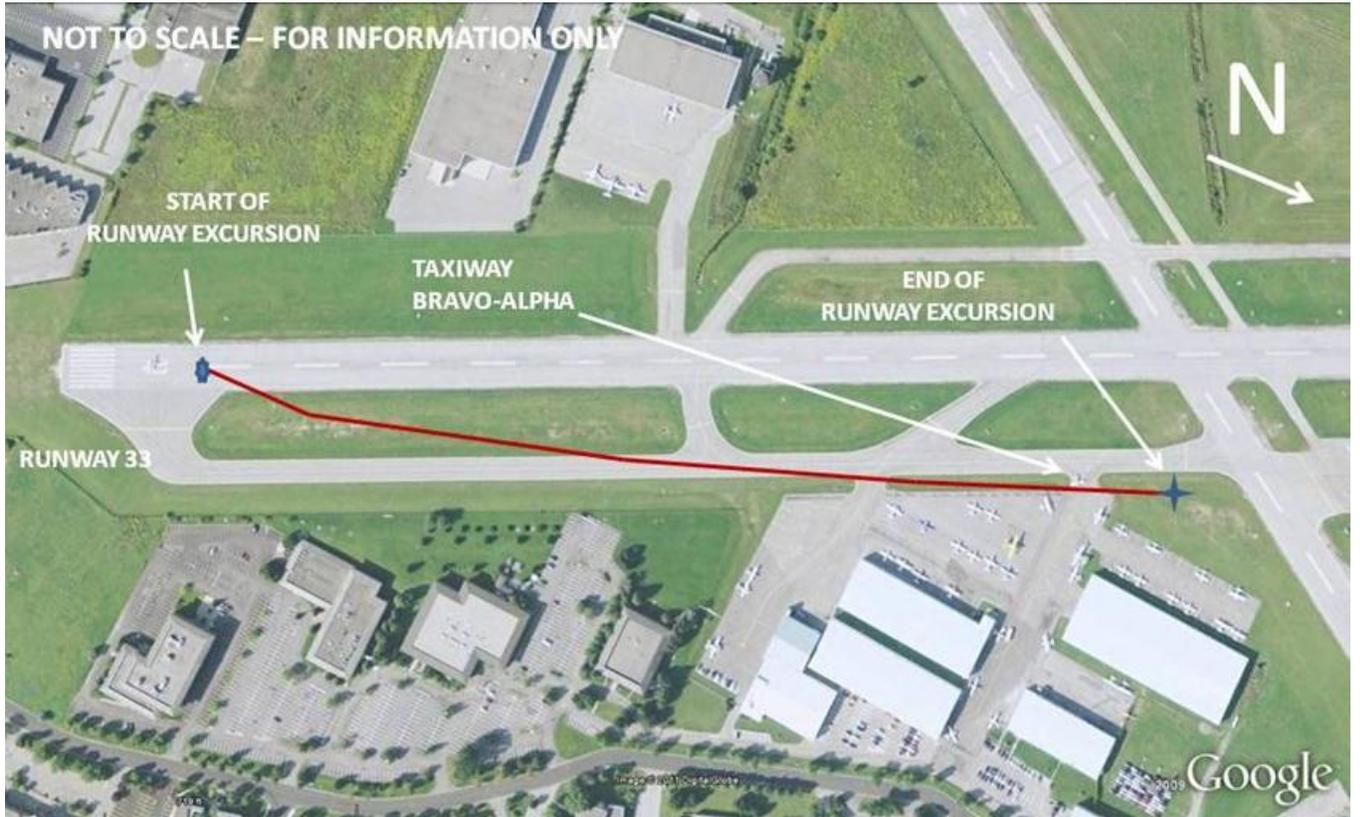
Appendix B - Runway Excursion Diagram

At 1504:49, the aircraft touched down hard on the main landing gear in a nose-high attitude, then immediately departed the runway surface to the right. The ground speed during the runway excursion could not be determined, but was estimated to be less than 110 knots. The captain applied the brakes and initially attempted to steer the aircraft onto the runway using the rudder. However, due to the infield's grass surface, braking and steering responses were minimal. Although the tiller was available for nose-wheel steering, it is not normally used until the speed is below 80 knots.

The aircraft traversed the grass infield to the intersection of taxiways Charlie and Bravo, continued onto taxiway Bravo, and struck a runway/taxiway identification sign before crossing the intersection of taxiways Bravo and Alpha. The aircraft struck the sign with the right side of the nose section, the inboard leading edge and the right-wing slats. The sign was struck with sufficient force that it was torn away from its base and came to rest behind the aircraft on the apron. The aircraft came to a stop on the grass just beyond the intersection of taxiways Bravo and Bravo/Alpha.

The main landing gear tire marks indicated the aircraft touched down on the left main landing gear first, followed by the right main landing gear 24 feet further. It was calculated that the aircraft exited the runway at an angle of 37° to the right of the runway centreline, or on a magnetic heading of 007°. Tire marks also indicated that the aircraft was already positioned at this angle when it touched down, and that, shortly after touchdown, brakes were applied with sufficient force to activate the anti-skid system (Appendix B).

Just prior to touchdown, the FO called for engine power, likely to arrest the high rate of descent. The captain did not increase engine power, and the aircraft touched down hard. Attempts at rudder steering and braking were ineffective in reducing speed and providing directional control, as tire traction would have been greatly reduced on the grass surface.

As the aircraft exited the infield and entered the paved taxiway Bravo, the brakes regained effectiveness. However, directional control was not fully regained, and the aircraft struck the runway/taxiway identification sign before exiting Bravo taxiway onto the grass infield.
