**AVIATION INVESTIGATION REPORT
A12W0031**

LOSS OF CONTROL AND COLLISION WITH TERRAIN

**KANANASKIS MOUNTAIN HELICOPTERS LTD.
BELL 206B JETRANGER (HELICOPTER) C-GLQI
LODER PEAK, ALBERTA 0.4 NM NW
30 MARCH 2012**

Report Number A12W0031

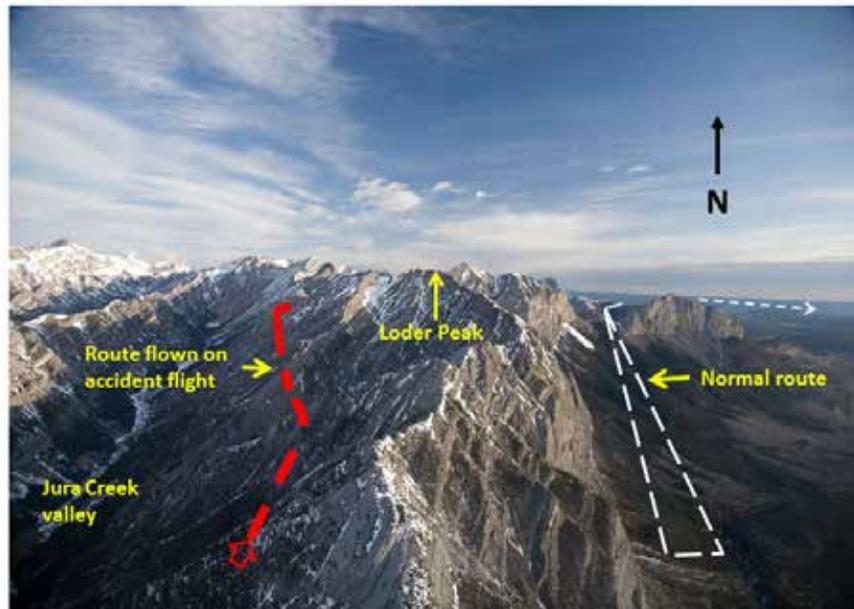
The Rockies Heritage Tour flight route was a 25- to 27-nautical-mile (nm) circular route. This flight normally proceeded south from the CNK7 base to Barrier Lake, then west to Heart Mountain, and north to the Trans-Canada Highway. After crossing the Trans-Canada Highway, the flight would continue northbound, and would normally track east of Loder Peak (Photo 1). A flight tracking west of Loder Peak would enter

Photo 1. Route of flight

On the accident flight, the pilot entered the Jura Creek Valley northbound, and flew in close proximity to the steep west-facing slopes on the eastern side of the valley (Photo 1). As the helicopter approached the crest of a 7300-foot-high ridge to the north of Loder Peak, in very close proximity to the outcrops and at an altitude below the crest, the helicopter encountered turbulence. Several seconds later, the pilot initiated a left turn toward the valley. Partway through the turn, control was lost, and the helicopter began to spin to the right. Control was not regained, and the helicopter continued to spin rapidly to the right, about the vertical axis, in close proximity to the mountain slope. The helicopter rotated an estimated 6 to 12 times, struck the slope 3 times, and came to rest on snowpack within an avalanche corridor, in a cirque (Photo 2).¹ The accident occurred at 1010.²

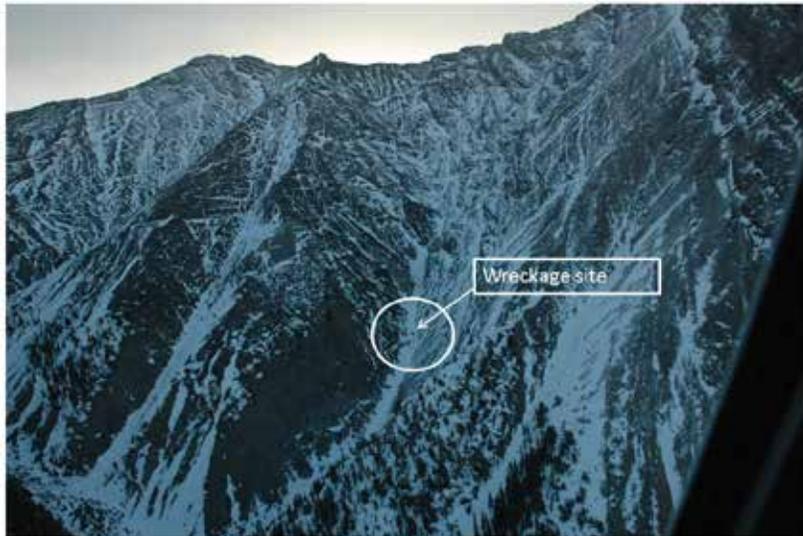
The wreckage came to rest at 6700 feet asl, at 51°06'38.63" N, 115°09'07.64" W. The tail boom and main rotor separated during the impact sequence. The fuselage came to rest in snow on its left side, in a nose-low attitude and partially inverted. Investigators were unable to travel to the accident site, due to the risk of rock slides and snowslides; therefore, ground scars associated with the accident were not identified.

Photo 2. Wreckage site

The helicopter sustained extensive damage from the impact. Approximately 95% of the helicopter, including all critical components, was recovered from the accident site. No mechanical discrepancies that would have contributed to the accident were identified during examination of the wreckage. All flight controls were continuous before the accident, and all damage was attributed to the impact sequence. The main-rotor and tail-rotor systems had sustained extreme damage due to ground contact, indicating that both systems were operating under high power at impact.
