**AVIATION INVESTIGATION REPORT
A13Q0098**

**FORCED LANDING FOLLOWING FUEL EXHAUSTION
AVIATION FLYCIE INC.
BEECHCRAFT KING AIR 100, C-GJSU
MONTRÉAL/ST-HUBERT AIRPORT, QUEBEC, 8 NM E
10 JUNE 2013**

Aviation Investigation Report A13Q0098

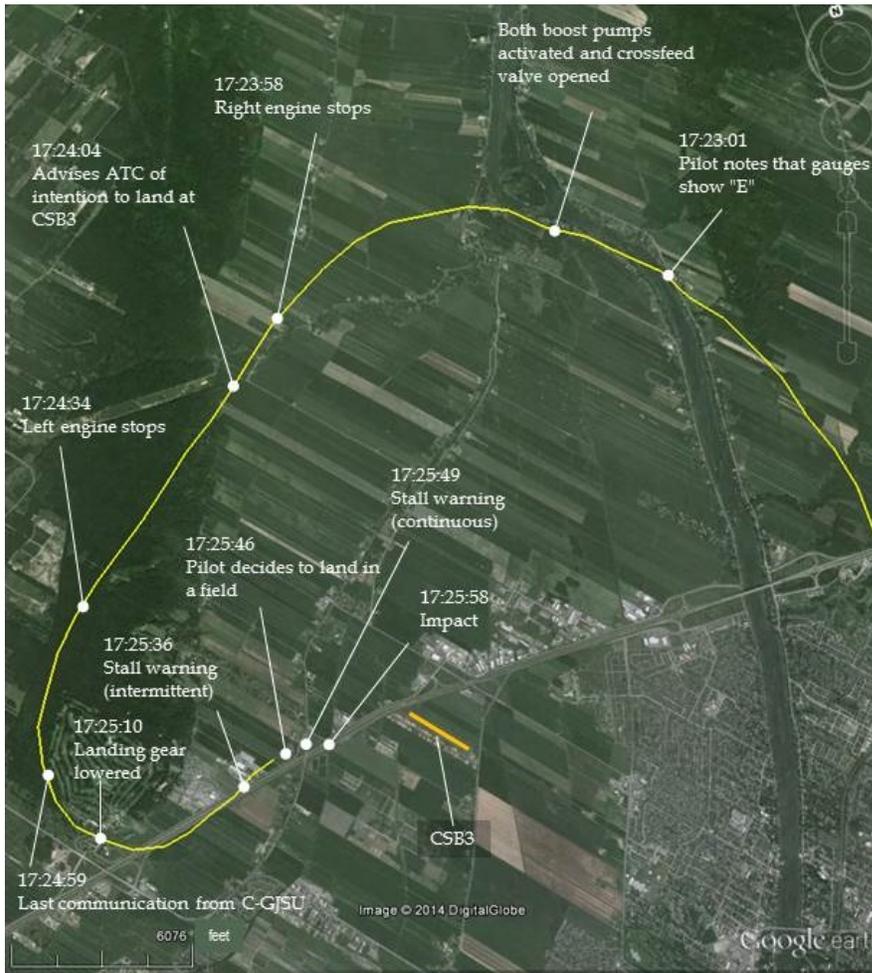
Figure 2. Aircraft flight path, based on radar data (Source: GoogleEarth, with TSB annotations)

At 1722:52, the propeller sound fluctuated, as the fault warning light and RH FUEL PRESSURE light illuminated.³ The pilot noted that the engine nacelle fuel tank gauges showed “E”.⁴ The pilot activated the left and right auxiliary boost pumps and opened the crossfeed valve. At 1723:44, the aircraft intercepted the localizer of Runway 24R at CYHU at an altitude of 2800 feet asl. At 1723:58, the propeller sound fluctuated again, and the right engine stopped (Figure 2).

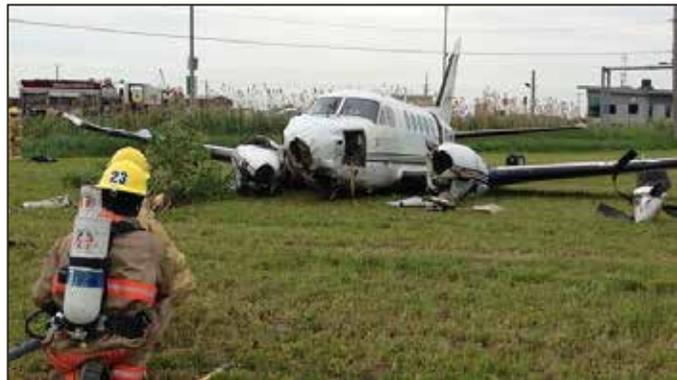
Photo 1. View of the wreckage (Source: Régie intermunicipale de police Richelieu-Saint-Laurent)

Both propellers were detached from their engines and showed damage consistent with an engine not producing power at the time of impact. Examination of the propellers showed that their blades were at a fine pitch angle. Both engines were partly torn off their engine mounts at the firewall (Photo 1).

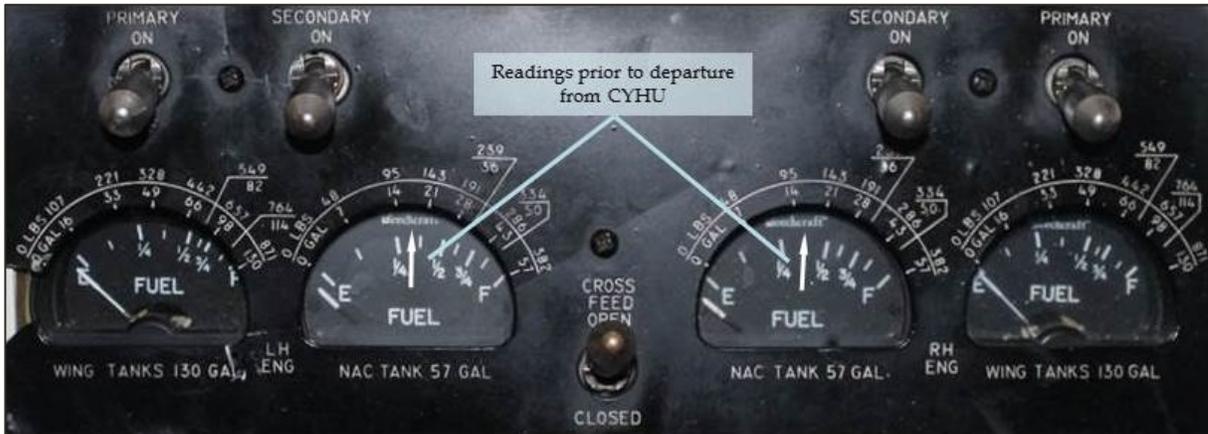
Figure 5. Illustration of the quantity of fuel before the occurrence flight

GJSU had approximately 260 pounds of fuel on board when it took off from CYHU, and did not experience a fuel leak during the occurrence flight.

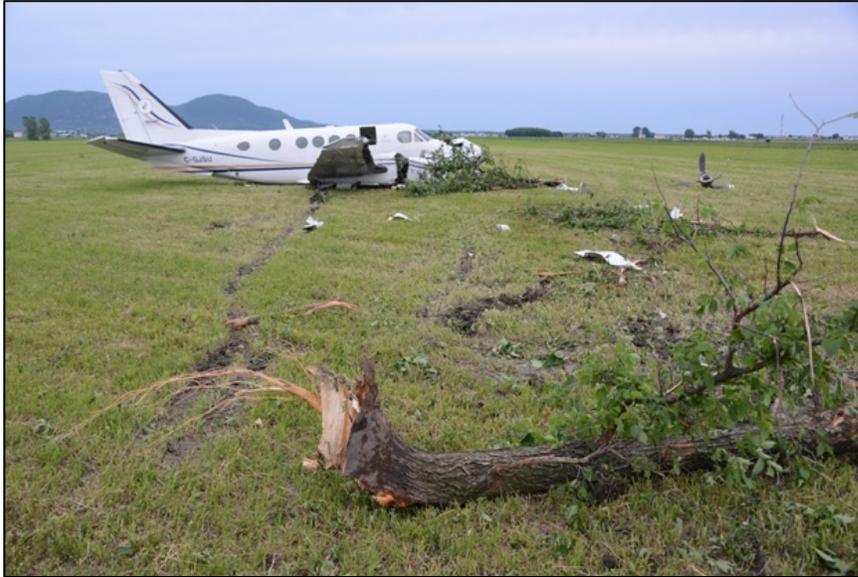
Photo 2. Post-impact trajectory of C-GJSU (Source: Régie intermunicipale de police Richelieu-Saint-Laurent)

An examination of the wreckage showed that

- there were no flight control system anomalies;
- the flaps were retracted;
- the landing gear was down;
- there had been no fire during the flight, nor post-impact;
- no fuel leak had occurred;
- the fuel caps were firmly closed;
- the fuel tanks were empty; and
- the propellers were not feathered.

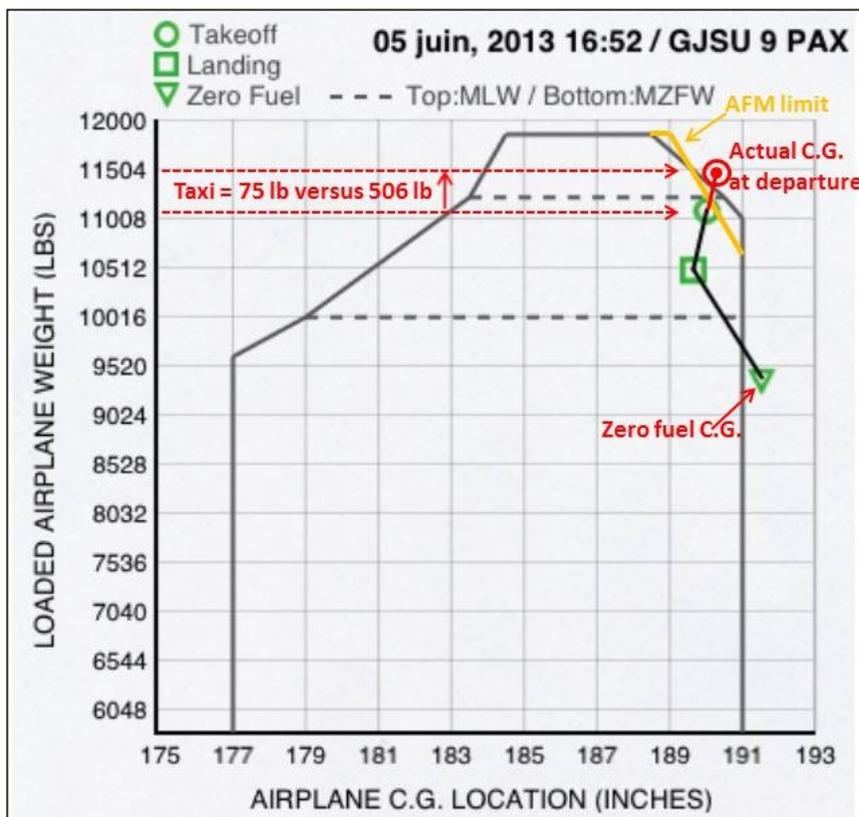
Figure 7. Weight-and-balance envelope for C-GJSU (Source: Aviation Flycie Inc., weight-and-balance form, with TSB annotations)

- The TC-approved weight-and-balance form included an incorrect upper limit for centre of gravity (between 189 and 191 inches). According to the limits published in the AFM, the upper limit of the envelope should follow the yellow line shown in Figure 7.
- Crew
 - 8 flights had been carried out with a co-pilot who had been assigned to a series of IFR flights with passengers, even though that individual had not completed the ground training, the flight training, or the PCC. Furthermore, the company did not have the required Operations Specification 011.⁷⁸

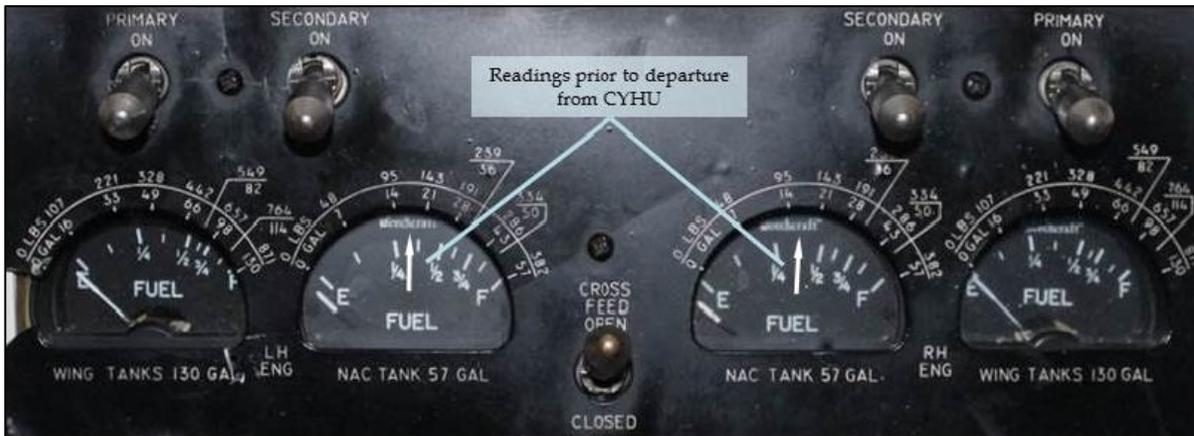
Figure 9. Illustration of the quantity of fuel before the occurrence flight

At the time of departure from CYHU, the wing tanks were empty, and each of the nacelle tanks contained approximately 130 pounds of fuel. Although the gauge indicator needles were showing slightly more than 1/4 tank of fuel in each nacelle tank (Figure 9), the needles were positioned at the midpoint of the dial because of the non-linear graduation scale of the gauges. Seeing the needle at the midpoint of the dial could have led the pilot to conclude that the tanks were half full.

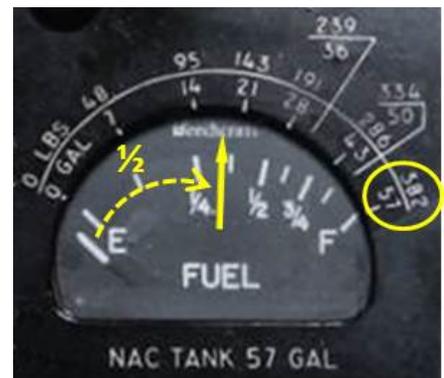
Figure 10. False equivalence between the gauge needle position visually and its actual indication of fuel quantity in the nacelle tanks

Based on these gauge characteristics, it was hypothesized that the pilot might have established a false equivalence between the visual position of the needle (Figure 10) and the total quantity of fuel in the tanks. However, given that the sum of 2 half-full nacelle tanks would have been about 382 pounds of fuel and the pilot estimated that 580 pounds remained, that hypothesis was ruled out.

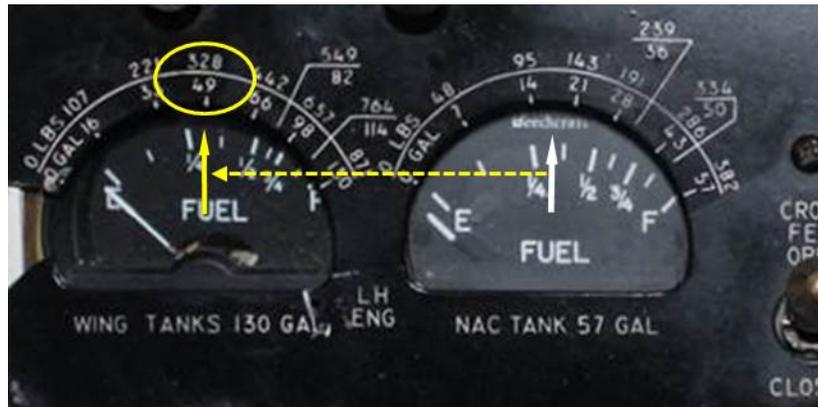
Figure 11. Transposition of the nacelle tank gauge needle to the scale of the wing tank gauge would result in a reading of approximately 300 pounds of fuel.

If the pilot transposed the gauge needle of the wing tank at the midpoint of the scale, it would have resulted in a reading of around 300 pounds for each tank, for a total of 600 pounds (Figure 11).

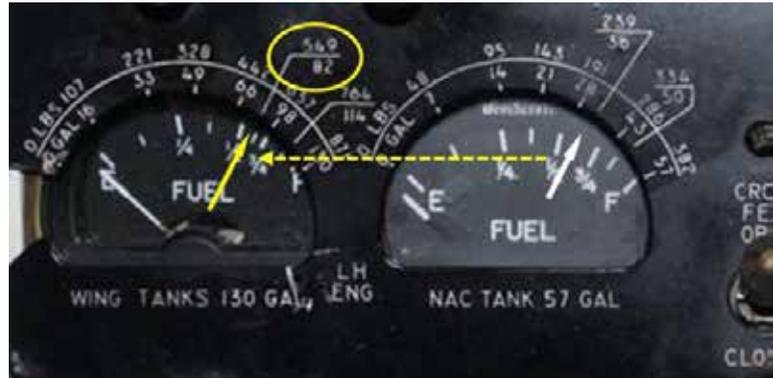
Figure 12. Transposition of the nacelle tank gauge needle to the scale of the wing tank gauge would result in a reading of approximately 1100 pounds of fuel.

Moreover, although the weight-and-balance form of the previous flight between CYUL and CYHU showed 1100 pounds of fuel, there were approximately 400 pounds on board (200 pounds in each nacelle tank) based on calculations. By transposing the needle of the nacelle tank gauge at that quantity to the scale of the wing tank gauge, one would arrive at a reading of approximately 550 pounds per tank, or 1100 pounds in total (Figure 12).

The second hypothesis could therefore explain the use of inaccurate quantities of fuel by the pilot at the beginning these 2 flights.

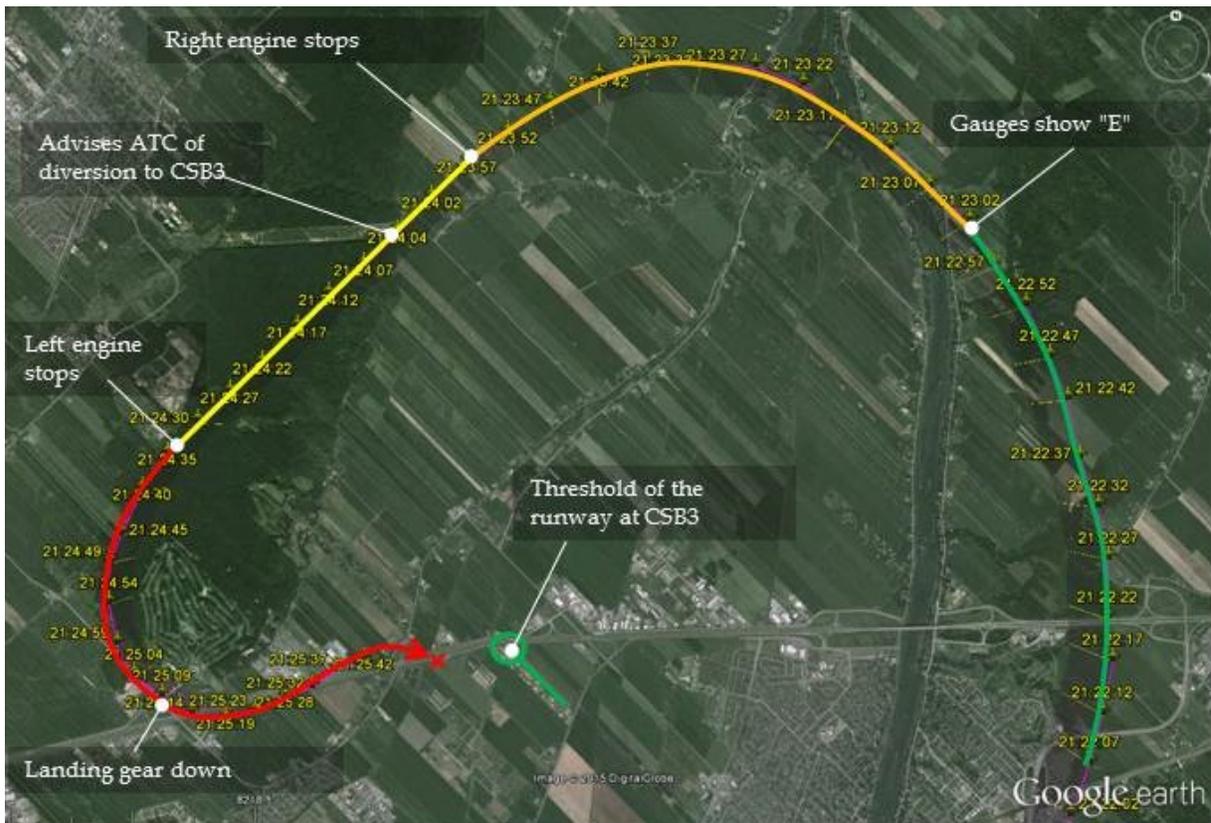
Figure 13. Flight path of C-GJSU until the moment of impact (Source: GoogleEarth, with TSB annotations)

The right engine stopped due to fuel exhaustion about one minute after the pilot noticed that the gauges were showing “E”, when C-GJSU was on the glide path 9.5 nm from Runway 24R, 2600 feet asl, and travelling at around 180 knots (Figure 13). Six seconds after the right engine stopped, the pilot advised ATC of the intention to land at CSB3, without explaining the reason for diverting.

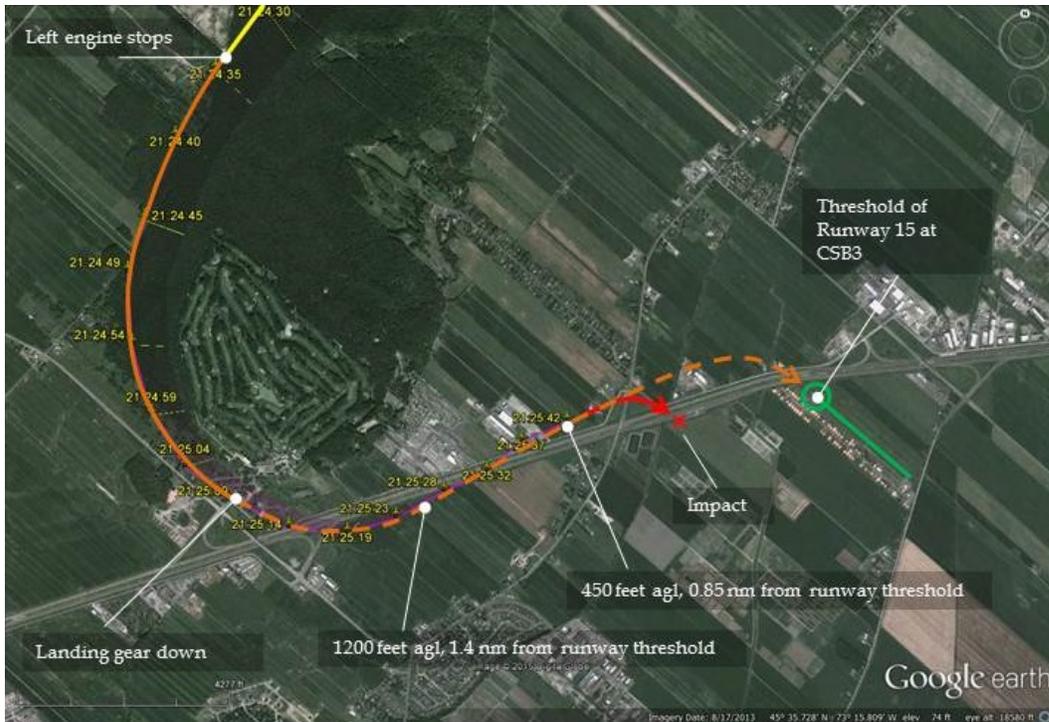
Figure 14. Flight path toward Runway 15 at St-Mathieu-de-Beloeil Airport (CSB3), Quebec (Source: GoogleEarth, with TSB annotations)

Reducing speed when the second engine stopped, from 180 knots to the stall limit, affected the movement of the selected landing point in the windshield. It was only once the aircraft had stabilized at a constant speed that a point on the ground became fixed on the windshield and represented the point on the ground that C-GJSU could reach. As a result, the reduction in speed may have delayed the pilot's decision to make a forced landing in a field (Figure 14).

The pilot's decisions and actions that reduced the glide ratio also shortened the amount of time before C-GJSU reached the ground. The high rate of descent gave the pilot less time in which to choose a field, formulate a plan, and prepare the aircraft and the passengers for a forced landing. As a result, the pilot was likely task-saturated and focused all attention on flying the aircraft until realizing, at approximately 450 feet agl, that the aircraft would not be able to reach the runway at CSB3.

Therefore, 12 seconds before impact, the pilot initiated a right turn toward a field bordered by electrical wires. Nine seconds before impact, the stall warning horn began sounding continuously until the right wing struck the ground 40 feet short of the selected field, at an angle of approximately 45°.
