RAILWAY INVESTIGATION REPORT

R01M0024

MAIN TRACK DERAILMENT

STEWIACKE, NOVA SCOTIA

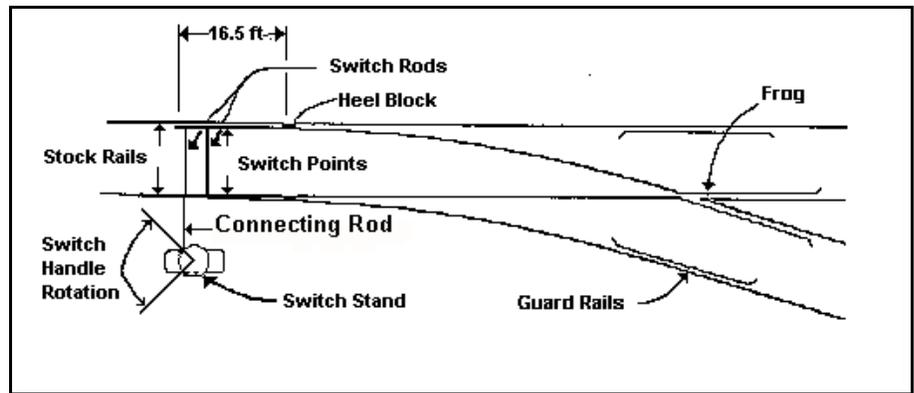
When the derailed train came to rest, the TU-29 switch stand handle was observed to be raised and sitting on top of the switch stand table and the switch points were open.

Track TU-29 was connected to the main track with a No. 10 turnout with a rated design speed of 15 mph. The distance from the tip of the switch point to the heel was 16.5 feet (Figure 7). It was noted that the tip of the switch point closest to the switch stand had some fresh markings and was slightly battered. It was also noted that the end of the switch point, by the heel block, had a slight bend. The guard rail on the main track opposite the frog was damaged by wheel impact and was bent towards the industrial spur track. There were marks noted on the base of the rail, on the ties, and in the ballast from the turnout location up to the first derailed cars. There was no track damage prior to the turnout location.

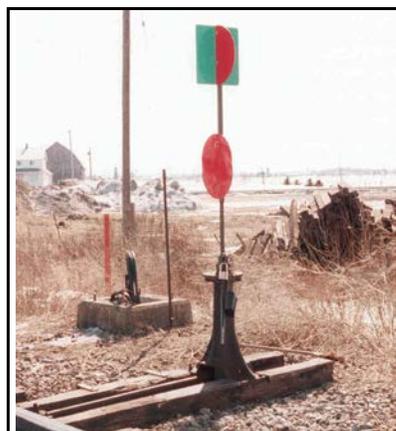
The switch stand was a standard 31B model equipped with a switch target and tip assembly (Figure 8). Due to the presence of a derail on the industrial spur track, the switch stand lever was painted yellow in accordance with CN *Standard Practice Circular* (SPC) 3603.

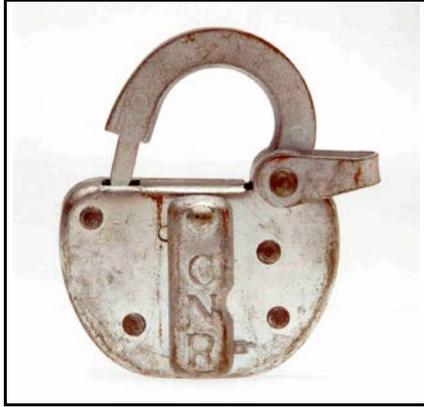
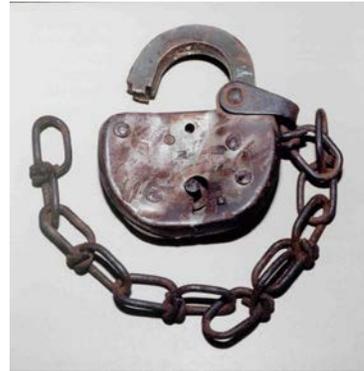
The switch stand was equipped with a standard CN switch lock (Figure 9). The clasp mechanism was broken and the switch lock was hanging loosely, suspended by the chain that affixes the lock to the switch stand. The lock had numerous dents and deformations (Figure 10).

The cause of the accident was not a matter of dispute as the damages to the switch lock and chain were a clear indication that the switch was unsecured due to tampering. The Royal Canadian Mounted Police (RCMP) conducted a criminal investigation that led to a local youth pleading guilty to ‘mischief endangering life’. As it is not the function of the TSB to assign fault or determine civil or criminal liability, the TSB investigation concentrated on all other aspects of the occurrence that would allow the further advancement of transportation safety.

Testing conducted by TSB indicated that a high-security switch lock would have been significantly less prone to damage or vandalism than the standard switch lock. To enhance safety and reduce the risk of vandalism, both CN and Canadian Pacific Railway reviewed their policies and practices regarding the installation of high-security switch locks. As a result, several thousand high-security switch locks were installed on all manually operated main track switches for both signalled and non-signalled territories. Priority was given to those locations with passenger train operations and those prone to vandalism. The applicable sections of the respective railway Standard Practice Circulars were revised accordingly to reflect the more stringent locking requirements.

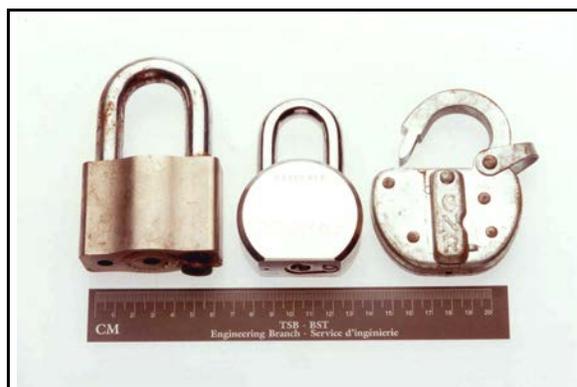
The use of high-security switch locks (Figure 11) was one outcome of *The VIA Passenger Train Speed Inquiry* (Railway Transport Committee, 1985). This inquiry was prompted by an act of vandalism to a main track switch in June of 1984 on the Smith Falls (Ontario) Subdivision of CN which caused a derailment of a VIA passenger train. Subsequent to the accident, and a *show cause*⁴ order (Order No. R-39612) issued 25 July 1986, CN implemented the widespread use of high-security switch locks in non-signalled territory, and on signalled territories that were historically prone to switch vandalism. In 1986, Order No. R-39910 governing high-security switch locks was issued to Canadian Pacific Railway Company Ltd. (CP). This order required high-security switch locks be installed on manually operated main track switches on:

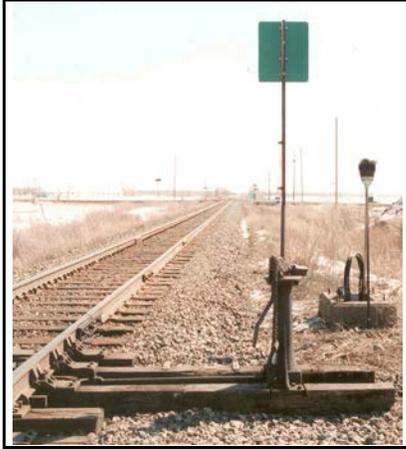
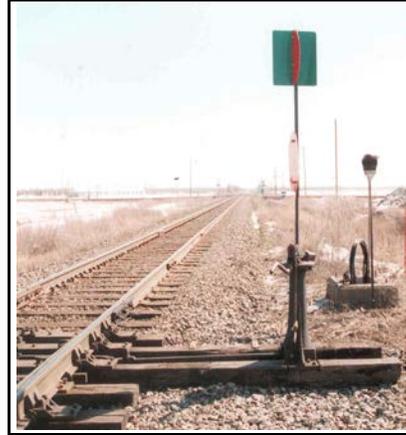
Lateral movement of the interconnected switch points, switch rod, and switch handle is required in order to rotate the switch stand mast and thereby display a red target and red tip assembly to an approaching crew, indicating that the switch is lined for the diverging route. However, when a switch stand handle is unlocked, or the switch points are even slightly open, the switch target will remain displaying a normal (e.g. green) indication, providing false information to an approaching train (figures 15 and 16).

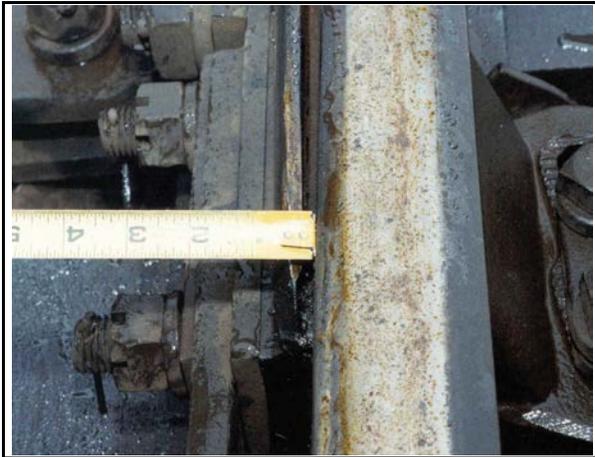
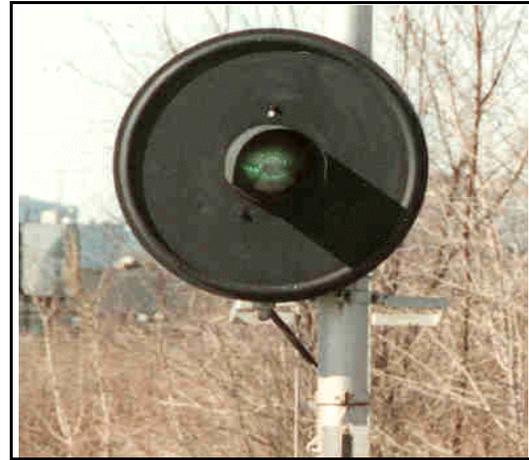
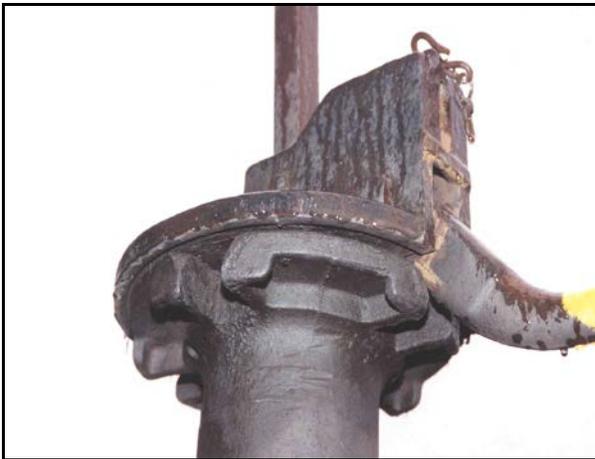
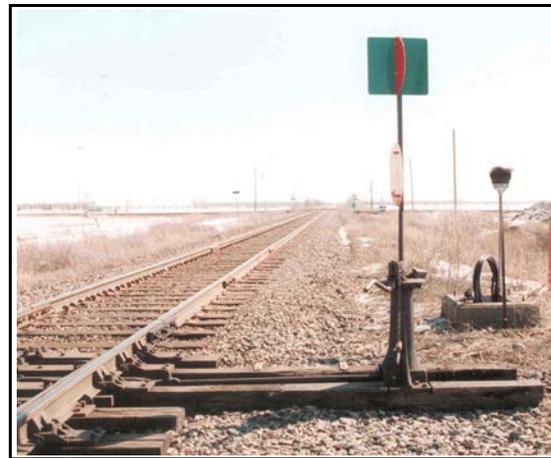
When the securement of a switch has been compromised, but the points have not moved 1/4 inch or more, the railway signal system continues to indicate to the crew of an approaching train that the switch condition is lined as intended. Also, should manually operated switch points be moved after a train has passed the last signal display location, the signal system does not communicate this change to the train crew. In such situations, an approaching train crew would be unaware of the unsafe switch position in front of them, as happened in this accident.

The lack of concordance between the information provided to the crew and the actual switch position resulted in the crew not being able to react to the unsafe condition (Figure 17).

Figure 17 - Top photographs show switch points open 3/16 inch yet a green CTC signal is displayed to a train crew. Bottom photographs show an unlocked and partially raised switch handle, yet a green switch target.
