**RAILWAY INVESTIGATION REPORT
R13D0054**

RUNAWAY AND MAIN-TRACK DERAILMENT

**MONTREAL, MAINE & ATLANTIC RAILWAY
FREIGHT TRAIN MMA-002
MILE 0.23, SHERBROOKE SUBDIVISION
LAC-MÉGANTIC, QUEBEC
06 JULY 2013**

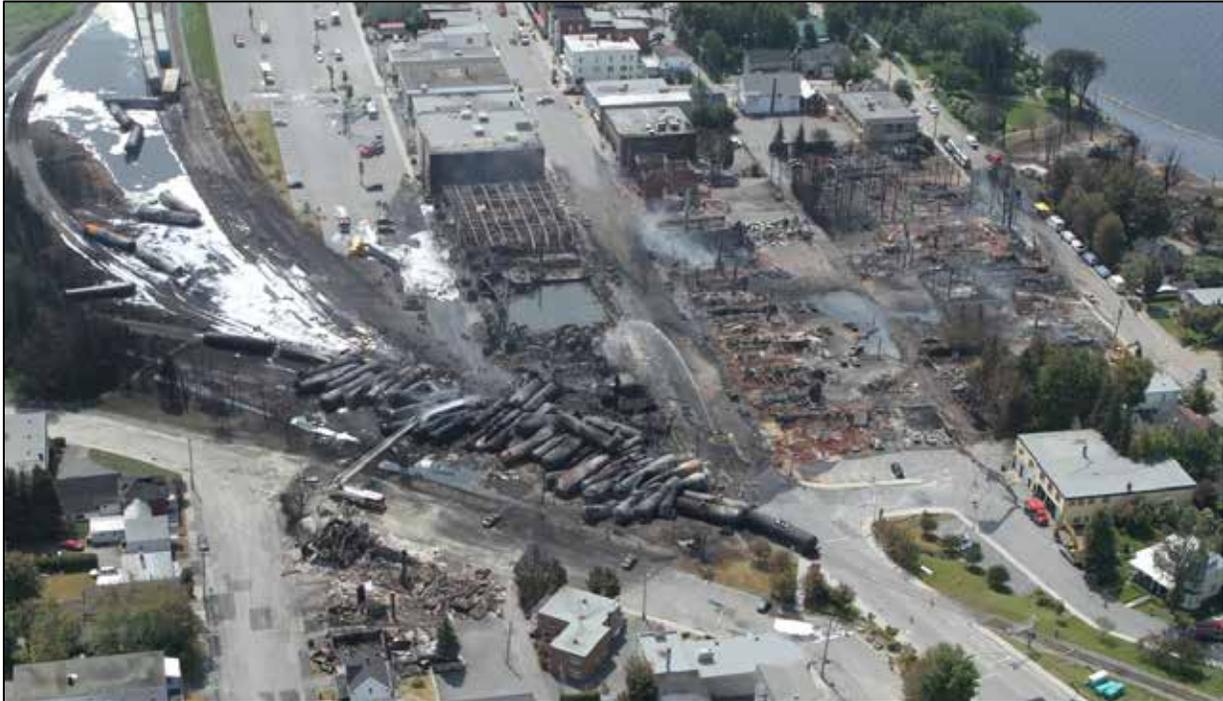
Photo 1. The Lac-Mégantic derailment site following the accident

As a result of the derailment and the ensuing fires and explosions, 47 people died, and about 2000 people were evacuated. Forty buildings and 53 vehicles were destroyed (Photo 1).

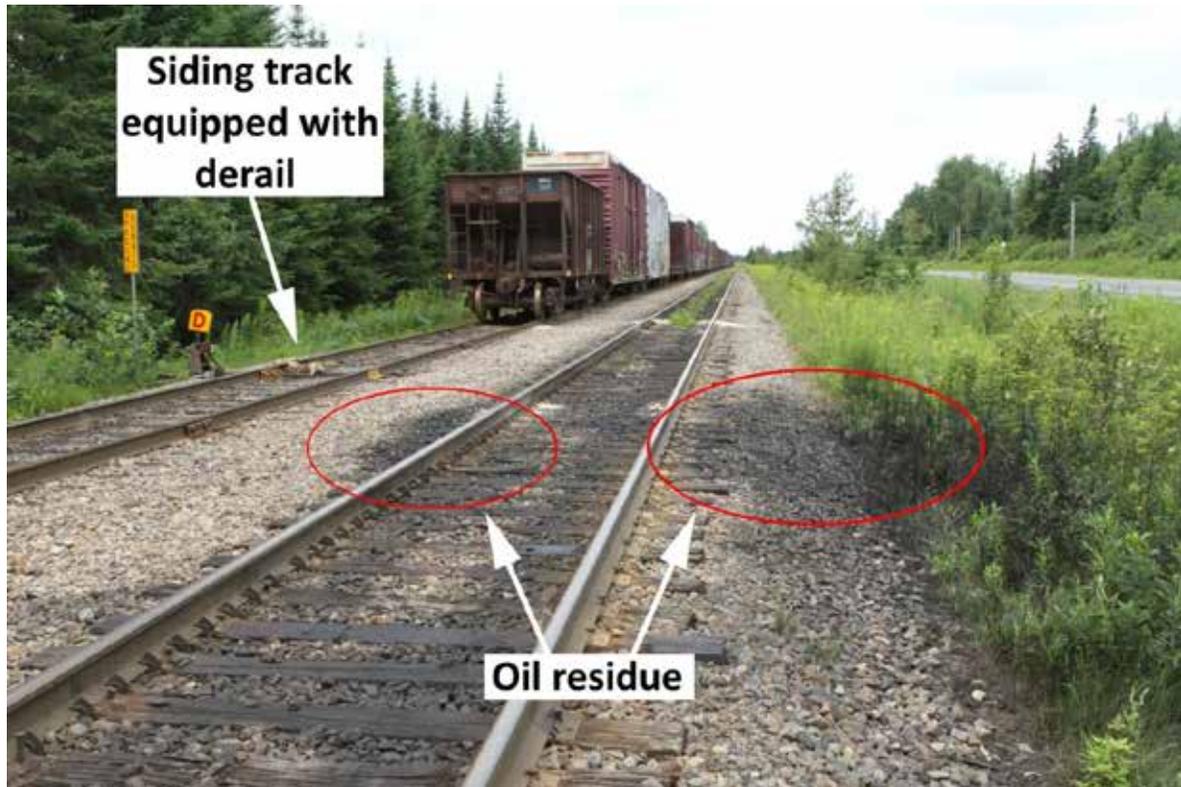
Railway lines at Nantes are located in a rural area where the main track and a siding run parallel and immediately adjacent to public highway 161. The average descending grade on the main track where the train was parked is 0.92%.⁹ During site examination, a black oily residue was found on the surrounding vegetation and on the rails where the lead locomotive was parked (Photo 3).

Photo 3. Oil residue on the ground and vegetation at Nantes. Note derail on adjacent siding track on left (view westward from the location where the lead locomotive was parked on the main track).

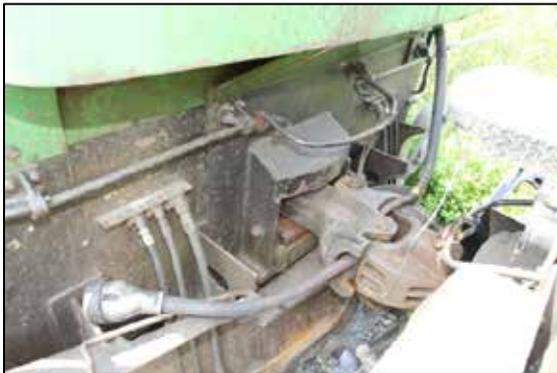
- One of the knuckles connecting the second locomotive (MMA 5026) and the third locomotive (CITX 3053) was broken, and a locomotive connector cable had been pinched between the knuckles (Photo 7), indicating that a separation had occurred and the consist had rejoined.

Photo 7. Pinched connector cable between couplers of second and third locomotives (occurring after the accident)

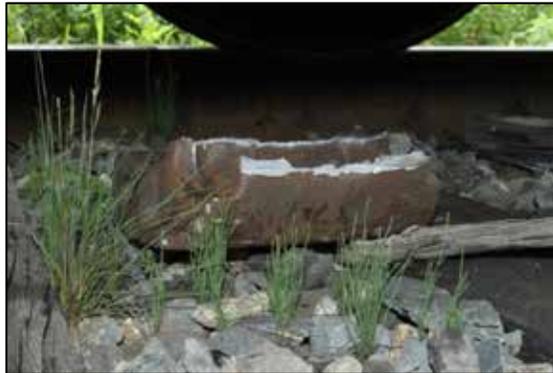
- A broken piece of the knuckle was found under the second locomotive, approximately 15 feet from the coupling (Photo 8). The locomotive knuckle and pin failed in tensile overstress mode, initiating at pre-existing fatigue cracks (Engineering Laboratory Report LP184/2013).

Photo 8. Broken locomotive knuckle segment found under the second locomotive

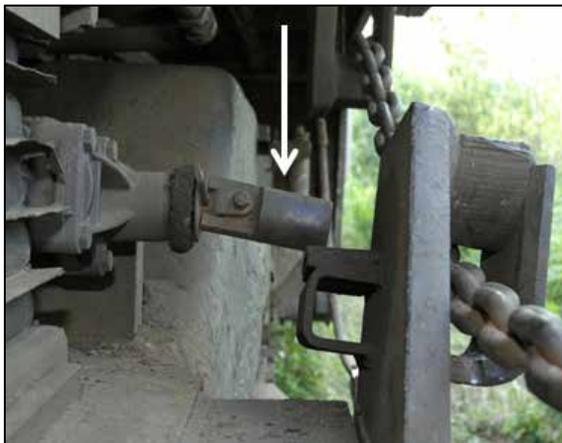
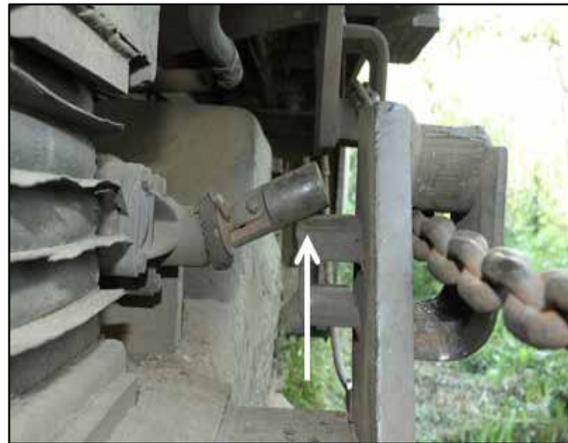
The QRB valve on the second locomotive (MMA 5026) did not trip to exhaust brake cylinder air when tested. An examination of the valve showed wear and damage to the QRB valve's lifter and inside surface of the retaining disc. In addition, the examination showed that non-standard repairs had been applied to the valve's release mechanism in an attempt to keep the valve working.

If the QRB valve does not trip, the hand brakes will not provide any braking effort. To ensure that the hand brakes remain operational on these locomotives, MMA issued *Summary Operating Bulletin 2-276*, which stated in part:

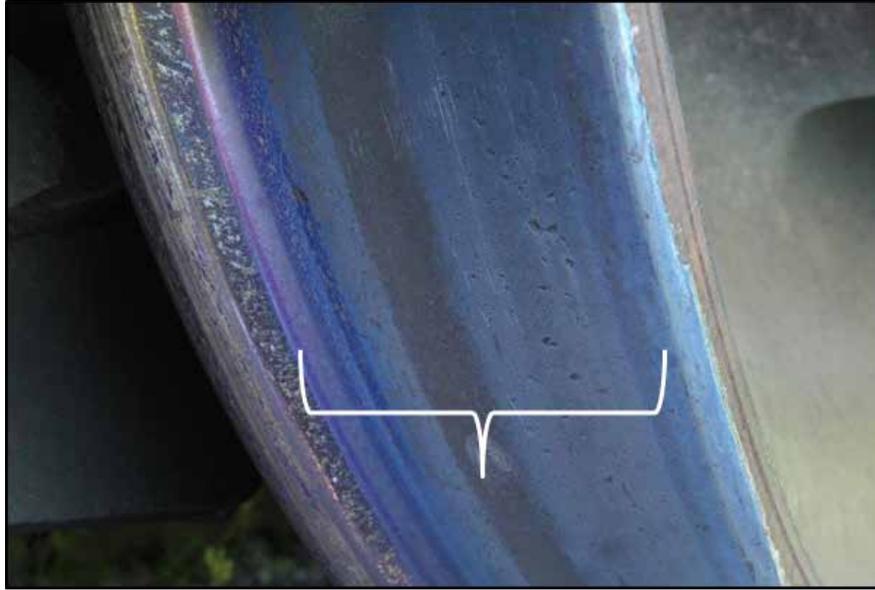
- Hand brakes were applied on all 5 locomotives and the VB car.
- There was severe wear on some of the brake shoes and various degrees of blueing¹² on most of the wheels.

Photo 12. Blueing of locomotive wheel due to heat

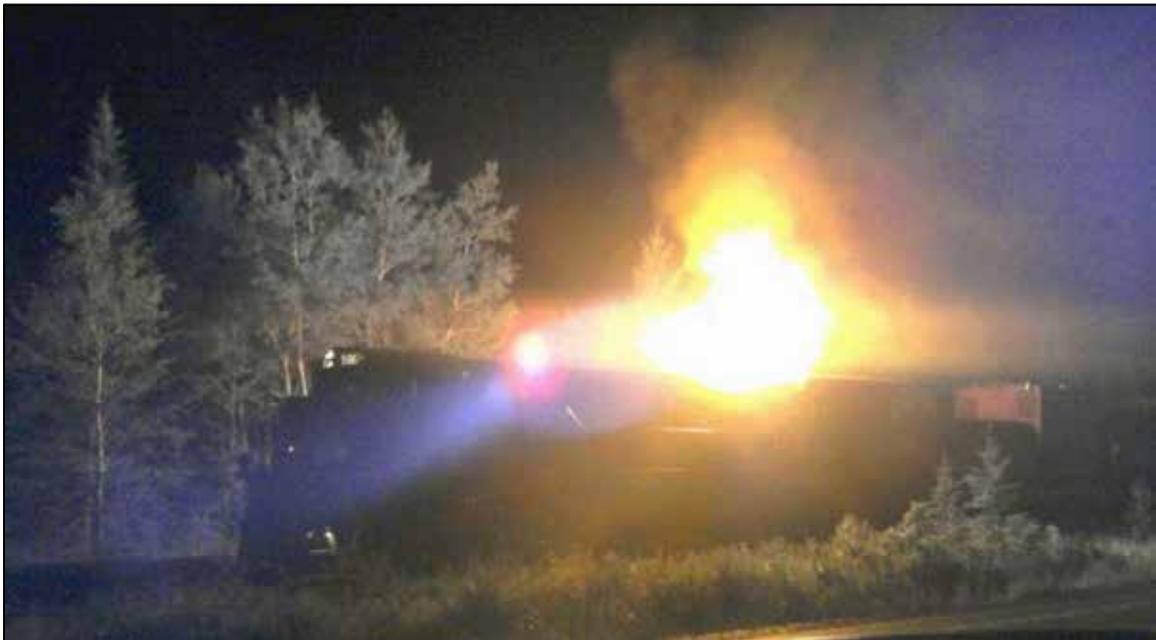
Photo 13. Locomotive fire at Nantes (photo: Nancy Cameron)

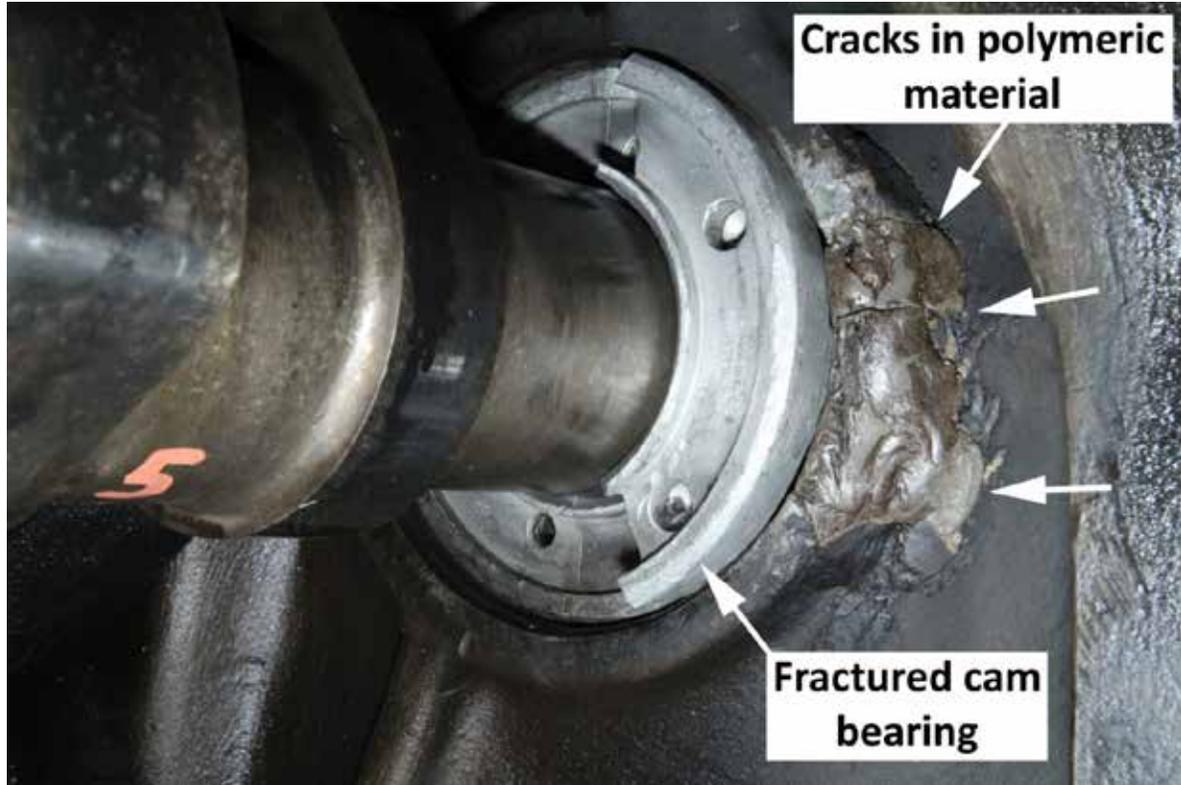
Following the accident, the locomotive consist was moved from Lac-Mégantic to a maintenance facility in Saint John for examination. A partial engine teardown of MMA 5017 was conducted (see Engineering Laboratory Report LP181/2013 for complete details). It was determined that the cam bearing had fractured when the mounting bolt was over-tightened after the cam bearing had been installed as part of a non-standard repair to the engine block. This temporary repair had been performed using a polymeric material, which did not have the strength and durability required for this use (Photo 14). Failure of the cam bearing reduced the engine oil supply to the valve train at the top of the associated power assembly. The decreased lubrication led to valve damage and eventually to a punctured piston crown. The damaged valves and piston crown allowed engine oil to flow into the cylinder and the intake and exhaust manifolds. Some of the engine oil collected in the body of the turbocharger. The engine fire later occurred in the exhaust stack due to the build-up and ignition of engine oil in the body of the turbocharger.

Photo 14. Polymeric material applied to cam bearing bore and fractured cam bearing

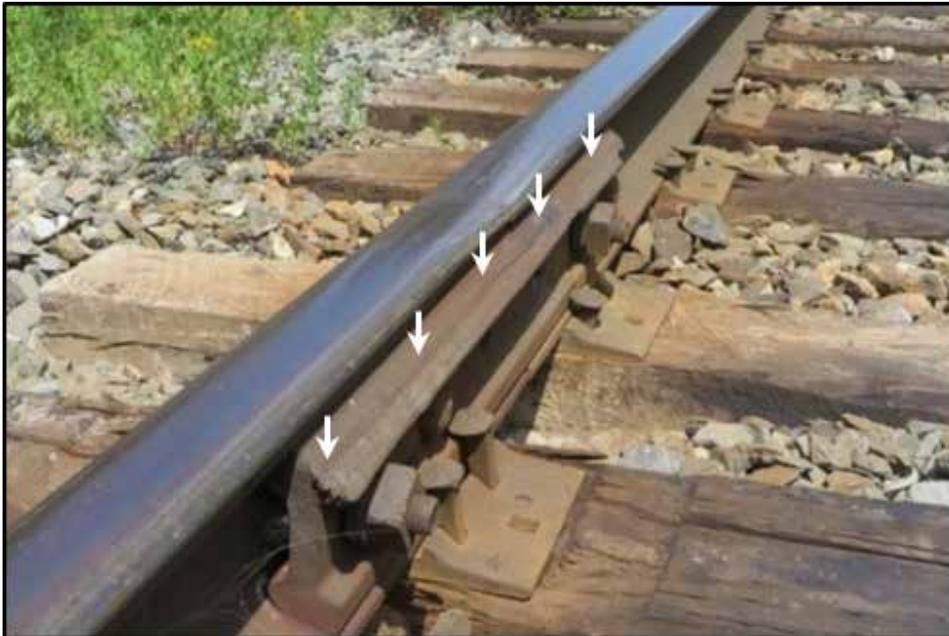
Photo 15. Damaged rail joint bar due to contact with wheel flanges

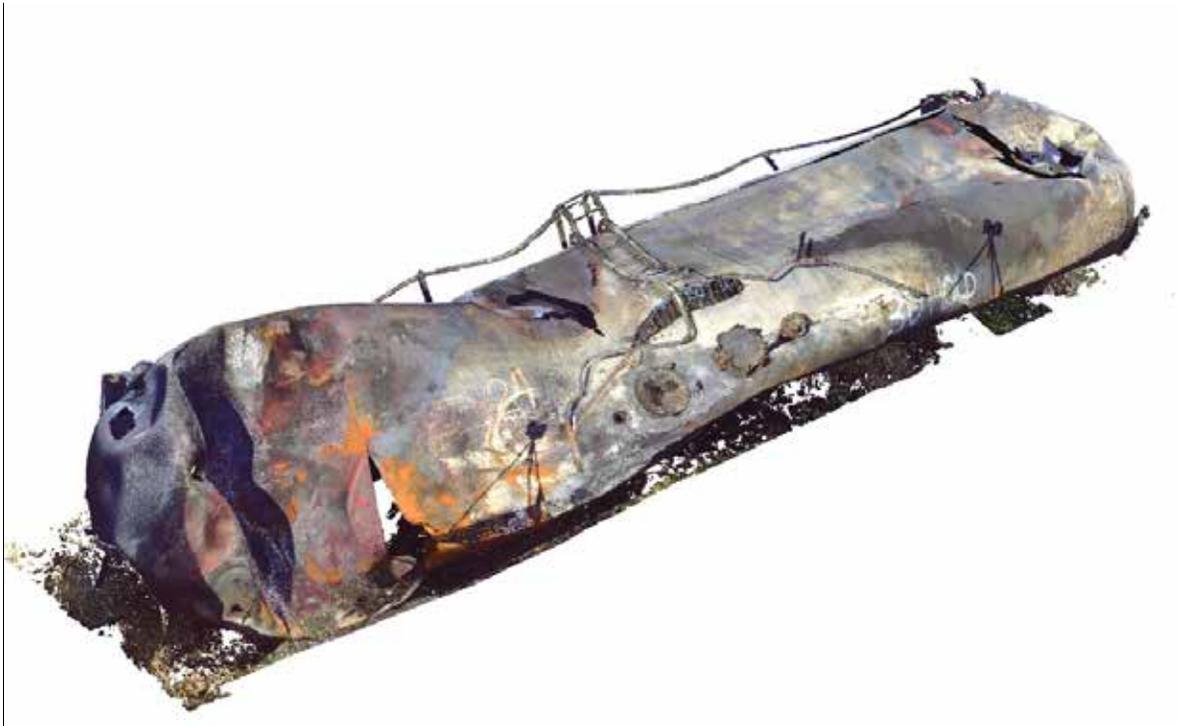
Photo 16. 3D laser scan of badly deformed tank

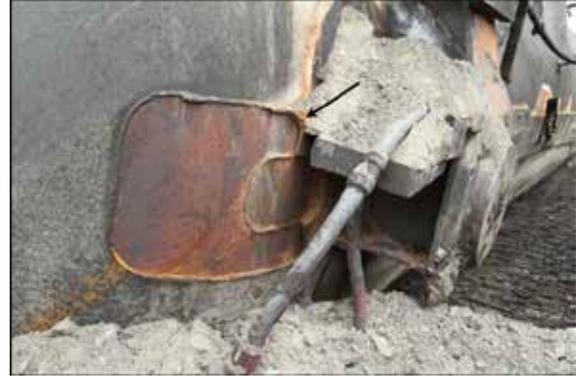
Photo 18. Damaged stub sill

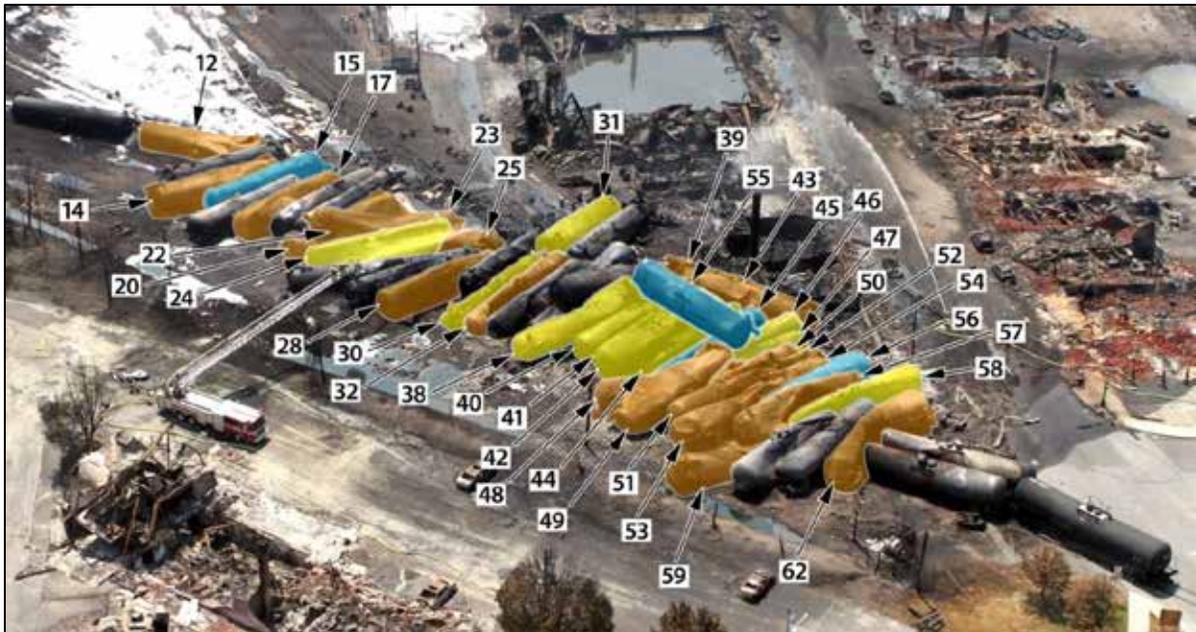
More than half of the tank cars (37 cars) released product due to impact damage to their shells (Photo 19). Other tank car shell damage included deformed/dented shells with no breach, as well as breaches due to thermal tears.

Photo 19. Tank cars with breaches to their shells (colour indicates relative size of breach: orange = large, yellow = medium, blue = small). The relative size of the breaches is also identified in Appendix B.

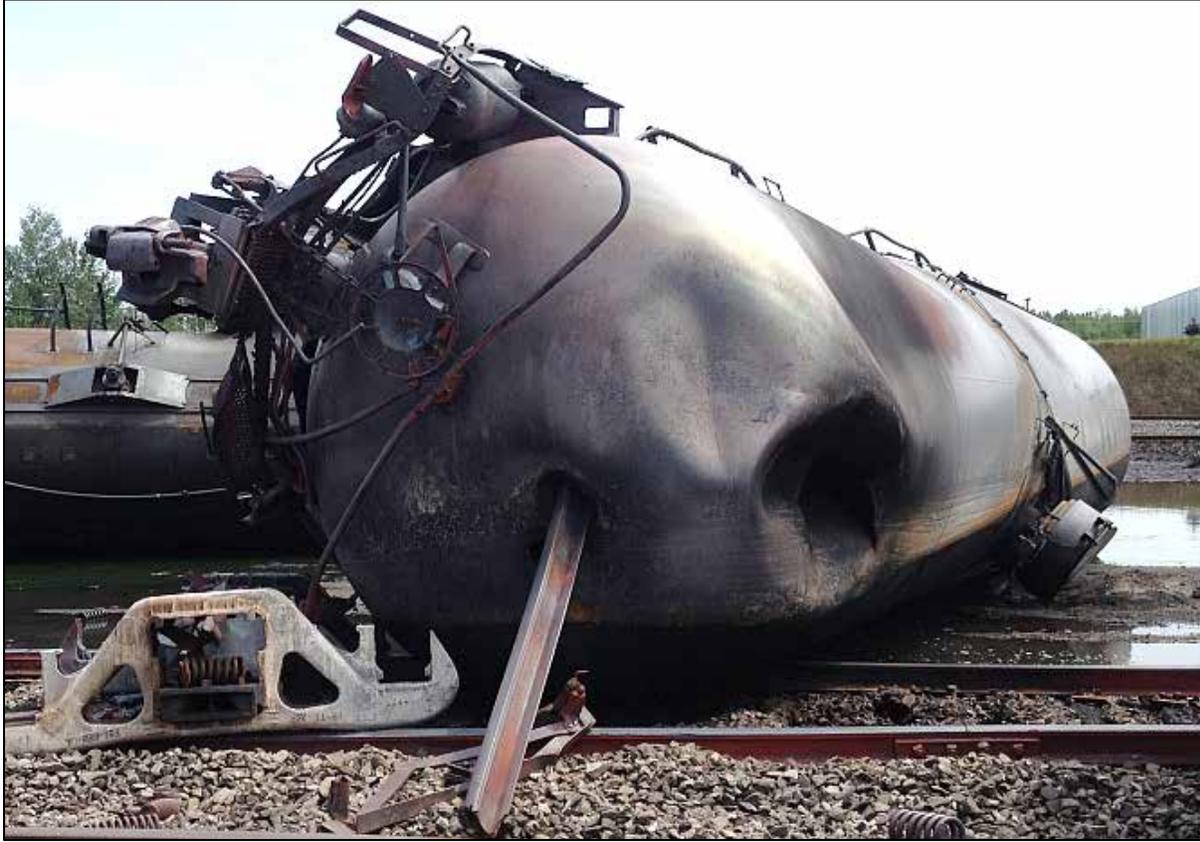
All but 4 of the 63 derailed cars exhibited some form of impact damage (for example, denting or breach) in the top portion of at least one head (Photo 20). About half of the tank cars (31) released product due to damage to the tank car head.

Photo 20. Head puncture due to rail impact

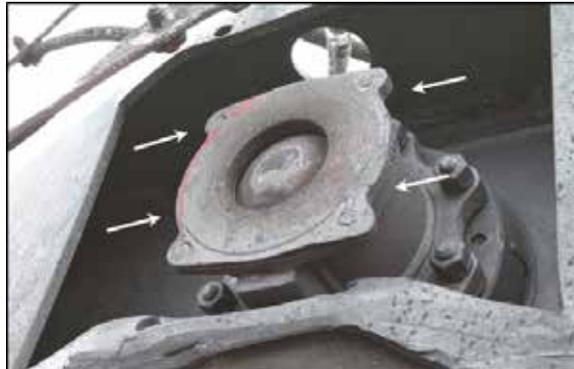
Photo 26. Bottom outlet valve with sheared-off nozzle

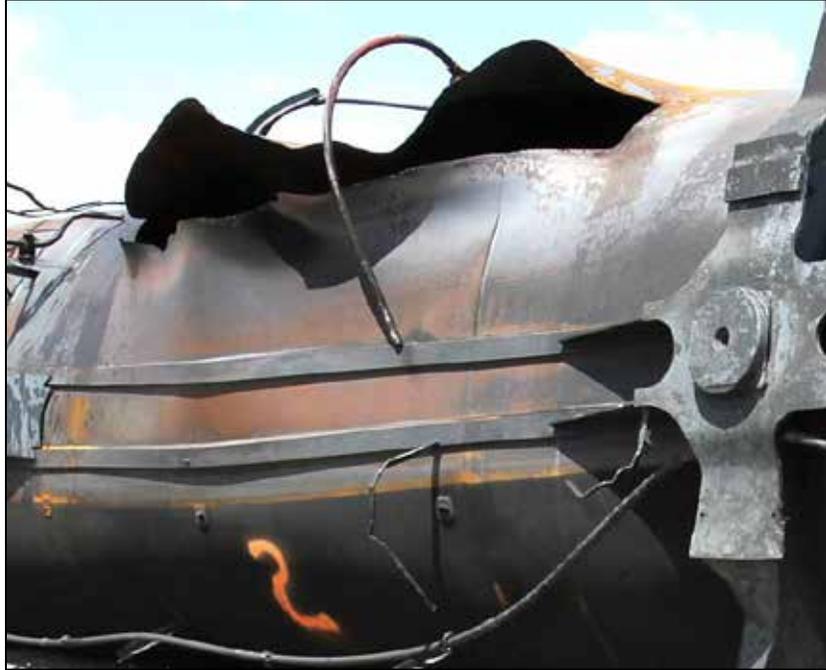
Photo 27. Thermal tear

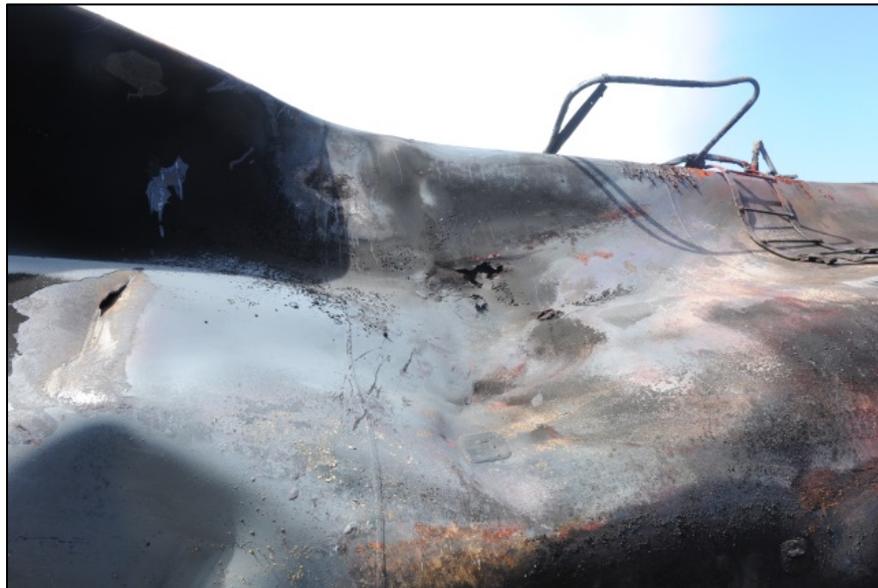
Photo 28. Burn-through

⁴⁵ A burn-through is a perforation of the tank shell caused by fire damage.

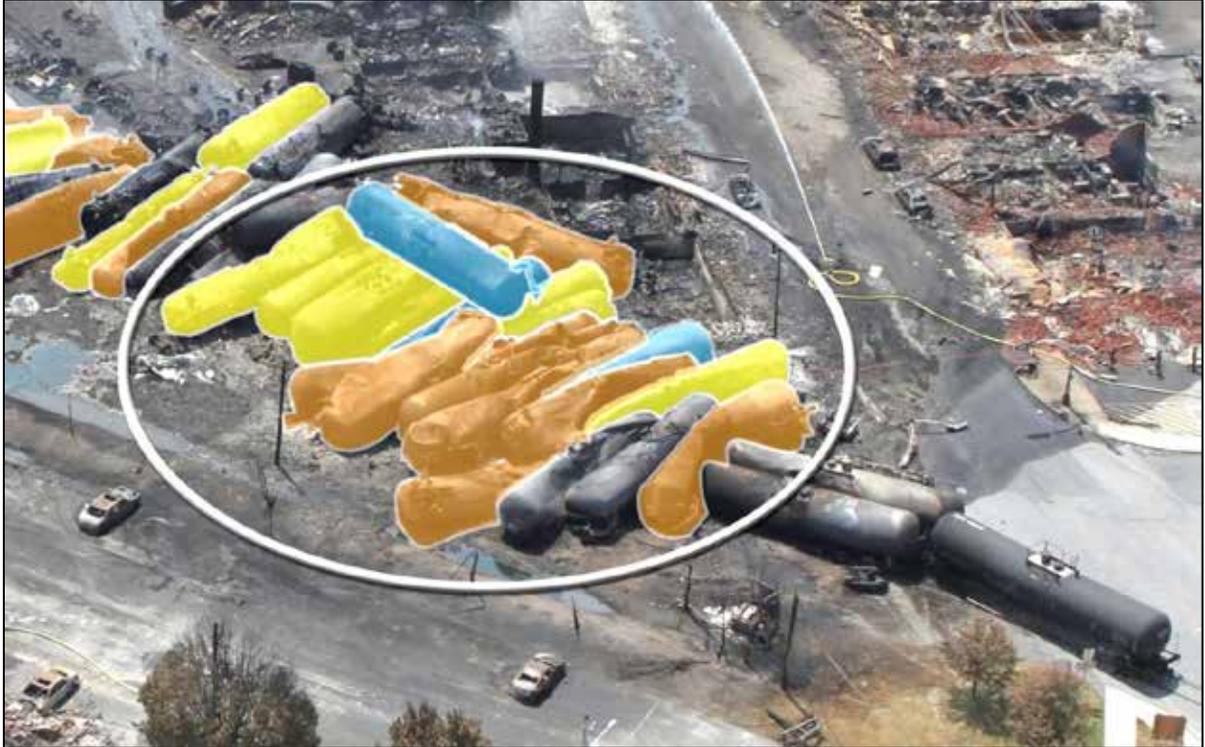
Photo 30. Concentration of large (orange) and medium (yellow) breaches toward the end of the derailment

About half of the cars with large breaches were clustered toward the end of the derailment. These cars would have encountered more severe derailment conditions than the conditions experienced by the cars located toward the front of the train, due to the large pileup ahead of them. This pileup likely acted as a wall for the cars derailing toward the end of the train. These highly constrained derailment conditions caused large-scale buckling and extreme tank deformations (that is, plastic collapse), which resulted in large shell ruptures. These cars derailed at a slower speed, and came to rest perpendicular to the track. Their thin wall construction (7/16 inch), as well as the absence of jackets, did not provide sufficient protection from the derailment forces. Consequently, large tank shell breaches occurred in a short period of time on about 1/3 of the derailed tank cars, which resulted in the rapid release of large quantities of petroleum crude oil.
