Transportation Safety Board
of Canada

SAFETY ISSUES INVESTIGATION REPORT

SII R05-01

ANALYSIS OF SECONDARY MAIN-LINE DERAILMENTS AND THE RELATIONSHIP TO BULK TONNAGE TRAFFIC

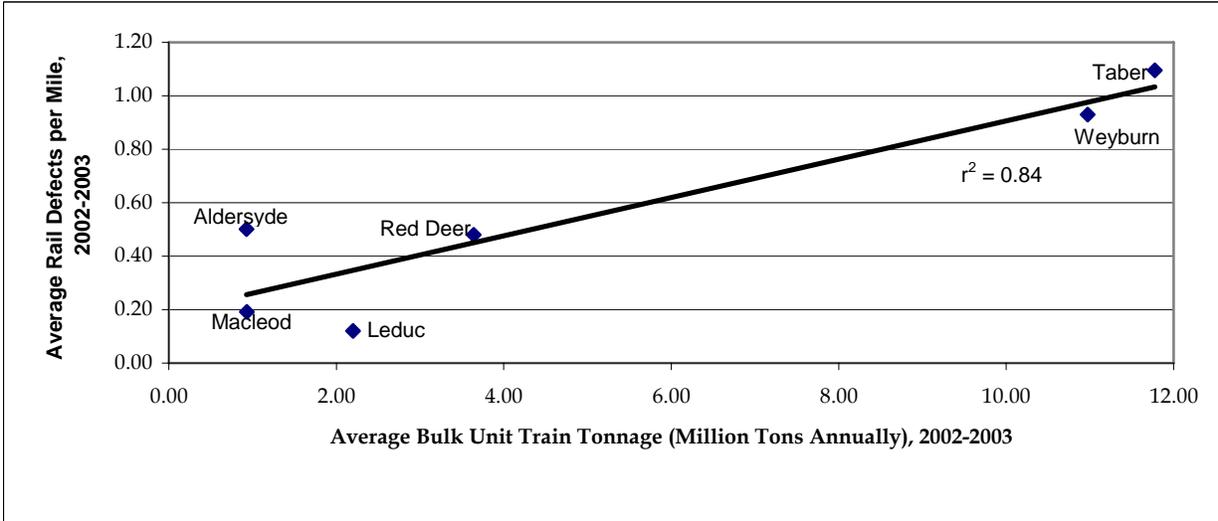
Figure 3. Relation of rail defect rate to bulk unit train tonnage on six CPR western subdivisions

The correlation of bulk unit train tonnage to rail defects per track mile was significant ($r = 0.92$, $p < 0.05$), indicating that 84 per cent of the variance in the number of rail defects is accounted for by bulk unit train tonnage, as shown in Table 3 and Figure 3. This means that there is a strong direct relationship between overall rail defect rates and annual bulk unit train tonnage for the six subdivisions that met the selection criteria.

The correlation of overall tonnage to rail defects per track mile was not statistically significant. Additionally, the correlation of rail defects per track mile to SRI was not statistically significant.

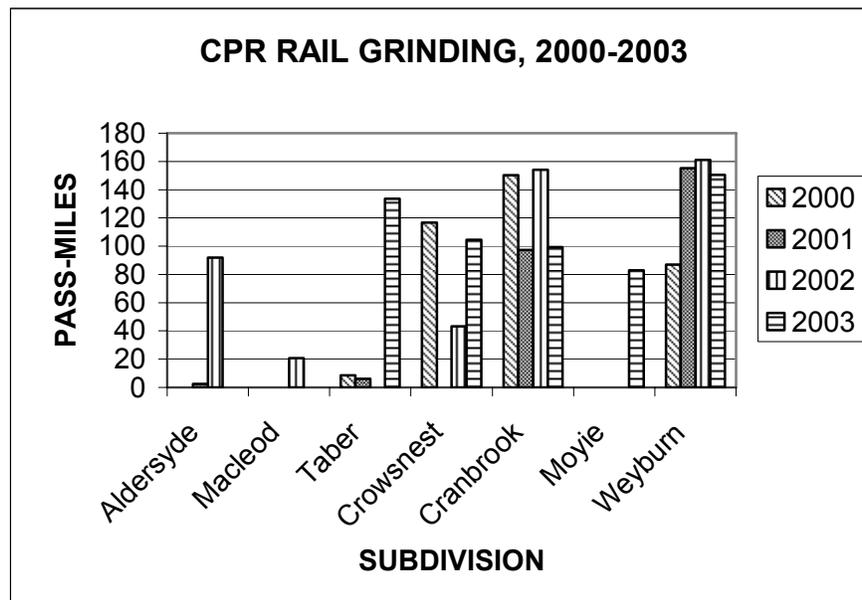
Figure 4. Rail grinding activity on selected CPR subdivisions, 2000-2003

All subdivisions that are part of this investigation received some grinding in recent years (see Figure 4). Being secondary main lines, the grinding was corrective and was performed in multiple passes less frequently. The time between corrective grinding programs may allow surface defects to develop and propagate, resulting in an increased incidence of undetected rail defects.
