RAILWAY INVESTIGATION REPORT
R07D0009

MAIN-TRACK TRAIN DERAILMENT

CANADIAN NATIONAL
FREIGHT TRAIN M-31031-10
MILE 99.13, DRUMMONDVILLE SUBDIVISION
DRUMMONDVILLE, QUEBEC
12 FEBRUARY 2007

Report Number R07D0009

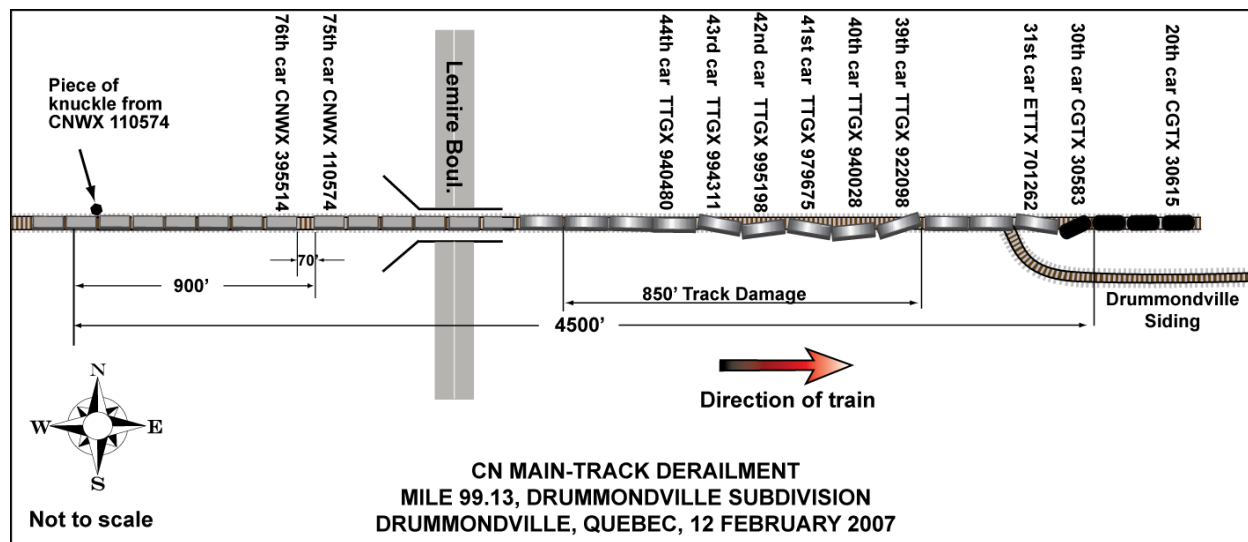
Figure 2. Site diagram

All derailed cars remained upright and sustained minimal damage. The cars jackknifed along the main track and derailed in two groups. The 30th car (CGTX 30583), a 59-foot-long empty tank car, and 31st car (ETTX 701262), a 93-foot-long loaded multi-level automobile car, separated and derailed at Mile 99.13. Wheel flange marks were observed on the head of the south rail between the two cars. The trailing end of the 30th car derailed to the south side of the track while the south-side wheels of the 31st car's lead truck dropped between the rails, near the Drummondville Siding west switch at Mile 99.20 (see Figure 2).

The second group (39th to 44th cars) were all 93-foot-long loaded multi-level automobile cars that derailed at Mile 99.24. Each of these cars came to rest across the track; the rails had rolled out from beneath them. The Drummondville Siding west switch and approximately 850 feet of main track were damaged. The derailed cars were examined and no pre-derailment defects were noted.

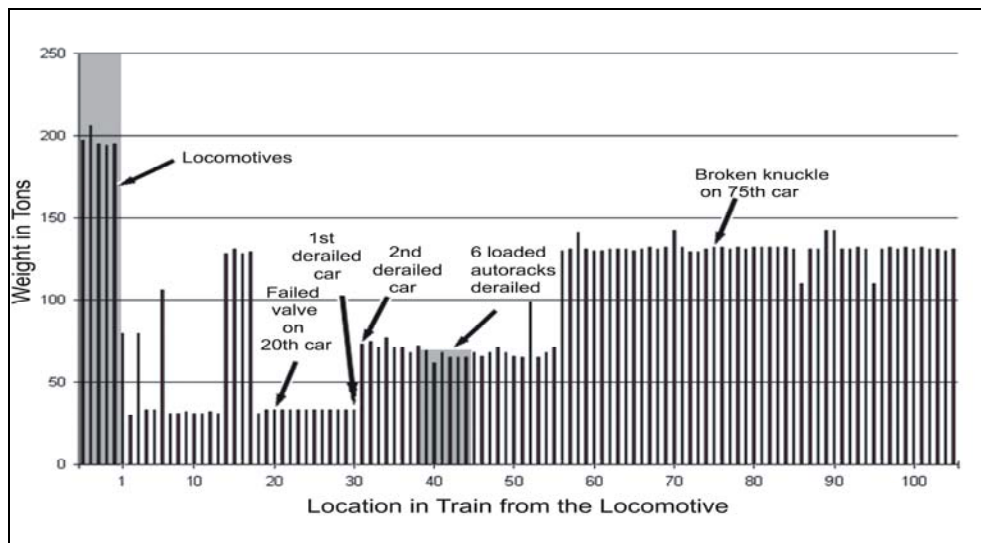
Figure 3. Train tonnage distribution

The train was marshalled with a mix of 23 empties and 7 loads in the head-end 30 cars, followed by a block of 25 loaded multi-level automobile cars equipped with long travel (10 inches) hydraulic end-of-car cushioning devices (EOCCD) and a block of 50 heavily loaded grain cars equipped with conventional draft gears on the rear of the train (see Figure 3).

The Association of American Railroads (AAR) *Train Make-Up Manual*³ indicates that cars equipped with EOCCD add to train slack and can greatly increase in-train forces. Specifically, the manual states that large blocks of EOCCD-equipped cars should not be placed ahead of large blocks of loaded cars with conventional draft gears.
