# INFORMATION FLOWING BUT:

INFORMATION KNOWN, BUT DID NOT REACH THE RIGHT PEOPLE

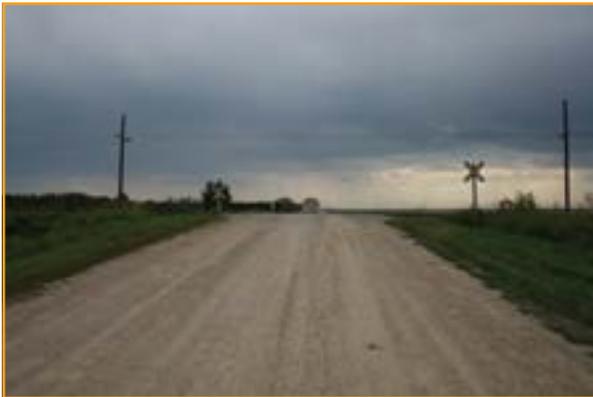
## R12W0182

On 9 August 2012, at about 1835 Central Standard Time, Canadian Pacific Railway freight train 205-09 was proceeding westward at 53 mph when it struck a southbound camper van at a passive public crossing equipped with crossbucks, located at Mile 128.90 on the Broadview Subdivision, near Broadview, Saskatchewan. The camper van was destroyed and 4 of the 6 vehicle occupants were fatally injured.

TC conducted a detailed inspection of the crossing a year before the accident. Although the sightlines were compromised and did not meet Guideline G4-A requirements. Transport Canada determined that the sightlines were adequate and did not require any mitigation and it did not notify the railway. Following the accident, brush-cutting was required at at least 13 crossings on the Broadview subdivision with obstructed sightlines.

If sightline maintenance activities are reactive, sightline obstructions may not be addressed until after they have compromised a driver's ability to assess whether or not a train is approaching, which increases the risk of an accident.

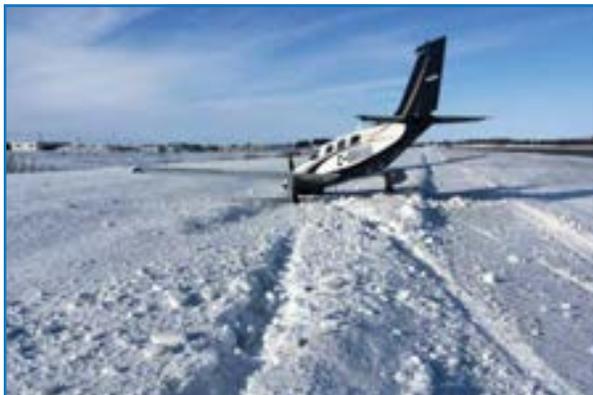
## A14Q0011

On 23 January 2014, the privately operated Piper PA-46-350P Malibu Mirage departed Mirabel Airport, Quebec, at 0848 Eastern Standard Time, for Alma, Quebec, with 1 pilot and 1 passenger on board. The flight was uneventful, and the aircraft landed at 1002 on Runway 31. As the nose wheel contacted the runway, directional control was lost. The aircraft veered left and departed the runway surface 400 feet after the loss of control. The aircraft came to a stop about 100 feet from the runway edge in a compacted snow bank, approximately 2200 feet from the threshold of Runway 31. There were no injuries.

Inspection criteria for this type of aircraft were modified after the accident. However, the requirements in the Special Air Worthiness Bulletin are not mandatory.

If the requirements prescribed in Service Bulletin 1103E are not made mandatory for operators in Canada, then there is a continued risk that fatigue cracks may not be discovered in a timely manner to prevent a similar occurrence.

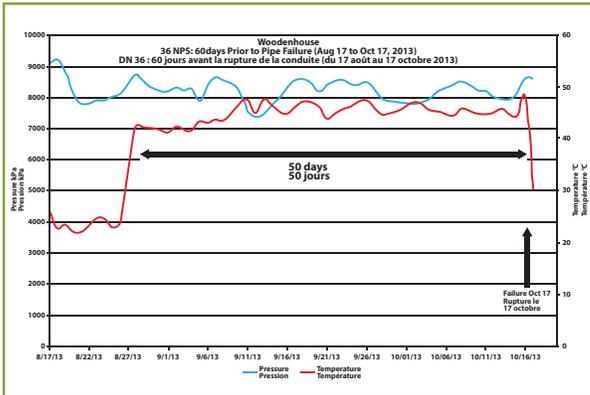
## P13H0107

At about 0235 Mountain Standard Time on 17 October 2013, a pipeline rupture occurred on TransCanada PipeLines Limited's (NOVA Gas Transmission Ltd.) 914 mm diameter North Central Corridor Loop Buffalo Creek West Section pipeline, located southwest of Fort McMurray, Alberta. A crater was created and 5 fragments of pipe were ejected up to approximately 130 m from the rupture site. An estimated 16.5 million cubic metres of natural gas was released. There was no fire, no injuries and no evacuation.

**AS TO CAUSES AND CONTRIBUTING FACTORS:** The use of the incorrect design parameter and the non-conservative temperature decay model were not identified by TransCanada PipeLines Limited's quality assurance process.

**AS TO RISK:** If the stress analysis conducted during pipeline design does not fully address the potential operating envelope (i.e., pressure and temperature), the pipeline or its components may not be sufficiently robust, increasing the risk of in-service ruptures.

**AS TO RISK:** If a pipeline company's integrity management program does not identify and mitigate the threat of improper design, there is an increased risk of pipeline rupture when operating near the upper limits of the pipeline.

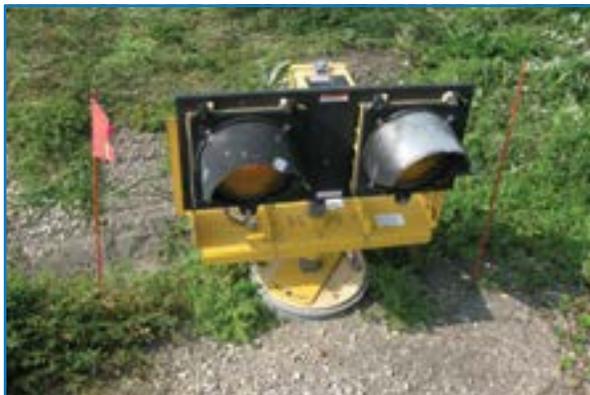
## A14C0112

On 04 August 2014, the ground controller at Winnipeg Richardson International Airport, cleared WestJet Encore Ltd. flight WEN3112, to taxi for departure via Runway 31 and to hold short of Runway 36. The WEN3112 crew acknowledged the clearance to hold short of Runway 36. When the tower controller observed that WEN3112 had entered the Runway 36 protected area at the intersection with Runway 31 without a clearance, he then instructed another flight, which was on short final for Runway 36, to go around.

**AS TO CAUSES AND CONTRIBUTING FACTORS:** The orientation of the runway holding position signs was optimized for traffic on Runway 31, which likely contributed to the pilots not identifying the hold-short position.

The fact that the left runway guard light (RGL) was aimed 15 degrees away from Runway 31, the orientation of the right RGL relative to the aircraft's position, and the reduced RGL intensity setting likely contributed to the pilots not identifying the hold-short position.

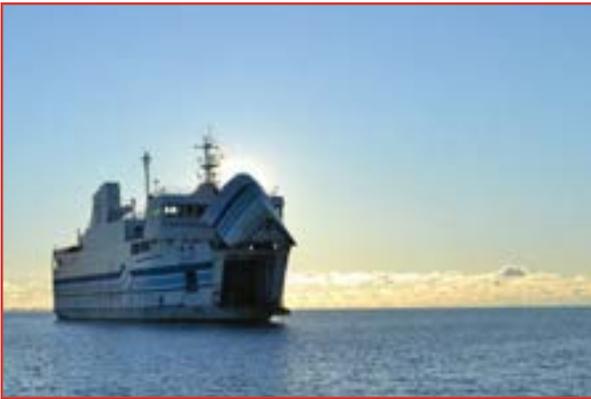
## M12C0058

On 11 October 2012, at approximately 1340 Eastern Daylight Time, the passenger vessel Jiimaan grounded while approaching the ferry terminal in Kingsville, Ontario. The 34 passengers and crew remained on board until the vessel was refloated at approximately 1308 the next day, after which time the Jiimaan was escorted to the port of Leamington, Ontario. There was no pollution, damage, or injuries.

This was a company who was trying to do the right things (good safety culture). They had voluntarily implemented an SMS which was audited by a third party. However, the risk assessment processes included in that SMS were weak and did not help them effectively mitigate the risk they had identified early in the season of greater than normal silting in the channel.

The absence of a risk assessment process within the company's safety management system (SMS) resulted in the risks, associated with deviating from the charted channel in response to the silting at the port of Kingsville, not being identified and mitigated.

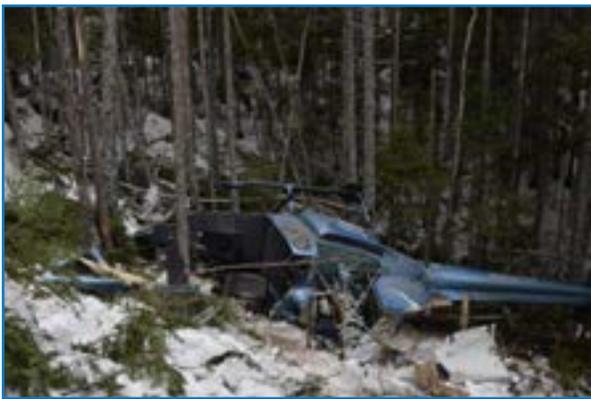
## A14Q0060

On 13 May 2014, the Héli-Boréal inc. Eurocopter AS 350 BA helicopter was on a flight to inspect power-line vegetation encroachment with a pilot and an observer on board. While completing a right turn in a valley, the pilot noticed a 315-kilovolt power transmission line crossing perpendicular to the direction of flight. The right turn was increased to avoid the transmission line, but one of the helicopter's main rotor blades struck the lower wire. The resulting damage to the rotor blade caused severe vibrations, which made it difficult to control the helicopter, which came to rest on its left side in the snow. Both occupants sustained serious injuries.

In many flight operations, whether in commercial or general aviation, charts are relied upon to assist in identifying potential hazards and navigating accurately. The accuracy of the information provided in the visual flight rules navigational charts must allow a pilot to safely perform a flight. NAV CANADA is responsible to provide accurate aeronautical data to the user or pilot. Many electronic digital navigation system manufacturers use NAV CANADA's information for their databases. Any erroneous or missing information is therefore propagated throughout the aviation community. The existing request process for obstacle data showed mixed results.

If the data collection process to update aeronautical information products does not function effectively, there is a risk that these products may not contain the information required to ensure the safety of flight.

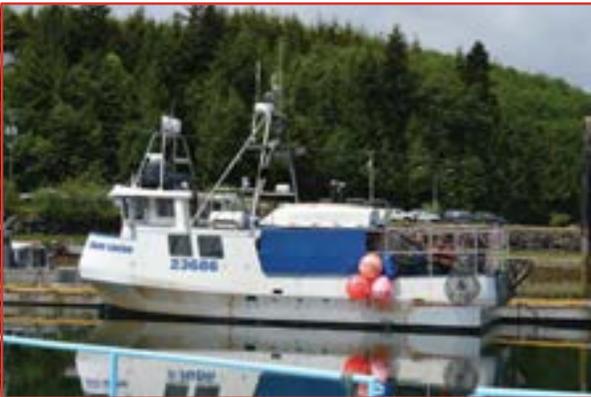
## M14P0110

On 06 June 2014, at approximately 1045 Pacific Daylight Time, a crew member on the fishing vessel Diane Louise went overboard while setting prawn traps 9 nautical miles west of Calvert Island, British Columbia. Although the crew member was recovered within minutes, he was unresponsive upon recovery.

If fishermen do not conduct comprehensive risk assessments, despite being aware of many workplace hazards and risks, unsafe work practices may persist or develop.

If fishermen continue to not wear PFDs or lifejackets while working on deck, despite the industry awareness initiatives and regulations requiring their use, there is an increased risk of drowning when overboard.

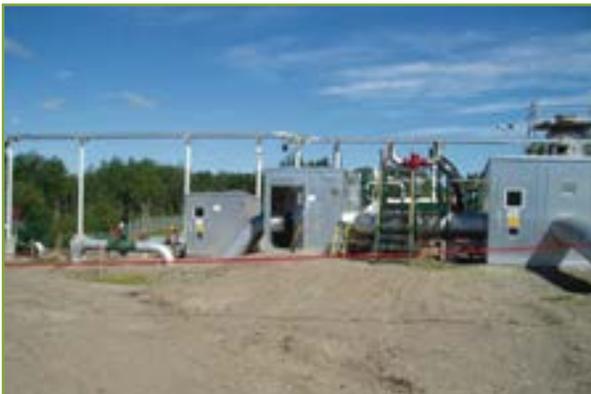
## P12H0103

On 23 June 2012, at approximately 1200 Mountain Standard Time, an ignition and fire occurred in a valve-enclosure structure at Spectra Energy Transmission Compressor Station N4, located approximately 160 km northwest of Fort St. John, British Columbia. Two maintenance employees sustained burn injuries when sweet natural gas that had been leaking from a station valve ignited. The 2 employees were performing annual inspection work on motor-operated valves.

When risk adaptation occurs and perceived risk is diminished, cues to potentially hazardous situations (e.g., the presence of leaking gas) will be overlooked, increasing the potential for workplace accidents.

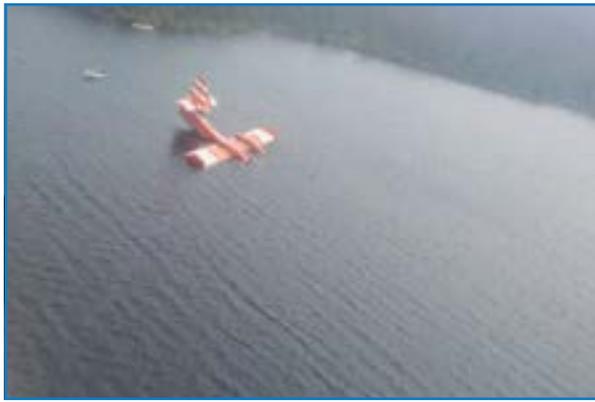
## A13A0075

On 03 July 2013, at about 1415 Atlantic Daylight Time, the Government of Newfoundland and Labrador Air Services Division Bombardier CL-415 amphibious aircraft, operating as Tanker 286, departed Wabush, Newfoundland and Labrador, to fight a nearby forest fire. Shortly after departure, Tanker 286 touched down on Moosehead Lake to scoop a load of water. About 40 seconds later, the captain initiated a left-hand turn and almost immediately lost control of the aircraft. The aircraft water-looped and came to rest upright but partially submerged. The flight crew exited the aircraft and remained on the top of the wing until rescued by boat.

The occurrence resulted from a loss of control following a scooping run in which too much water was scooped resulting in the aircraft being overweight. The auto probes system was not set prior to the scooping run. Water cooler talk among the pilots prior to the occurrence included the fact that this item was not on the checklist and had led to similar overweight situations. This issue was not raised through any formal process partly because these processes did not exist.

If companies do not have procedures for recording overweight take-offs and flight crews do not report them, then the overall condition of the aircraft's structures will not be accurately known, which could jeopardize the safety of flight. If organizations do not use formal and documented processes to manage operational risks, there is an increased risk that hazards will not be identified and mitigated.

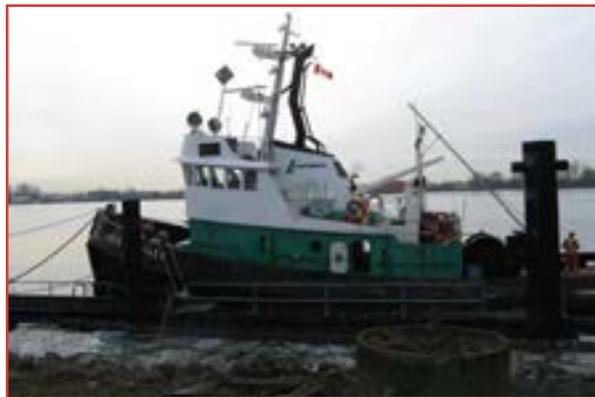
## M14P0023

On 11 February 2014, at approximately 0305 Pacific Standard Time, the tug Jose Narvaez, while towing the empty barge TCT 8000 down the South Arm Fraser River, British Columbia, sustained a loss of propulsion due to a main engine seizure. The tug and barge were towed back to the Lafarge marine dock and secured. The main engine was deemed a constructive loss; there were no injuries or pollution.

The Jose Narvaez was not required to have an SMS in place. Deficiencies in operations included the following:

- On-board documentation to support crew members on aspects such as training, familiarization, drills, and maintenance, was extremely limited. For example, the engine manufacturer maintenance documentation was not on board the vessel.
- The vessel crew did not maintain adequate record-keeping, including records of maintenance being done and vessel log entries.
- The company did not provide the crew with checklists to assist with the operation of the vessel or procedures related to maintenance.

If companies do not provide an adequate framework for the management of safety, which includes the implementation of procedures, documentation, and adequate record-keeping, there is an increased risk that operational hazards will not be identified.

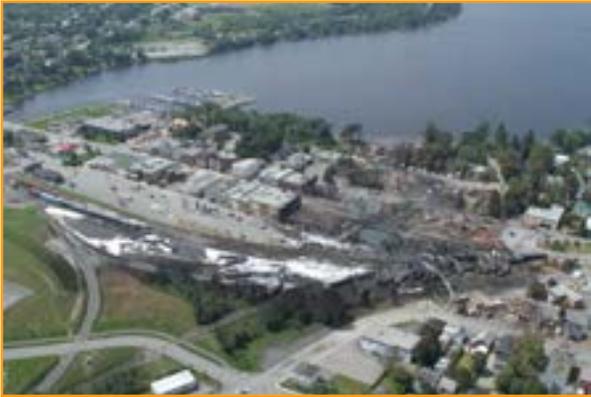
## R13D0054

On 06 July 2013, shortly before 0100 Eastern Daylight Time, eastward Montreal, Maine & Atlantic Railway freight train MMA-002, which was parked unattended for the night at Nantes, Quebec, started to roll. The train travelled approximately 7.2 miles, reaching a speed of 65 mph. At around 0115, when MMA-002 approached the centre of the town of Lac-Mégantic, Quebec, 63 tank cars carrying petroleum crude oil (UN 1267) and 2 box cars derailed. About 6 million litres of petroleum crude oil spilled. There were fires and explosions, which destroyed 40 buildings, 53 vehicles, and the railway tracks at the west end of Megantic Yard. Forty-seven people were fatally injured. There was environmental contamination of the downtown area and of the adjacent river and lake.

Training and oversight issues allowed unsafe practices relating to train securement to develop. An SMS that was not being used in a poor safety culture meant these unsafe practices were not identified.

**AS TO CAUSES AND CONTRIBUTING FACTORS:** Montreal, Maine & Atlantic Railway did not provide effective training or oversight to ensure that crews understood and complied with rules governing train securement.

**AS TO CAUSES AND CONTRIBUTING FACTORS:** Montreal, Maine & Atlantic Railway's weak safety culture contributed to the continuation of unsafe conditions and unsafe practices, and compromised Montreal, Maine & Atlantic Railway's ability to effectively manage safety.

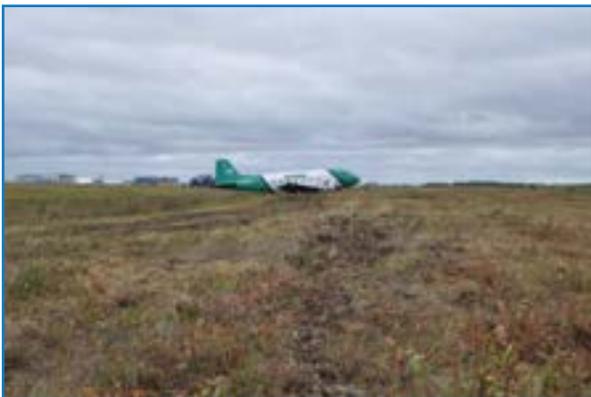
## A13W0120

On 19 August 2013, a Buffalo Airways Ltd. Douglas DC-3C was operating as a scheduled passenger flight from Yellowknife, Northwest Territories, to Hay River, Northwest Territories. After lift-off from Runway 16 at 1708 Mountain Daylight Time, there was a fire in the right engine. The crew performed an emergency engine shutdown and made a low-altitude right turn towards Runway 10. The aircraft struck a stand of trees southwest of the threshold of Runway 10 and touched down south of the runway with the landing gear retracted. An aircraft evacuation was accomplished and there were no injuries to the 3 crew members or the 21 passengers.

The aircraft was unable to climb on the remaining engine partly due to the fact that the aircraft was overweight. The practice in place at the company was for the first officer to work out the weight and balance as the aircraft was enroute – a practice condoned at the highest level of management.

**AS TO CAUSES AND CONTRIBUTING FACTORS:** An accurate take-off weight and balance calculation was not completed prior to departure, resulting in an aircraft weight that exceeded its maximum certified take-off weight.

**AS TO CAUSES AND CONTRIBUTING FACTORS:** The operator's safety management system was ineffective at identifying and correcting unsafe operating practices.

**AS TO RISKS:** If companies do not adhere to operational procedures in their operations manual, there is a risk that the safety of flight cannot be assured.

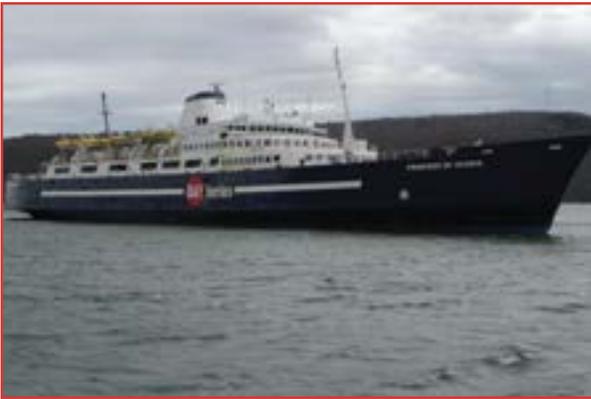
## M13M0287

On 07 November 2013 at 1200 Atlantic Standard Time, the roll-on/roll-off passenger ferry Princess of Acadia, which was carrying a total of 87 passengers and crew, sustained a main generator blackout and grounded while approaching the ferry terminal at Digby, Nova Scotia. No pollution or injuries were reported.

The vessel had experienced a similar, but less serious, occurrence sometime before the occurrence investigated by the TSB. Few of the systemic issues identified in the TSB investigation were identified in the previous investigation. As a result they persisted and contributed to this occurrence.

If a safety management system does not provide guidance for the master to proactively identify risks and investigate hazardous occurrences, underlying risks may not be addressed.

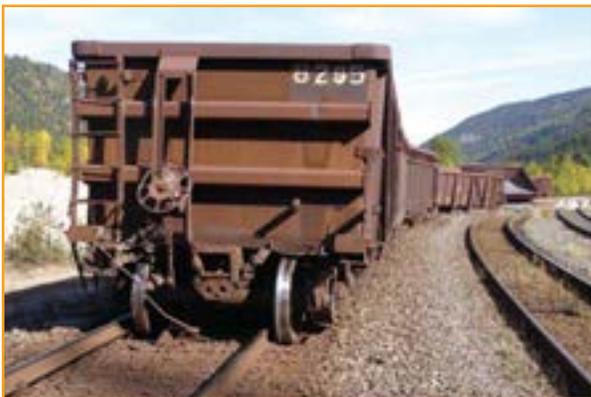
## R11Q0050

At approximately 0615 Eastern Daylight Time on 26 September 2011, Quebec North Shore and Labrador Railway train PL485 derailed 17 loaded ore cars at Mile 56.33 of the Wacouana Subdivision near Tika, Quebec. About 450 feet of main track was damaged and about 200 feet of the siding track was damaged. There were no injuries and no permanent environmental damage.

There were over 500 QNS&L train separations between January 2006 and October 2011. Even though locomotive engineers submitted a form giving an informal description of the defect type, that description was lost when the train separation was entered in the database because all defect types affecting the coupling device were entered under the generic term of broken knuckle. It was impossible to know if other train separations could have been caused by ill-positioned carrier plates because all mechanical defects were entered as broken knuckles.

Without sufficient historical data, it is difficult to determine if the problem is recurring or systemic and it is difficult to identify other affected cars and also minimize the potential risks.
