AVIATION INVESTIGATION REPORT

A0000279

INCIDENT—RUNWAY OVERRUN

ANTONOV124-100 UR-82029

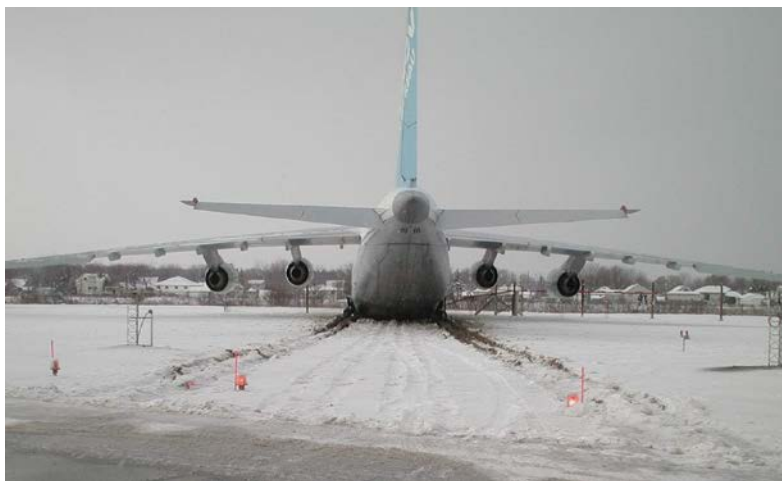
The aircraft landed on Runway 25 in Windsor after an instrument landing system (ILS) approach in instrument meteorological conditions. The weather at 2300 eastern standard time,¹ 33 minutes before the occurrence, was reported as follows: wind 080° true at 4 knots; visibility 1.5 statute miles in light snow; broken cloud at 900 feet above ground level (agl); overcast cloud at 1300 feet agl; temperature -9°C; dewpoint -10°C; and altimeter 29.83 inches of mercury. Approximately 20 minutes before the AN124 landed, the centre 120 feet of the runway were reported as being 90% covered with traces of loose snow and 10% ice patches. The remaining 80 feet of the runway was 75% covered with 1 inch of loose snow and 25% ice patches. Snow ploughing and sweeping were in progress immediately before the aircraft arrived. The aircraft touched down an estimated 3400 feet past the threshold. The flight crew was unable to stop the aircraft in the remaining 4450 feet of runway. The aircraft overran the runway and came to rest about 340 feet beyond the end of the runway, 20 feet from the airport boundary fence. Indications of tire skid marks left by the aircraft started about 100 feet before the end of the runway, slightly left of the runway centreline. The incident occurred during the hours of darkness

The aircraft sustained minor damage that required repair to the right nose-gear oleo bracket and replacement of the right fuselage landing light.

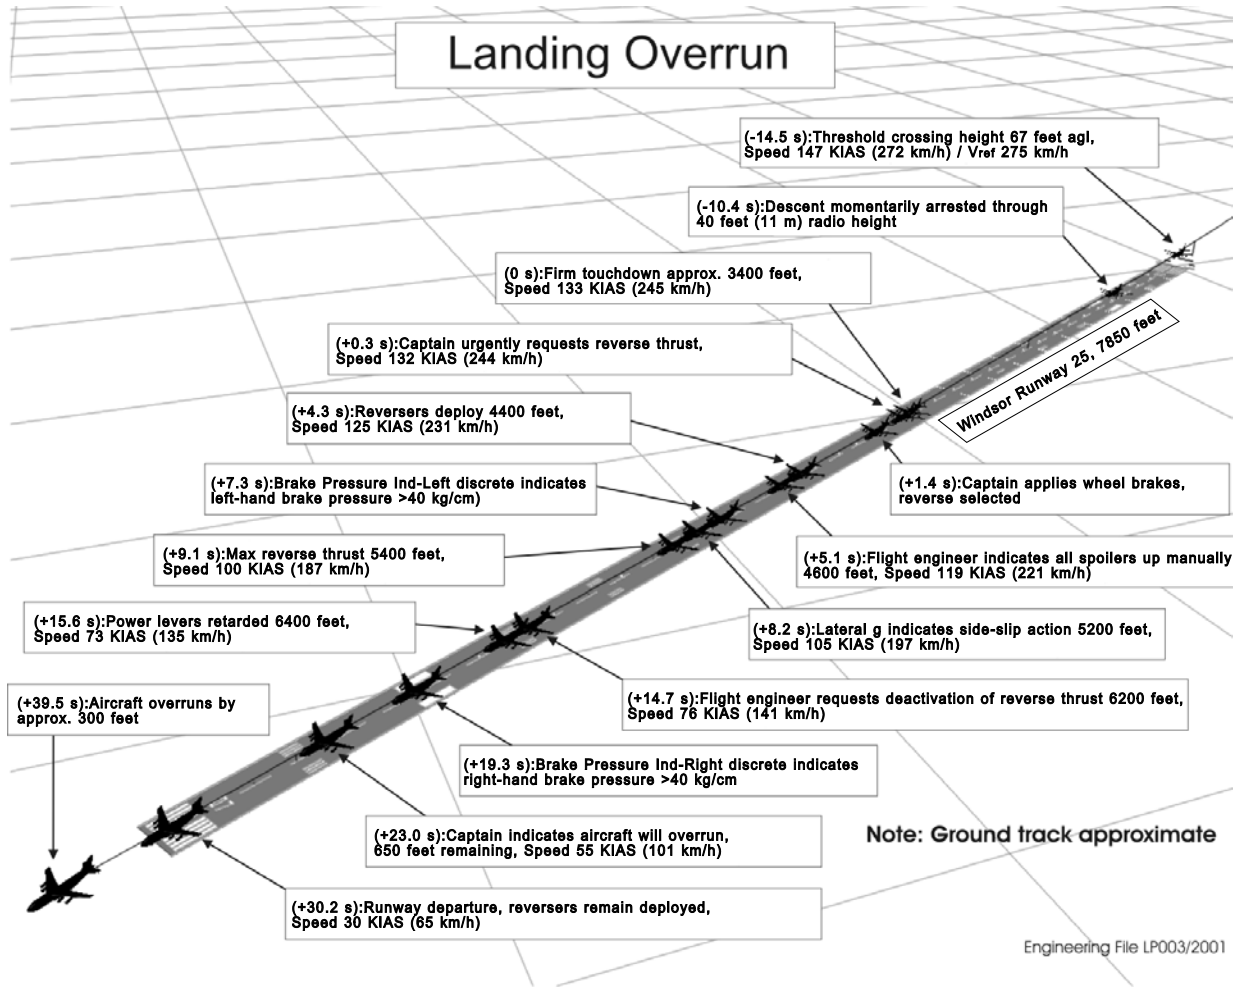
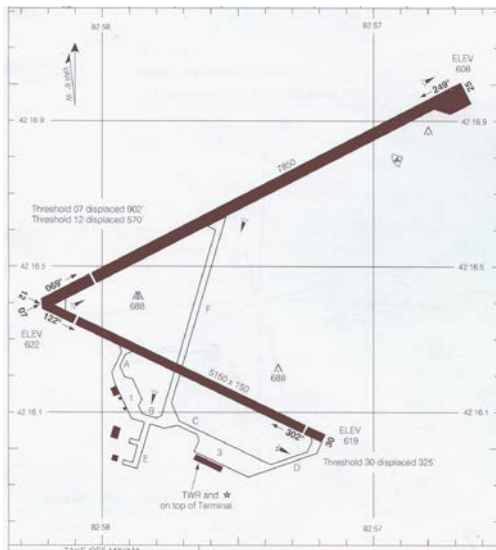
Appendix A—Landing Overrun and Windsor Airport

The aircraft overran the end of the runway by about 340 feet at approximately 30 knots. The ground past the end of Runway 25 was soft, causing the aircraft to decelerate quickly. Damage to the aircraft was minimal.

1. The aircraft touched down 3400 feet past the threshold of Runway 25 and could not be stopped in the remaining 4450 feet.
2. Because of the weather minima on Runway 07, the aircraft was landed with a 4-knot tailwind component on Runway 25. The aircraft was about 20 feet higher and about 6 knots faster than recommended when it crossed the threshold of Runway 25. Consequently, the aircraft touched down well beyond the normal touchdown point.
