AVIATION INVESTIGATION REPORT

A04P0110

LOSS OF CONTROL / PARACHUTE SYSTEM DESCENT

CIRRUS DESIGN SR 20 C-GEMC
MOUNT O'LEARY, BRITISH COLUMBIA

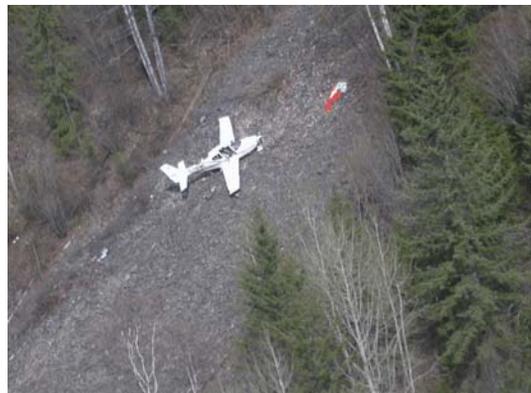
At approximately 2111, the aircraft/parachute landed on a steep mountainside on the southern slope of Mount O'Leary, British Columbia at the 2300-foot level. The aircraft sustained substantial damage, but there were no injuries. A search and rescue operation was initiated. The four occupants were found and rescued early the following morning and returned to Kelowna by military helicopter.

Photo 1. Accident site

Damage to the aircraft was mainly to its underside, and the nosewheel leg was broken. The engine crankshaft was damaged when a propeller tip contacted the ground. The right door was torn off during the CAPS deployment and was not found.

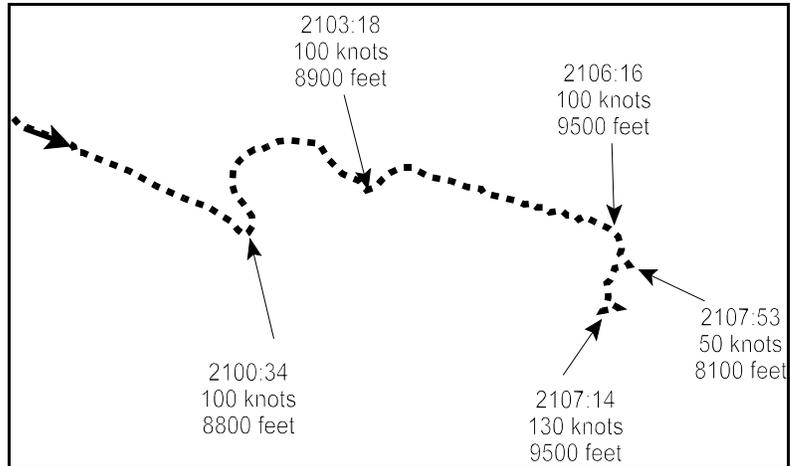
Radar data show that the aircraft was first detected at 2043:56 Pacific daylight time¹ at a position 13 nautical miles (nm) southeast of Kelowna Airport, on an east-southeast heading, climbing through 5700 feet, with a ground speed of 100 knots. The aircraft climbed steadily on that heading until 2100:34 when, at an altitude of 8800 feet and a ground speed of 100 knots, it made a fairly abrupt turn to the left reaching a heading of 325° True (T) before correcting back to the east-southeast heading.

Figure 1. Radar track of C-GEMC

At 2103:18 the aircraft made another left turn, reaching a heading of 052° T before again correcting to the east-southeast heading. At 2106:16, the aircraft reached 9500 feet and 25 seconds later began a turn to the south. At 2107:14 the event began. The last radar return was at 2107:53 as the aircraft descended through 8100 feet.
