AVIATION INVESTIGATION REPORT

A08W0007

ENCOUNTER WITH WAKE TURBULENCE

AIRBUS A319-114 C-GBHZ

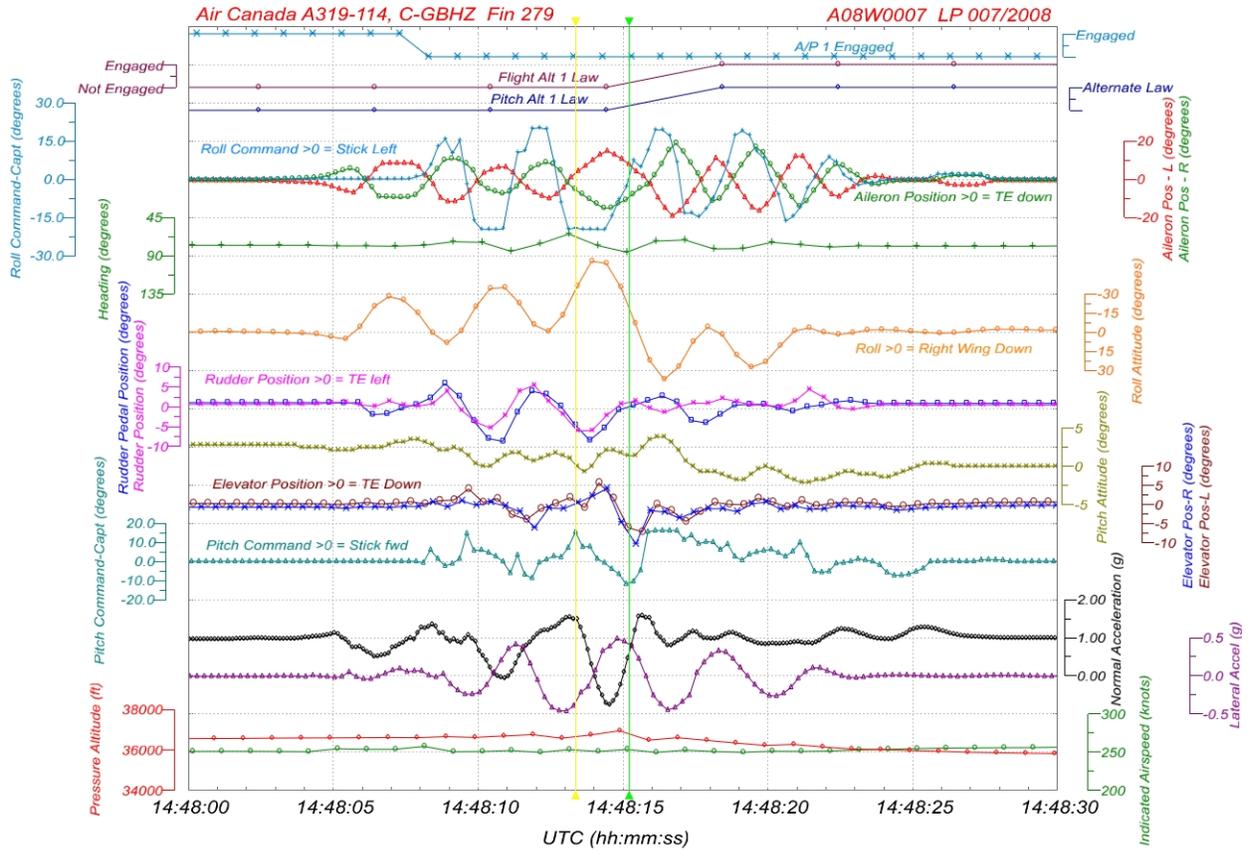
Appendix B – DFDR Summary of the Event

At 0648, at a point 9 nm south of the Canada/United States (U.S.) border in northern Washington State, 34 nm east of the IWACK intersection, ACA190 was in a stable wings level climb through FL 366. Three sharp jolts described as similar to hitting automotive speed bumps were felt. This was followed by a roll to the right of 5.6° which was countered by the autopilot with aileron input. The aircraft rolled past wings level to 27.8° left, with the autopilot responding. When this roll was near its maximum, the captain, who was the pilot flying, disengaged the autopilot and autothrottles and attempted to correct the roll. This was followed by four rolls varying in magnitude from a few degrees to a maximum of 55° (see Appendix B - DFDR Summary). The aircraft then returned to level flight with minor oscillations.

During the 18-second duration of the event, heading varied from 065°M to 086°M. The captain reacted to the rolls with a total of nine sidestick roll inputs, accompanied by coordinated rudder pedal deflections. Five sidestick inputs were to full travel of 20°. Seven successive rudder pedal inputs were made, with six cyclic reversals from left to right. Rudder deflection followed pedal inputs with maximum deflection of 6° left and 7° right.

Analysis of DFDR data indicated that, during the event, vertical accelerations reached peak values of +1.57g and -0.77g.³ Lateral accelerations reached peak values of +0.49g (right) and 0.46g (left) during four oscillations.

From 06:48:07 to 06:48:25, pilot sidestick roll inputs were 90° out of phase with aircraft motion. From 06:48:07 to 06:48:15, lateral accelerations and heading deviations were approximately 90° out of phase with the rudder pedals. This indicated that after the autopilot was disconnected, most of the aircraft motion in the roll axis resulted from pilot inputs and that lateral accelerations were due mostly to pilot rudder control inputs. Rudder control inputs, which were coordinated with the out of phase roll inputs, had a direct relationship with vertical stabilizer loads. Abnormal accelerations in the normal or vertical axis were correlated with changes in angle of attack, and sidestick pitch control inputs opposed these aircraft angle of attack excursions.
