AVIATION INVESTIGATION REPORT

A08W0244

CONTROLLED FLIGHT INTO TERRAIN

DORNIER 228-202 C-FYEV

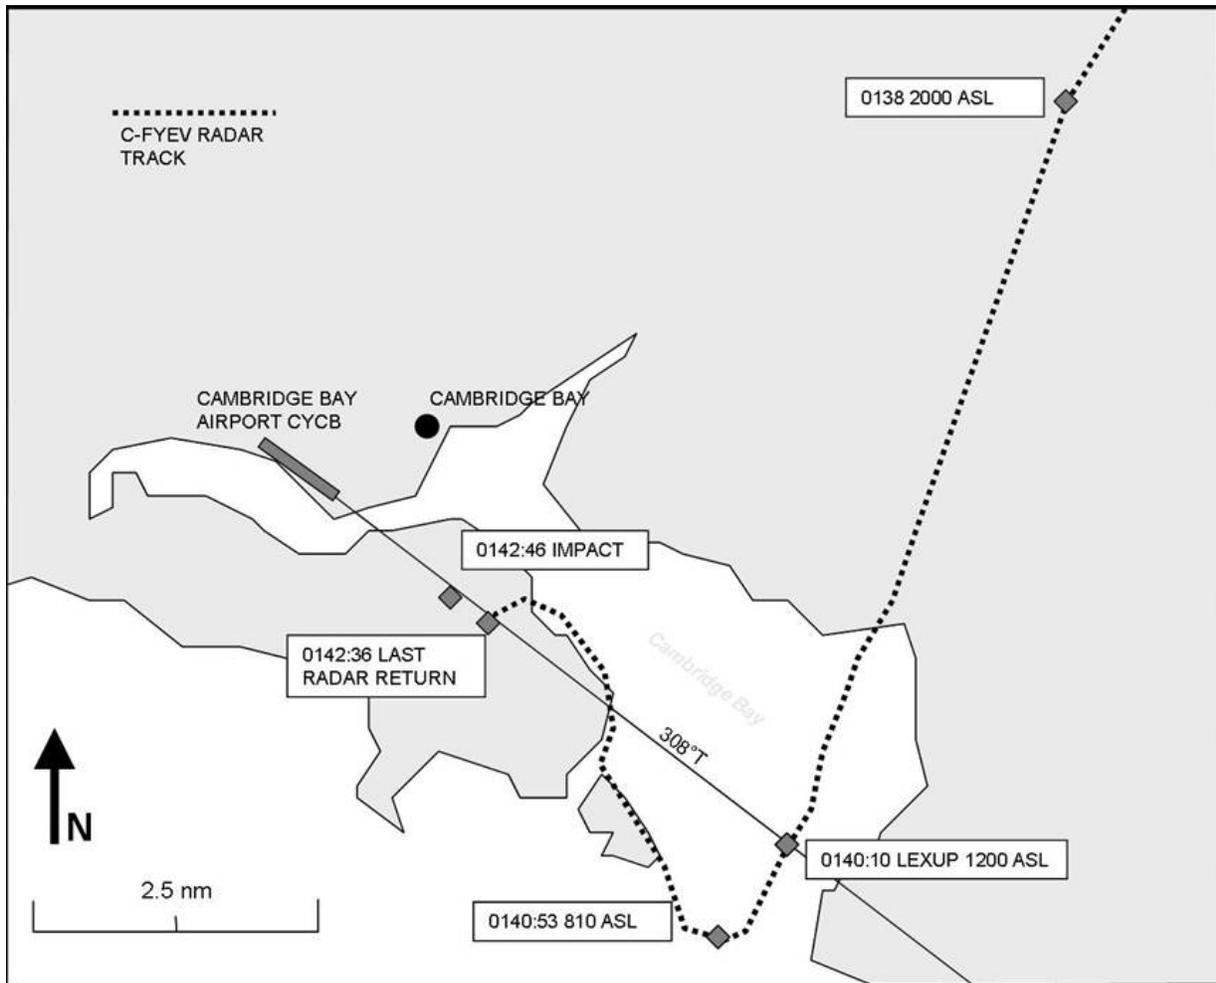
Appendix B – Radar Plot of C-FYEV

The aircraft crossed the extended runway centreline for the second time, 2.8 nm from the runway threshold; at 2.1 nm, a left turn was made toward the runway centreline (see Appendix B - Radar Plot of C-FYEV). When the runway lead-in strobe lights became dimly visible, the captain turned toward the runway. The precision approach path indicator system (PAPI), positioned on the left side of the runway, 1000 feet from the threshold, was not visible to the crew. Due to reflected glare from falling and blowing snow, the captain requested that the aircraft's landing lights be turned off, and confirmed with Cambridge Bay Airport Radio that the runway lights were at maximum illumination level. A maximum of two runway lights were visible to the captain. Fifteen seconds before ground impact, the propellers were set to

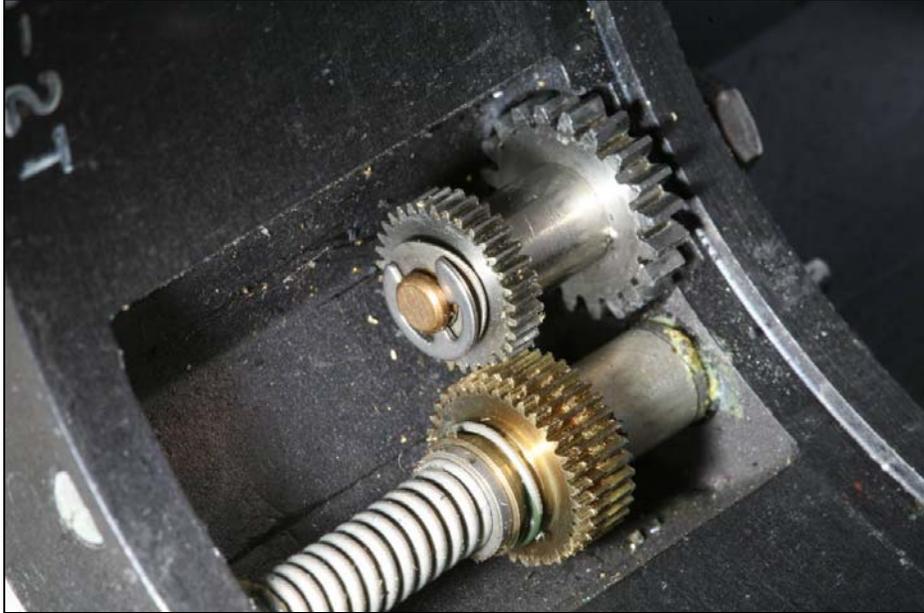
Appendix C – Altimeter Number 1 Gear Damage

When the barometric pressure/pointer setting mechanism was disassembled, the dowel pin (part number 25096) fit loosely in the knob shaft bore and drive gear (part number 24319). Because the dowel pin retains the gear on the knob shaft, the difference in the bore/dowel pin measurements allowed end play of approximately 0.006 inch. The altimeter *Component Maintenance Instruction Manual* required that, during inspection, the end play of all rotating assemblies should be 0.003 ± 0.001 inch, unless otherwise specified. The knob shaft was bent approximately one degree between the shoulder and the threaded end, and exhibited tool marks in the area of the shoulder. It could not be determined from records when this damage occurred.

Misalignment of the drive gear due to the bent knob shaft, combined with radial and axial play, resulted in improper meshing of the drive gear and the pointer drive train gear, part number 24593. This resulted in abnormal wear and damage to gear part number 24319, which showed advanced wear rub marks and separation of five tooth tips (see Appendix C - Altimeter Number 1 Gear Damage).

Barometric pressure/pointer setting gears

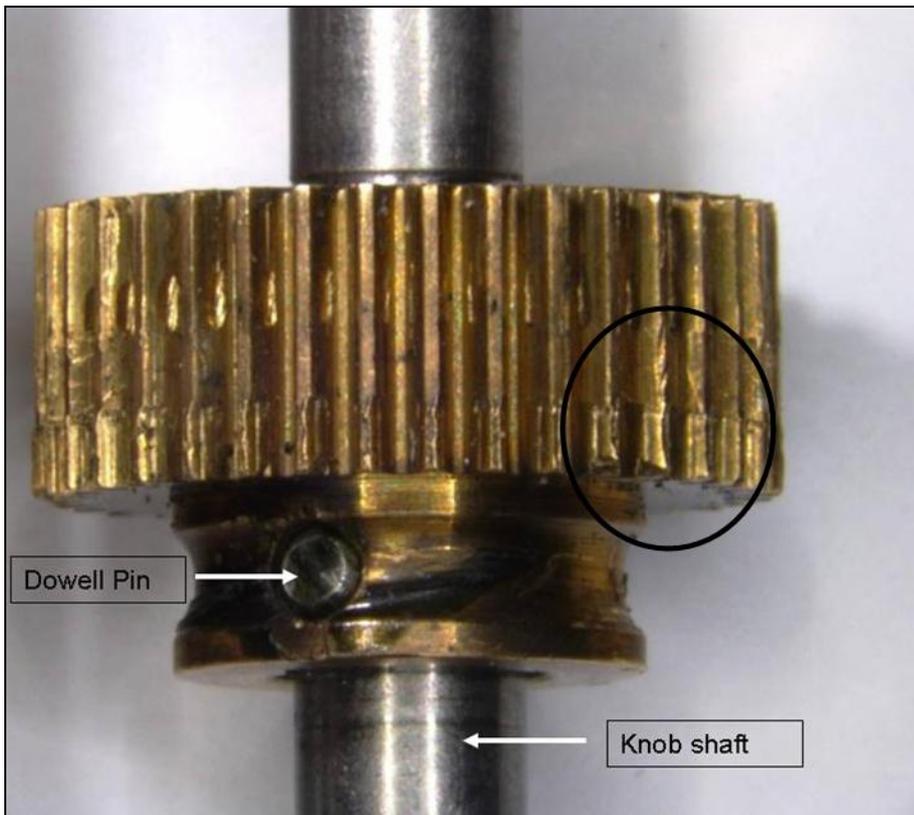
TSB testing determined that the No. 1 altimeter (serial number 1386) read 130 feet high. It was noted that the barometric pressure pointer setting mechanism of this altimeter was difficult to turn and felt rough during rotation. When the case was removed, the drive gear (part number 24319) was found to be damaged.

Because the aft end of the drive gear drives only the pointer setting gear train, the failure of the teeth did not affect the setting of the barometric pressure scale. However, when the setting knob was rotated, the failed teeth on the drive gear would slip on the driven gear and the pointers would not move synchronously with the barometric pressure setting gear train. This lack of synchronous movement resulted in the loss of the altimeter calibration. The loss of five teeth on this gear created an offset of 139 feet, consistent with the observed error of 130 feet.¹² Similar damage, although not as extensive, was observed in the No. 2 altimeter and did not result in loss of calibration.

Gear part number 24319 showing representative damaged teeth (circle)
