**AVIATION INVESTIGATION REPORT  
A12C0005**

**LOSS OF CONTROL AND COLLISION WITH TERRAIN**

**KEYSTONE AIR SERVICE LIMITED  
PIPER PA31-350 NAVAJO CHIEFTAIN, C-GOSU  
NORTH SPIRIT LAKE, ONTARIO  
10 JANUARY 2012**

Report Number A12C0005

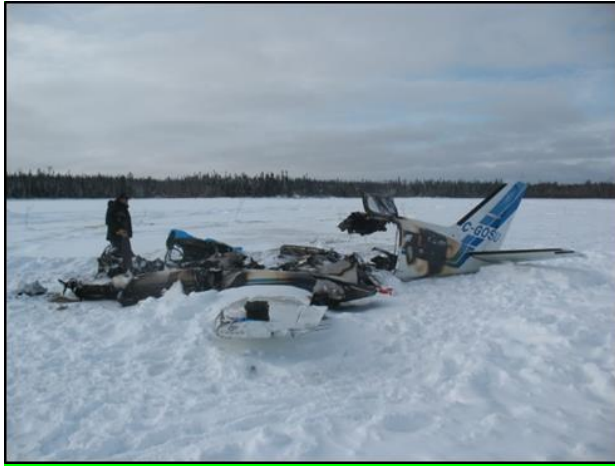
TSB investigators arrived on scene approximately 26 hours after the accident. The aircraft struck the frozen surface of the lake in a right-wing-low attitude at both a high rate of descent and forward speed. Contents of the aircraft, such as baggage and cargo, were found strewn halfway up the wreckage trail, indicating an early breakup of the cockpit and cabin area. The wreckage trail was generally aligned with the extended centreline of the runway. It was approximately 380 feet long, and the aircraft had come to a rest in an upright position, facing a southeasterly direction (Photo 1). Damage to the propellers suggests that the engines were producing power at the time of the impact. A post-impact fire consumed a majority of the aircraft.

**Photo 1.** Wreckage on site

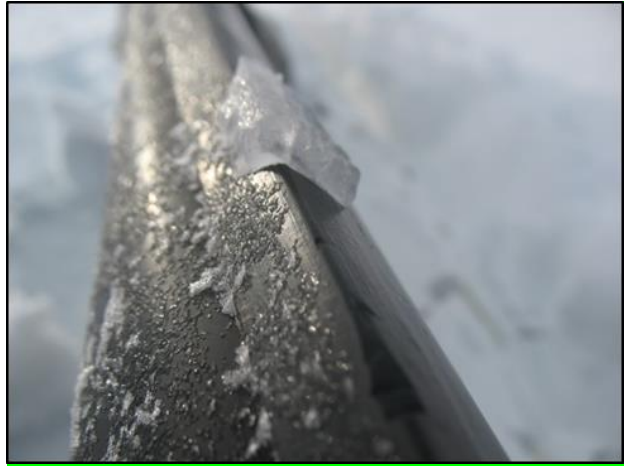
An approximate 4-foot section of the right-wing leading edge containing the stall warning vane was torn off and found approximately halfway down the wreckage trail. This section of leading edge was not affected by the fire, and exhibited some clear and mixed ice that was approximately 3/8 inch thick (Photo 2). The stall warning vane was not heated, and exhibited hard packed ice inside the stall warning housing, trapping the vane in a downward position (Photo 3). The left horizontal-stabilizer leading edge was also not affected by the fire, and exhibited ice accumulation (Photo 4).

**Photo 2.** Leading edge ice

The remaining ice found on the 4-foot section of the right-wing leading edge and on the left horizontal-stabilizer leading edge indicates that a significant amount of ice accumulated on the aircraft's critical surfaces in flight. The investigation was not able to assess the serviceability of the de-ice system because of extensive impact and fire damage.

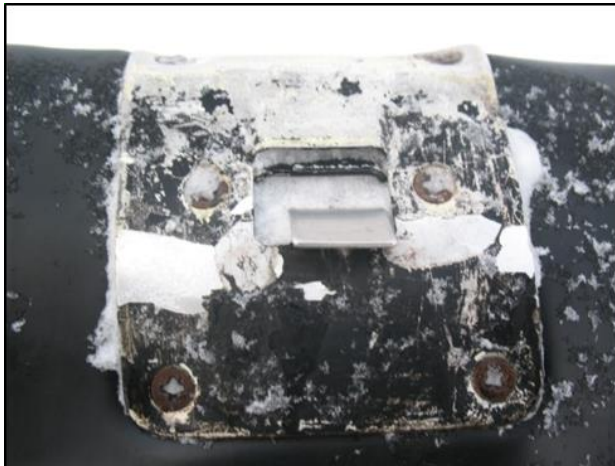
**Photo 3.** Stall warning vane

It is likely that once the runway was cleared, the pilot extended the landing gear and set approach flaps before turning onto final approach. With the stall warning vane trapped in a downward position, the stall warning system would have been inoperative and would have provided no warning to the pilot of a stall condition. The accumulation of ice and the change in aircraft configuration resulted in an increased stall speed and an increase in drag.

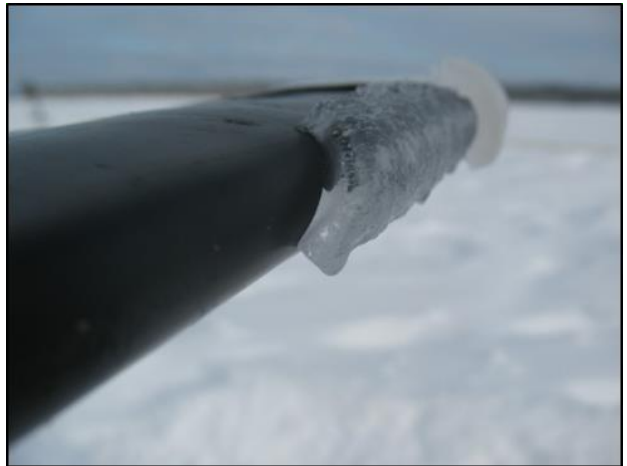
**Photo 4.** Ice on the horizontal stabilizer leading edge
