**AVIATION INVESTIGATION REPORT
A12A0085**

ENGINE FAILURE AND HARD LANDING

**UNIVERSAL HELICOPTERS NEWFOUNDLAND LIMITED
BELL 407 (HELICOPTER), C-FTJU
WABUSH, NEWFOUNDLAND AND LABRADOR, 4 NM SW
12 AUGUST 2012**

Report Number A12A0085

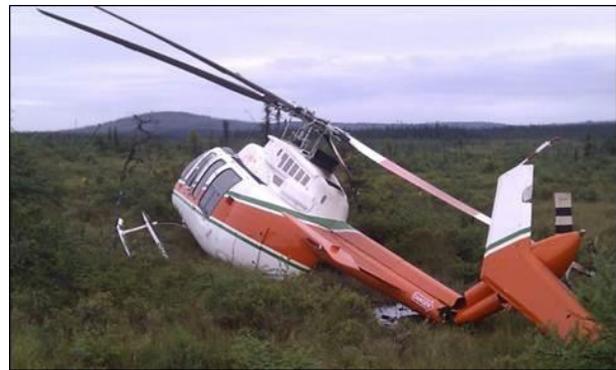
Photo 1. Occurrence helicopter (Source: Universal Helicopters Newfoundland Ltd.)

The helicopter remained upright (Photo 1), and the main rotor stopped rotating. About 17 seconds after impact, the pilot completed the engine shutdown checks, then selected electrical power off.

The high-skid landing gear was deformed, a portion of the lower fuselage was crushed, and the tailboom was separated aft of the horizontal stabilizer. One main rotor blade was buckled mid-span. The other 3 main rotor blades and both tail rotor blades were relatively undamaged, consistent with low rotor revolutions per minute at impact. The engine exhaust duct had several holes made by portions of turbine assembly as they exited the engine.

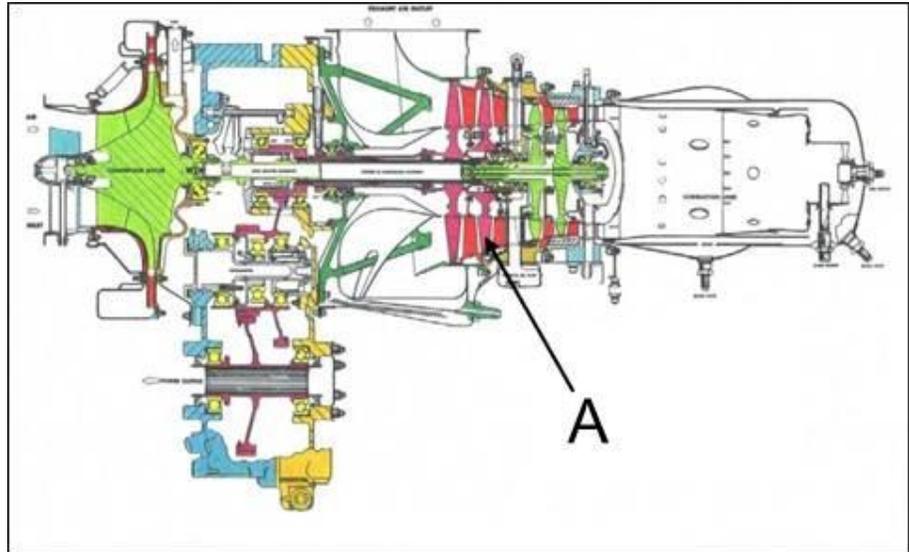
Figure 1. Engine cross-section schematic: A – third-stage power turbine wheel (Source: Rolls-Royce)

The engine is a reverse-airflow modular-type turboshaft free turbine engine. It consists of a compressor, a gearbox, a turbine assembly, and a combustion chamber. The turbine assembly consists of a 2-stage gas producer turbine that drives the compressor, and a 2-stage power turbine that drives the rotor systems through the gearbox (Figure 1).

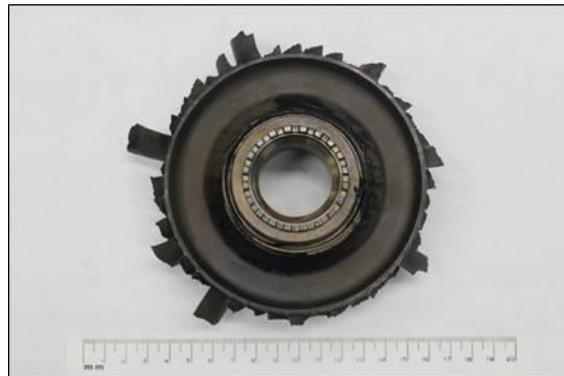
Photo 2. Occurrence third-stage power turbine wheel

The engine examination revealed that all 40 airfoils (blades) of the third-stage power turbine wheel, part number (P/N) 6898663, were separated, most near the hub (Figure 1 and Photo 2). Examination of the fracture surfaces found that several blades had a flat, relatively smooth region at the trailing edge, indicating progressive cracking.

Metallurgical and scanning electron microscope examination of the third-stage power turbine wheel identified high-cycle fatigue (HCF) striations on 6 blades, initiating at the trailing-edge tip of the blade close to the hub and propagating toward the leading edge. One of these blades had a HCF crack, which had propagated about 0.40 inch before it separated in overstress. The failure of the first blade led to a rapid failure of the turbine wheel as the remaining blades separated in overstress due to impact with blade fragments.

It was noted that the HCF cracked blades were located in a pattern around the turbine wheel. This pattern corresponds to a known third-mode vibration in a family of second diametral pattern modes (referred to as the 2D-3 mode). The 2D-3 mode pattern occurs in the 68.4% to 87.1% power turbine speed (N_2) range. ⁶

According to RRC, certain operational conditions (particularly temperature exceedances during start-up and shutdown) can create large temperature differentials in the hub trailing-edge area of the blades. This effect can induce tensile residual stresses, ⁷ which lower the threshold for the initiation of fatigue cracks at the

trailing-edge tips. Operating within the 2D-3 mode exacerbates this condition. Once initiated, these cracks are then driven by the fatigue loading and propagate rapidly to failure.

The third-stage turbine wheel failed due to the overstress extension of high-cycle fatigue cracks in the blade trailing edges, in a manner consistent with a known pattern, resulting in a loss of engine power. Rolls-Royce Corporation (RRC) has not been able to specifically identify what engine operating condition, or conditions, cause the tensile residual stresses to be induced at the blade hub trailing edges. Also, it is unknown what extended engine operations are being conducted in the 68.4% to 87.1% power turbine speed (N_2) range. As a result, there is a continued possibility of engine failure, in turn increasing the risk of injury and helicopter damage.

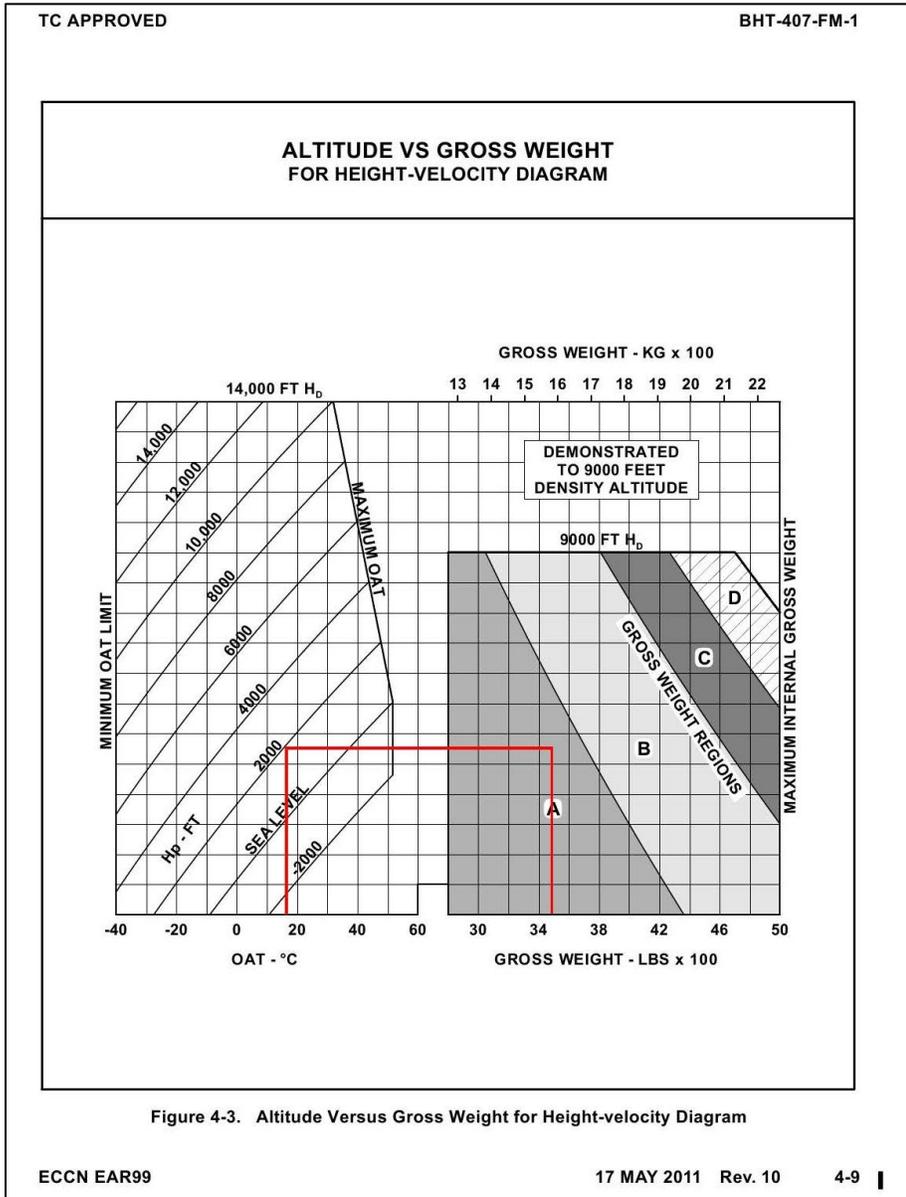
Appendix A – Altitude Versus Gross Weight for Height-velocity Diagram (Bell 407 Rotorcraft Flight Manual)

At the time of the engine power loss, the occurrence helicopter was about 2000 feet above sea level, and the outside air temperature was 17°C. According to the Bell 407 HVD, the occurrence helicopter was operating within the avoid region (Appendix A and Appendix B).

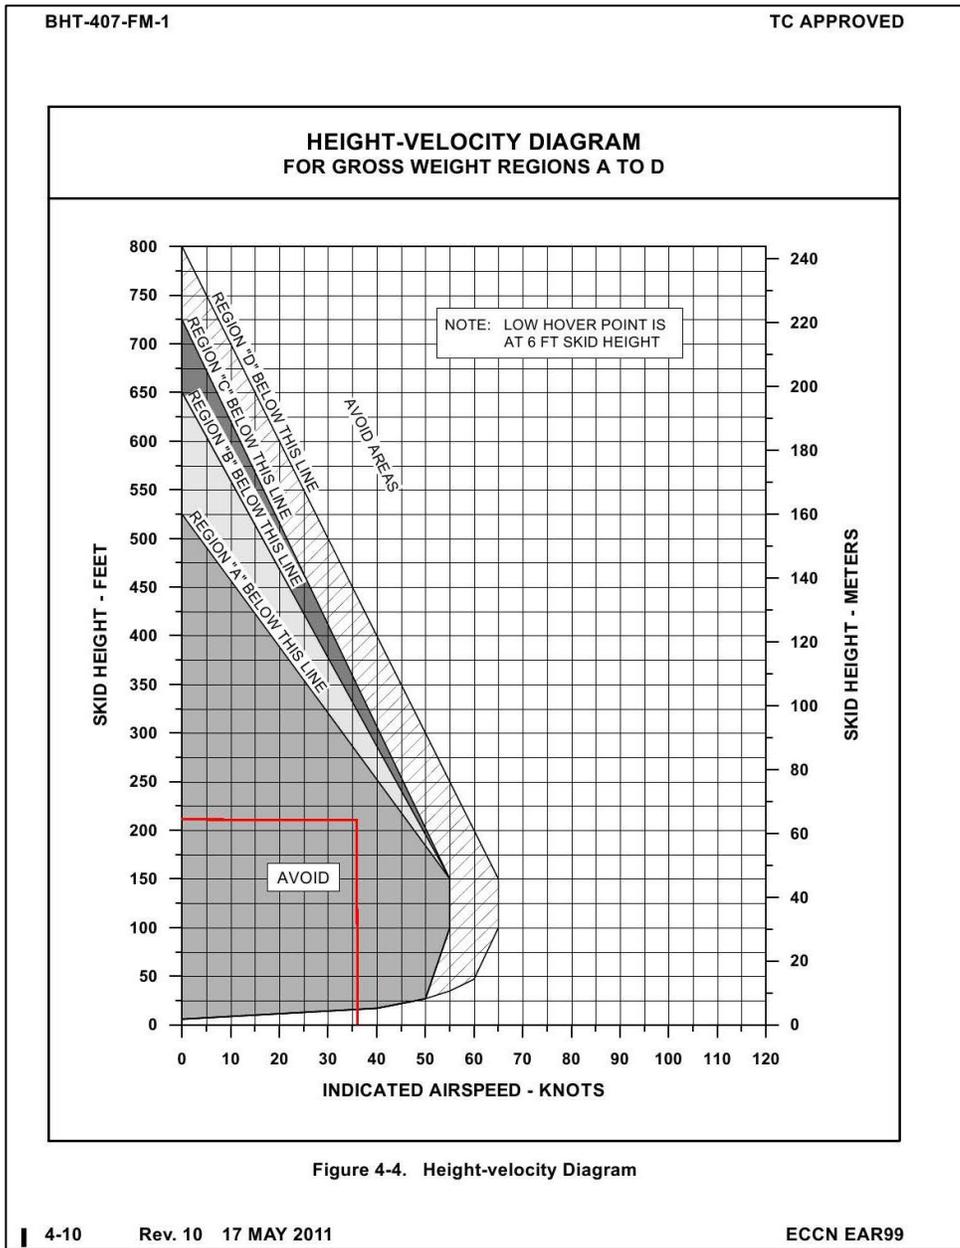
Appendix B – Height-velocity Diagram (Bell 407 Rotorcraft Flight Manual)

The helicopter was operating within the HVD avoid range. The engine power loss occurred at an altitude from which a safe landing could not be assured, resulting in minor injury and substantial helicopter damage.
