**AVIATION INVESTIGATION REPORT  
A12C0141**

**COLLISION WITH TERRAIN**

**AEROFAB INC. LAKE 250, C-GZLC  
PICKLE-LAKE, ONTARIO  
16 OCTOBER 2012**

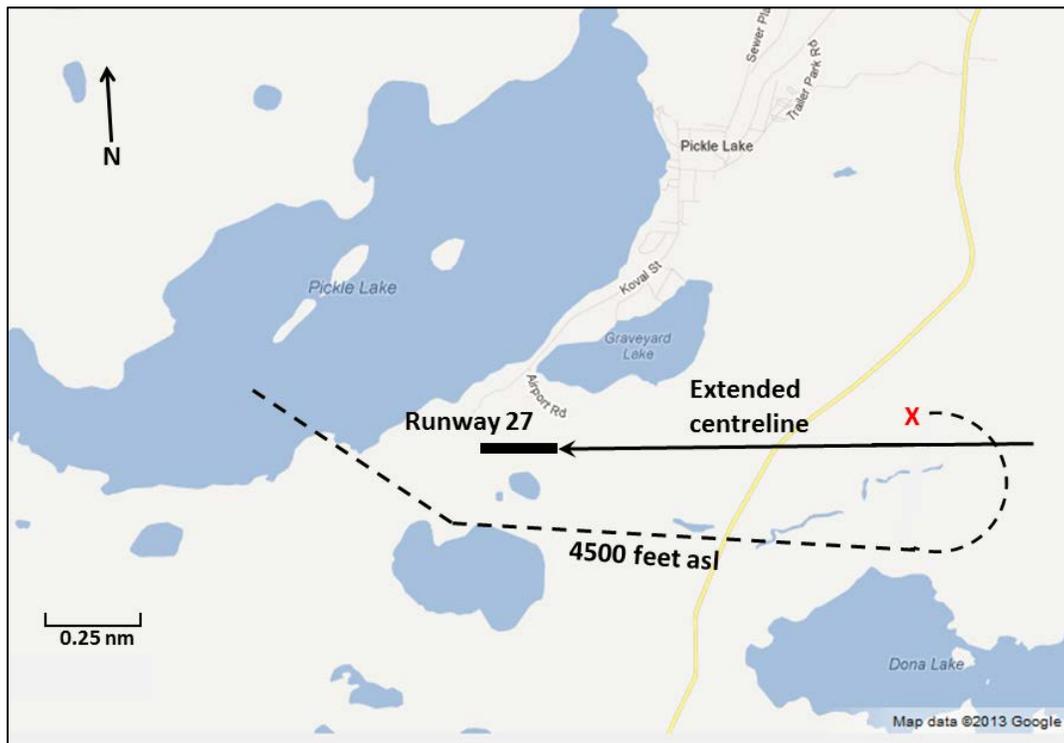
The normal circuit altitude at Pickle Lake is 2300 feet asl. The relative positions of the 2 aircraft resulted in the second aircraft reaching final approach for Runway 27 ahead of C-GZLC. A series of 3 microphone clicks was heard on the MF, and shortly afterward the second aircraft landed on Runway 27 (1927:52). As it turned off the runway lighting, the crew of the second aircraft observed C-GZLC approximately 1-mile on what appeared to be a final approach in steep descent towards Runway 27. Visual contact with C-GZLC was lost as the second aircraft turned on to the taxiway. The last transmission from C-GZLC was at 1928:20 when the pilot called final for Runway 27.

**Figure 1.** Pickle Lake Airport and estimated flight path (shown by the dashed line); **X** marks the approximate point of impact

On final approach, the landing gear was extended and the associated landing gear lights illuminated, actions that the PIC had instructed the left-seat pilot to perform. The pilots did not appear to be having any difficulty controlling the aircraft; however on final approach, C-GZLC entered a steep descent and struck trees approximately 1 nm short of Runway 27.

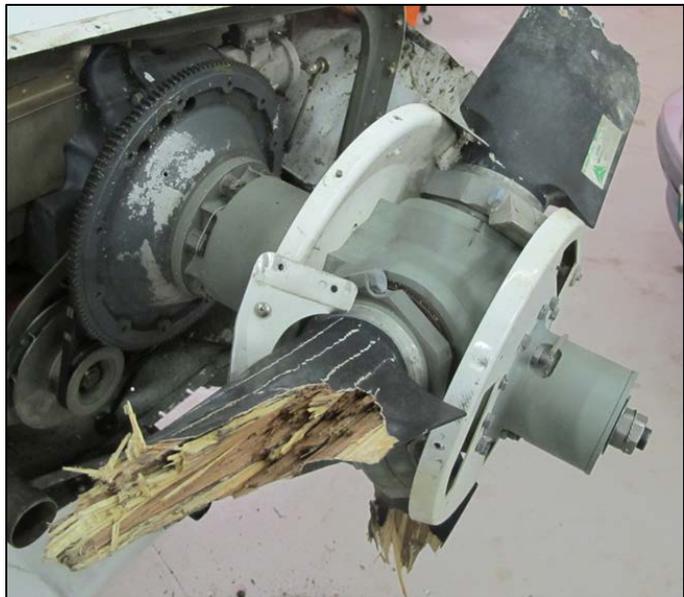
**Photo 1.** Propeller hub after occurrence; propeller in governing range.

Initial inspection of the propeller indicated that the blades were in the flight (coarse blade angle) governing range at the time of impact.

The propeller had sustained substantial damage during impact. All 3 blades had been shorn off approximately 8 inches from the propeller hub. Disassembly of the propeller hub revealed strike marks corresponding to varying blade angles. These marks would have resulted from rotational forces derived from the propeller blades striking surrounding terrain at the time of impact. No damage or conditions of the propeller hub assembly that could have caused an uncommanded propeller-reversing operation or blade angle were observed.

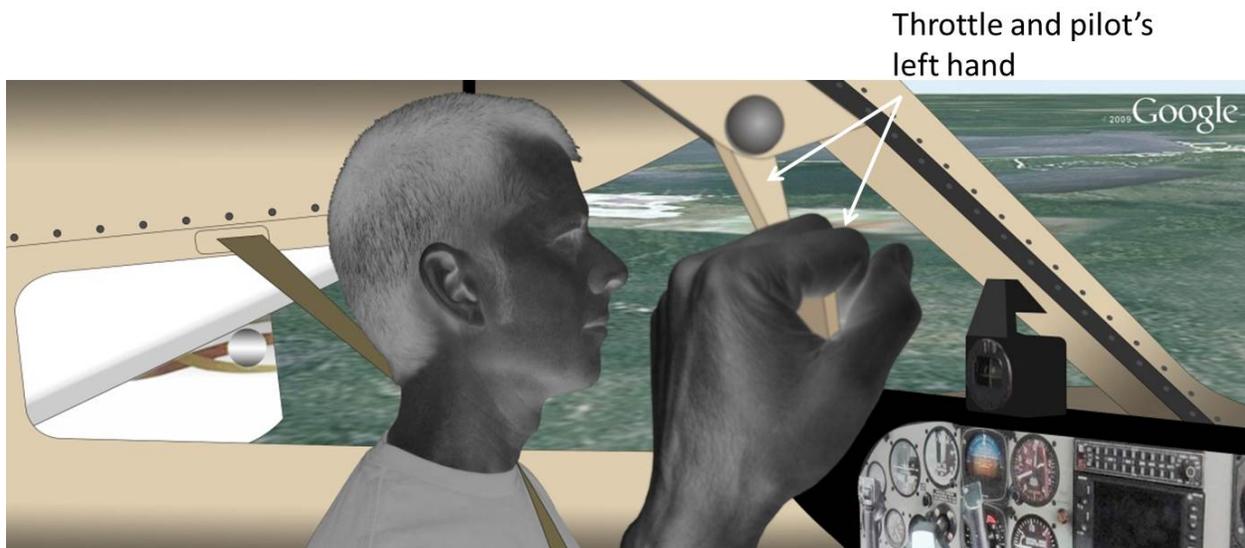
A light associated with the landing gear extension had illuminated in the cockpit, and was shaded on the PIC's command. The momentary flash of the light could have impaired the pilots' night vision to a certain degree. The PIC was flying in the right seat while carrying out a left-hand circuit. Looking across the cockpit past the pilot in the left seat would have made visual acquisition of the runway more difficult (Figure 2).

**Figure 2.** Right seat pilot's view obstructed by left seat pilot.
