**AVIATION INVESTIGATION REPORT
A12O0074**

ENGINE FAILURE DURING INITIAL CLIMB-OUT

**AIR CANADA
BOEING 777-333ER, C-FITW
TORONTO-LESTER B. PEARSON INTERNATIONAL
AIRPORT, ONTARIO
28 MAY 2012**

Report Number A12O0074

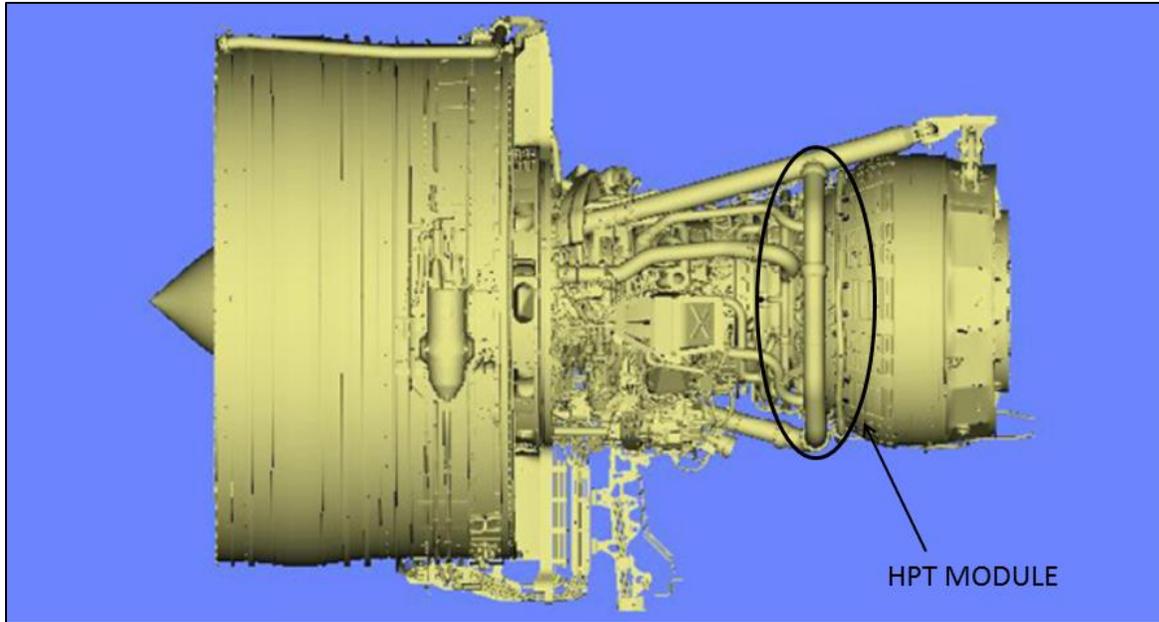
Figure 1. Location of the HPT module on the engine

The propulsor⁵ core was seized by several HPT stage 2 nozzle fragments jammed in different locations, which prevented the core from rotating freely. There was no indication of a bird strike or component failure forward of the HPT module (Figure 1).

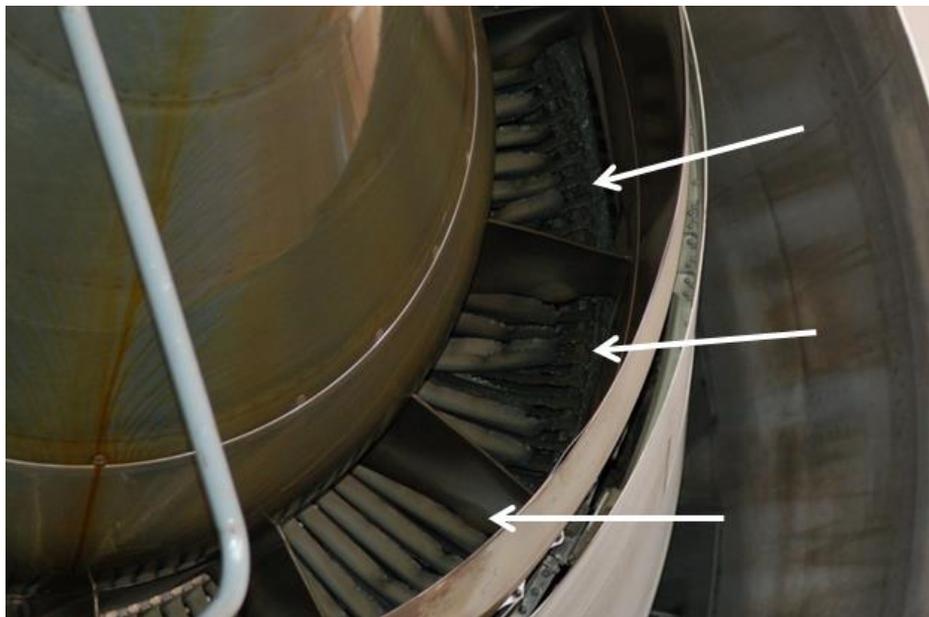
Photo 1. LPT blade damage at the aft end of the engine

The engine exhaust cone contained pooled engine oil and small fragments of high-pressure turbine (HPT) and low-pressure turbine (LPT) hardware. Most of the damage to the LPT was located towards the outer periphery. This damage was consistent with excessive heat and impact from debris originating from forward of the LPT stage. The engine damage was contained, and there was no damage to the engine cowlings. However, there was heat damage to the HPT module near the HPT active clearance control panels.

The damage was observed on the HPT stage 1 stator shrouds and appeared to be more prevalent at the 11 o'clock position. Approximately 1 ½ of the stator shroud segments at this position were burnt, and the remainder were missing. HPT stage 1 blades were found in place; however, they displayed substantial damage to the leading and trailing edges, and to the blade tips. Three holes were located in the HPT casing, which appeared to have been created by excessive heat exposure. There was no damage observed to the combustor, which was located directly forward of the HPT.

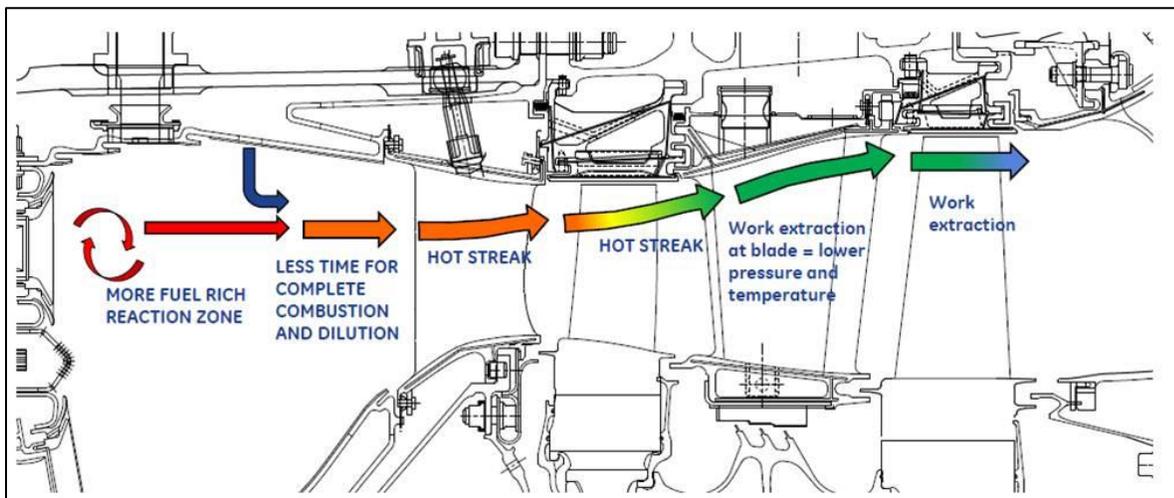
Figure 2. Diagram shows fuel rich area, and coloured arrows show the gas flow through the HPT stages in the engine (Source: General Electric)

This phenomenon is most likely to occur at HPT stage 1, as temperatures are higher than anywhere within the engine. As the gas continues to flow aft, energy is extracted by the different turbine stages. Temperatures are relatively lower, reducing the possibility of a super-heated zone developing further aft of HPT stage 1. The condition that started the shroud

deterioration was identified to be related to the laser-drilled cooling holes in the shroud. The subsequent shroud deterioration decreased the effectiveness of the shroud cooling and increased the rate of material loss.
