# AVIATION INVESTIGATION REPORT A12P0034

## RUNWAY EXCURSION

**NORTHERN THUNDERBIRD AIR INC.  
BEECHCRAFT 1900C, C-GCMZ  
BLUE RIVER, BRITISH COLUMBIA  
17 MARCH 2012**

Report Number A12P0034

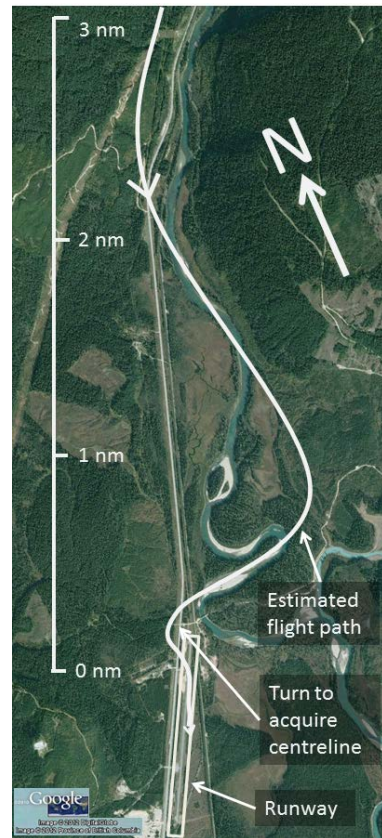
**Figure 1.** Estimated flight path of C-GCMZ

During the approach, the crew rushed to complete the pre-landing checks, visually acquire the runway, and manoeuvre the aircraft to land. The captain turned slightly to the left, away from the runway centreline (Figure 1). At this point, the FO called visual contact with the runway, and the captain turned right, back towards the runway centreline, and again passed through the runway centreline. The captain did not acknowledge that the runway was in sight.

The aircraft was configured for landing 25 seconds prior to touchdown. As viewed from the pilot's perspective, the aircraft was to the left of centreline. Several seconds later, the aircraft initiated a right turn to line up with the centreline of Runway 19, but actually crossed to the right of the centreline. The aircraft then overflew several buildings on the right of the runway centreline, approximately 75 feet adjacent to the runway threshold. The aircraft then turned sharply to the left as it passed abeam the threshold, then sharply right to acquire the centreline before touching down approximately 2000 feet past the threshold. Immediately after touchdown, the aircraft veered left into the snow bank.

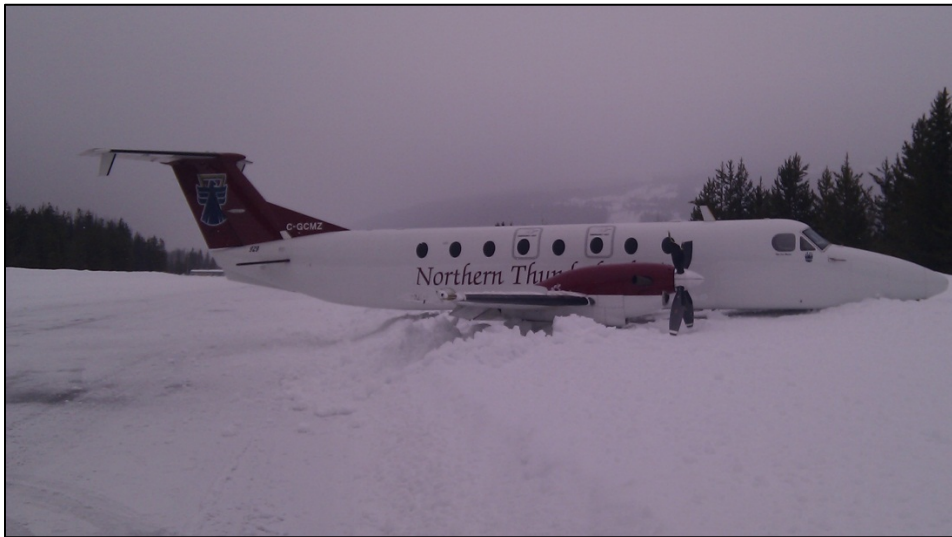
The aircraft sustained substantial damage. Both propellers were damaged when the blade tips came in contact with the snow banks. Several of the blade tips separated approximately 10 inches from the end. Both engines were removed for overhaul. The nose gear had partially collapsed when a gear-down linkage broke due to overload. A number of main and nose gear doors were damaged or destroyed. The outboard section of the right wing was damaged. The flaps and nacelles were damaged, but there was no significant damage to the main fuselage (Photo 1 and Photo 2).

**Photo 1.** Right side of damaged aircraft

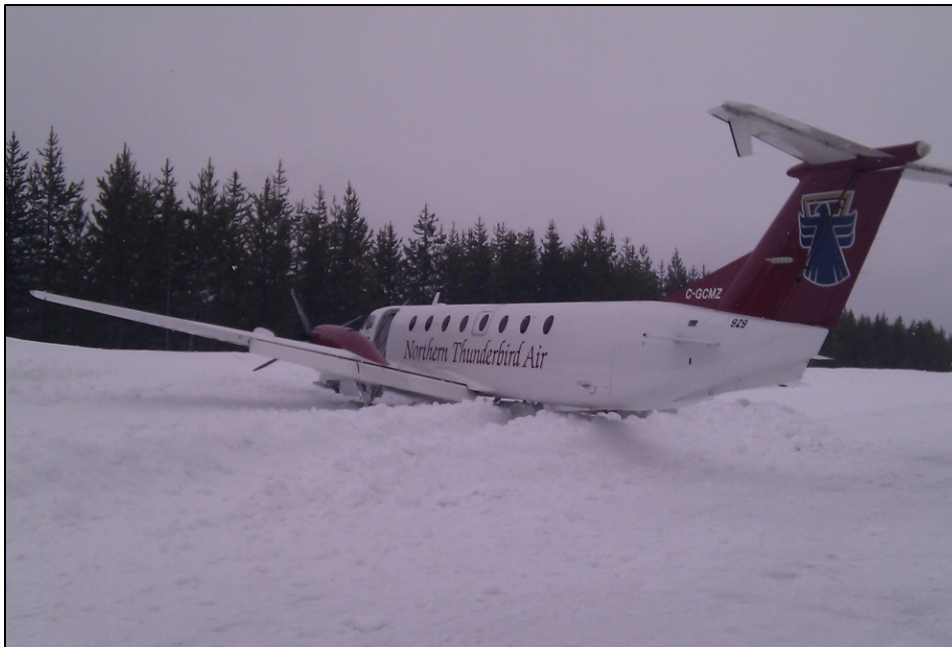
**Photo 2.** Left side of damaged aircraft
