Air Transportation Safety Investigation Report A18P0108

LOSS OF CONTROL AND COLLISION WITH WATER

Fort Langley Air Ltd.
Cessna 180H, C-FCDQ
Tyaughton Lake, British Columbia
01 August 2018

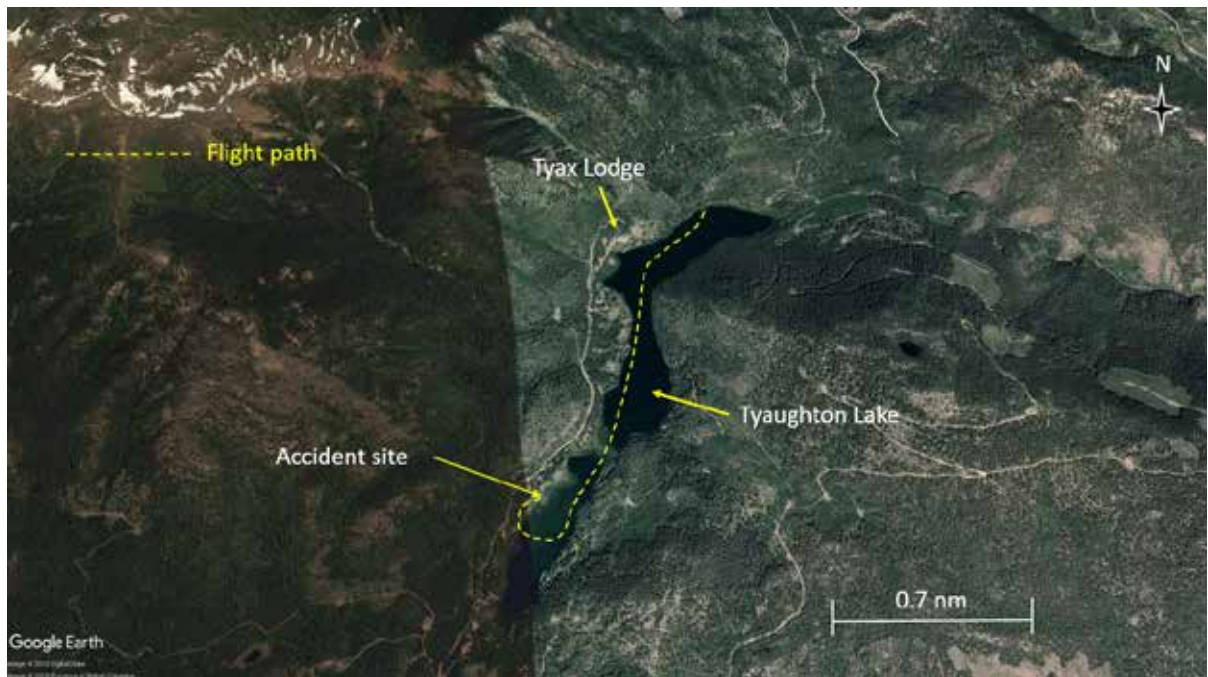
Figure 2. The occurrence aircraft's flight path (Source: Google Earth, with TSB annotations)

Given the local terrain, the pilot reduced the airspeed and banked the aircraft steeply to the right, turning back toward the lake. The aircraft then abruptly rolled further to the right and struck the lake in a near-vertical attitude at approximately 1255 (Figure 2). The aircraft was substantially damaged on impact and sank.

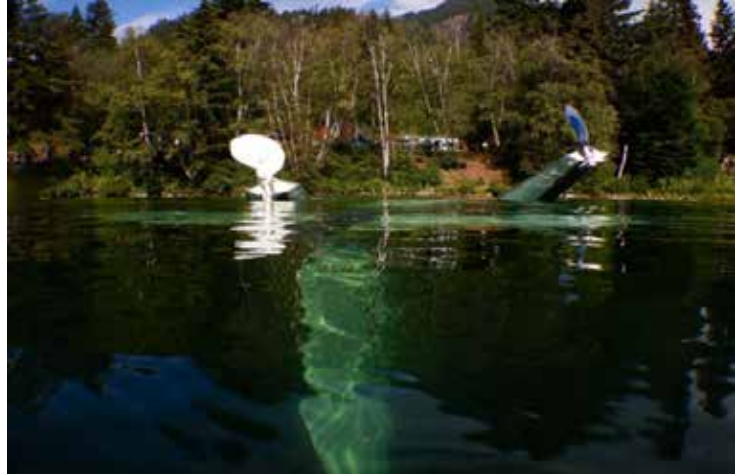
Figure 3. Accident site (Source: Royal Canadian Mounted Police)

Tyaughton Lake is approximately 3300 feet above sea level. The aircraft struck the lake in a near-vertical attitude and came to rest inverted, in 10 to 15 feet of water about 50 feet from shore, with the floats partially above the water (Figure 3).

The majority of the wreckage was located near the fuselage. Both floats had severe damage to the tips and showed impact damage

resulting from the contact with the water. All of the control surfaces were accounted for. An examination of the flap system indicated that the flaps were in the 20° position at the time of impact. All damage to the airframe was attributable to impact forces. The fuel selector was found to be set to both tanks, which contained sufficient fuel for the remainder of the flight. The left fuel cap had not been replaced after refuelling and was found hanging from its chain. Damage to the engine and propeller were consistent with a high power setting at the time of impact.
