AIR TRANSPORTATION SAFETY INVESTIGATION REPORT A18W0116

POWER LOSS AND LOSS OF CONTROL IN FLIGHT

Aries Aviation International
Piper PA-31, C-FNCL
Calgary/Springbank Airport, Alberta, 40 nm SW
01 August 2018

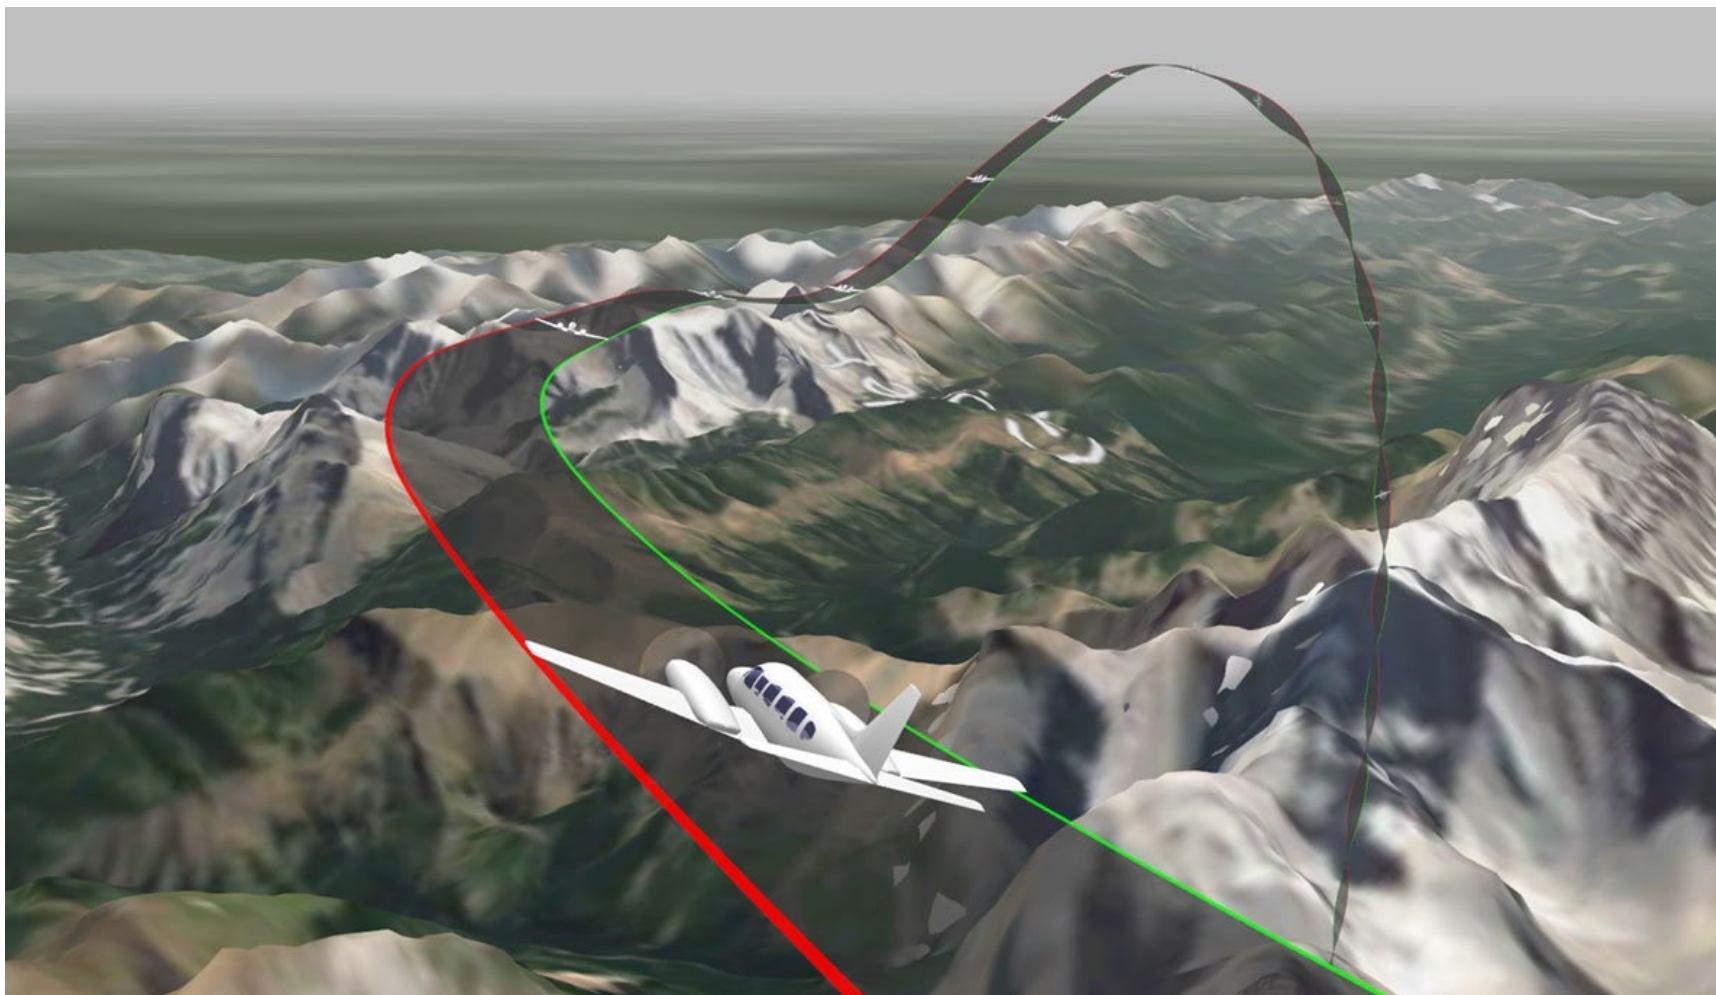
Appendix A – Final flight path of the aircraft leading up to the loss of control and spin entry (looking toward the southeast)

At 1334:40 the aircraft deviated to the right (south) of the intended track, and its altitude decreased to 13 500 feet. The aircraft then began to climb, and the IAS began to decrease below V_{YSE} once again. At 1335:43, ATC called the pilot to confirm that he was going to the IGVEP waypoint. The stall warning horn was sounding continuously at this time. The pilot replied that there was a problem with the right engine. Shortly afterward, the airspeed decreased to 71 KIAS, and the aircraft departed controlled flight and went into a right-hand spin (Appendix A).

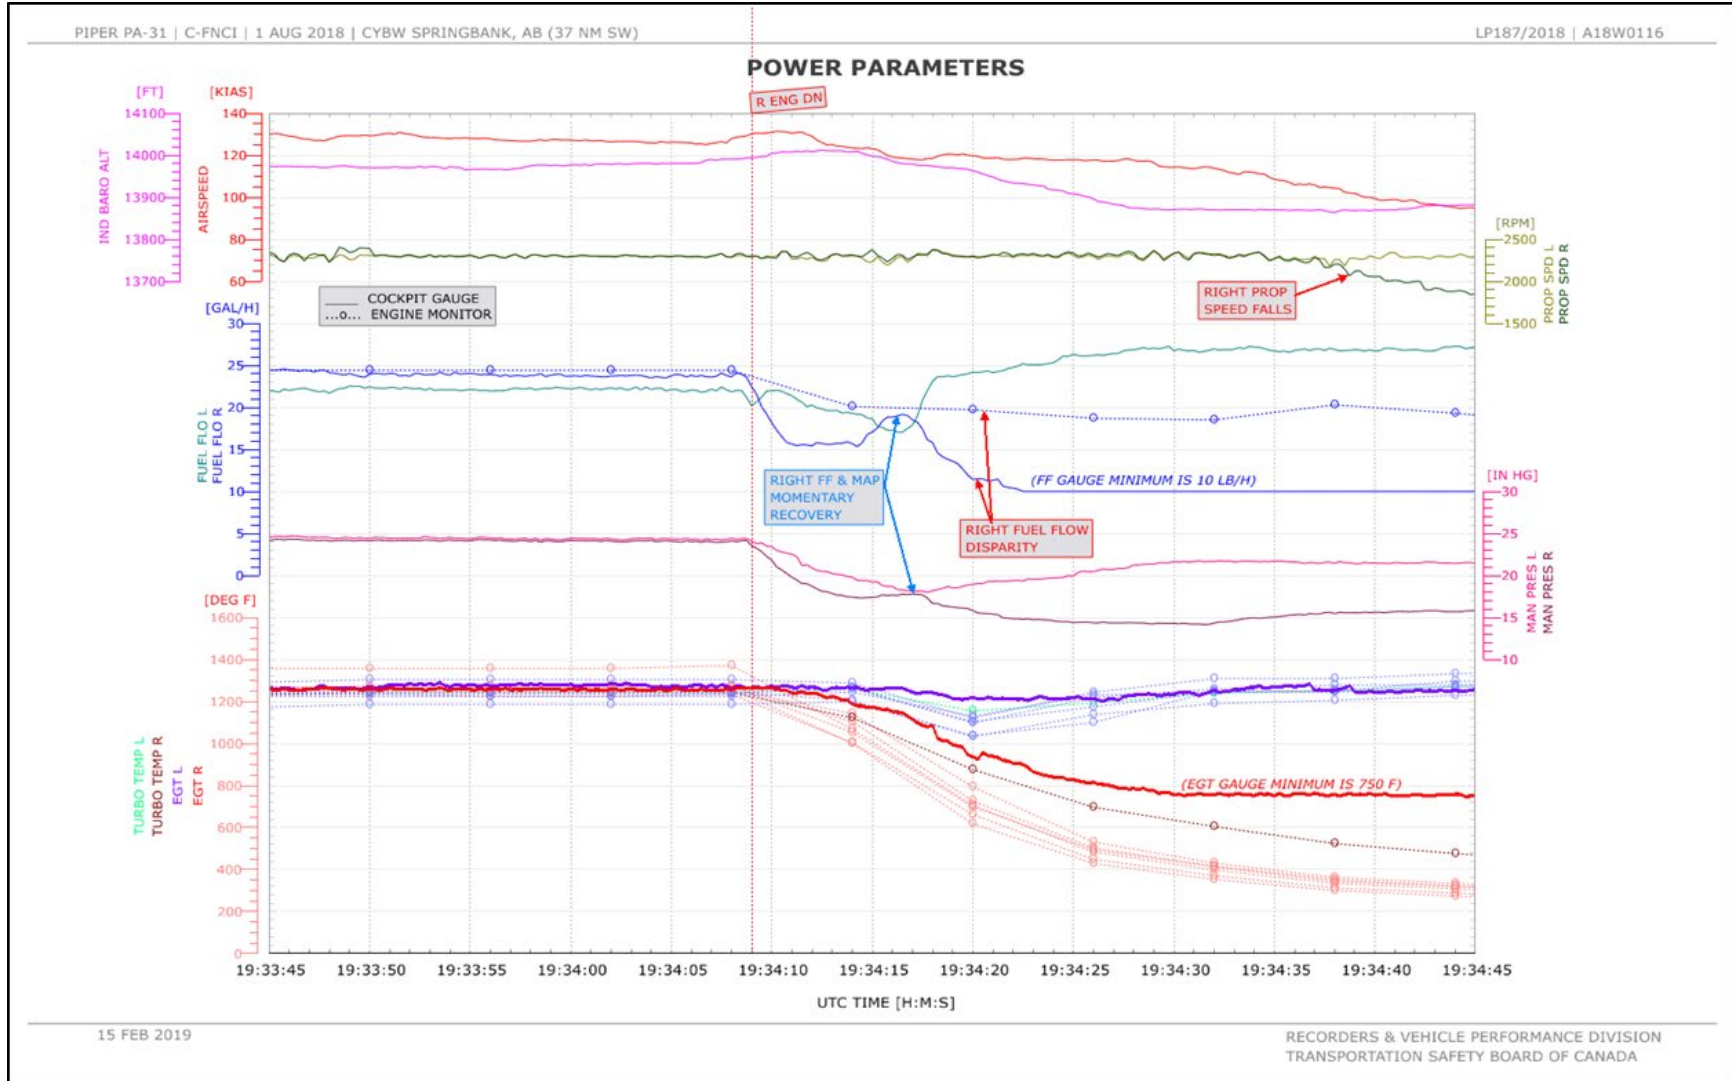
Figure B2. Parameters for 1 minute during the power loss of the right engine (Source: TSB Engineering Laboratory)

A few seconds later, the manifold pressure (MP) on both engines decreased, which resulted in the left-hand MP gauge indicating an MP of 18 inches of mercury (inHg) and a fuel flow of 22 U.S. gallons per hour, and the right-hand engine indicating an MP of 15 inHg and a fuel flow of 14 U.S. gallons per hour.
