AIR TRANSPORTATION SAFETY INVESTIGATION REPORT A19O0006

RUNWAY INCURSION

Greater Toronto Airports Authority
Snow removal vehicles
Toronto/Lester B. Pearson International Airport
Mississauga, Ontario
28 January 2019

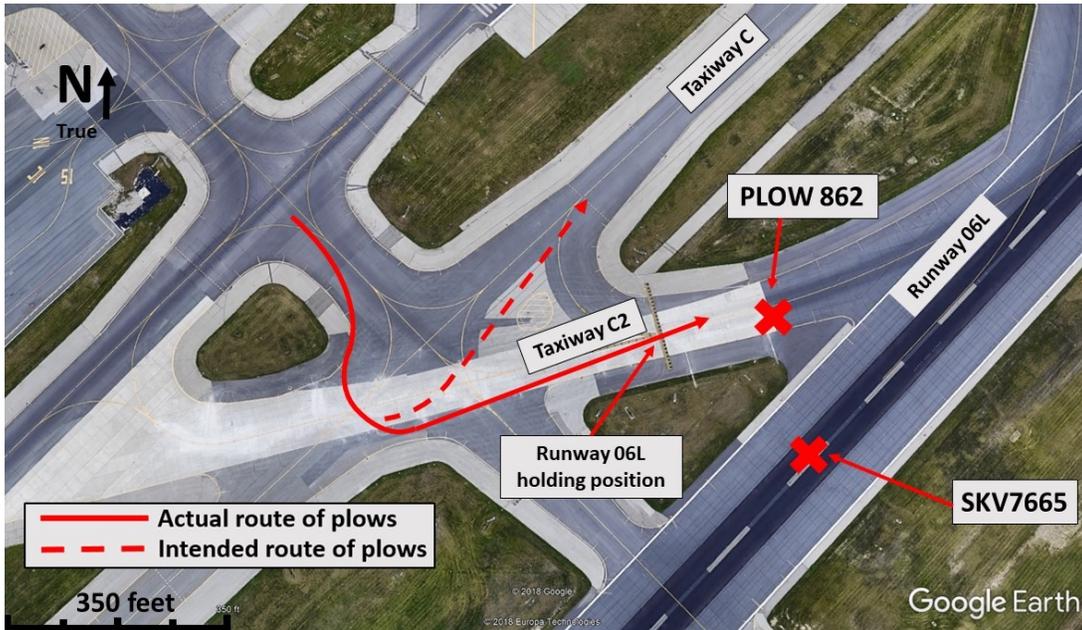
Next, PLOW 862 inadvertently proceeded onto Taxiway C2 instead of Taxiway C and continued toward Runway 06L, with the other vehicles following (Figure 1). At this point the operator of PLOW 862 believed that they were on Taxiway C.

Figure 1. The intended and actual route of the plow vehicles, and the locations of PLOW 862 and flight SKV7665 when they came to a stop (Source: Google Earth, with TSB annotations)

When PLOW 862 came to a stop, it was approximately 270 feet beyond the holding position for Runway 06L, but still on the taxiway surface, approximately 100 feet laterally from the edge of the runway.

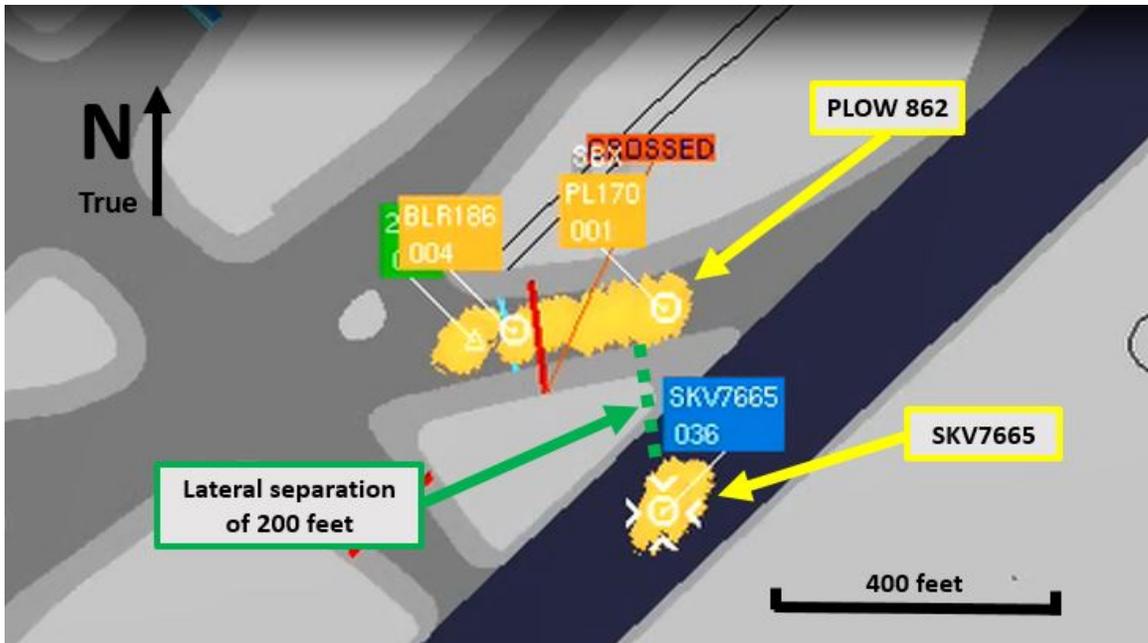
The aircraft came to a stop on the runway centreline, approximately 200 feet before the intersection of Runway 06L and Taxiway C2, and separated from PLOW 862 by about 200 feet laterally (Figure 2).

Figure 2. Lateral separation between flight SKV7665 and PLOW 862 on ground radar display (Source: NAV CANADA, with TSB annotations)

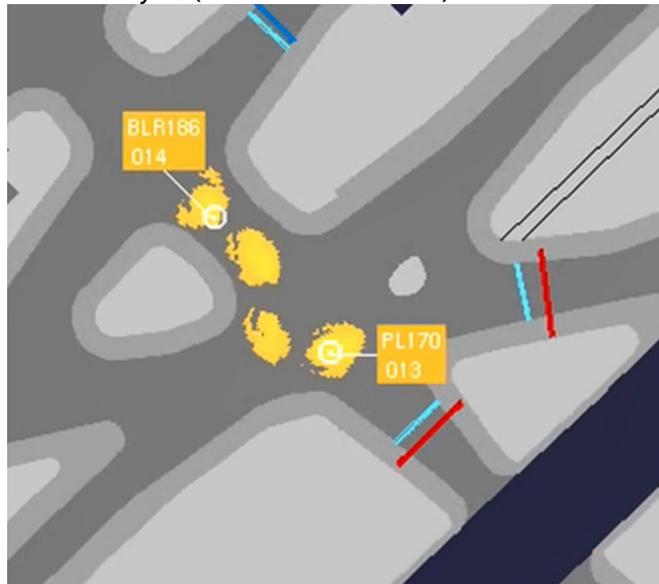
In this occurrence, the lead plow (PLOW 862) was shown as PLOW 170 on the controller's A-SMGCS display. The call signs of the next 2 vehicles in the convoy did not appear on the display, and the last vehicle was shown as BLR 186.

Figure 3. Depiction of plow vehicles on the controller's A-SMGCS display screen as the vehicles were manoeuvring onto Taxiway C2 (Source: NAV CANADA)

In this occurrence, the ground controller saw the lead plow vehicle on the A-SMGCS display as it crossed the holding position; however, the display showed the vehicle as PLOW 170. When there was no response from the ground controller's first 2 transmissions to stop, the ground controller referred to the EXCDS display, saw the correct call sign for the plow, and then referred to the plow by the correct call sign in his next instruction to stop.

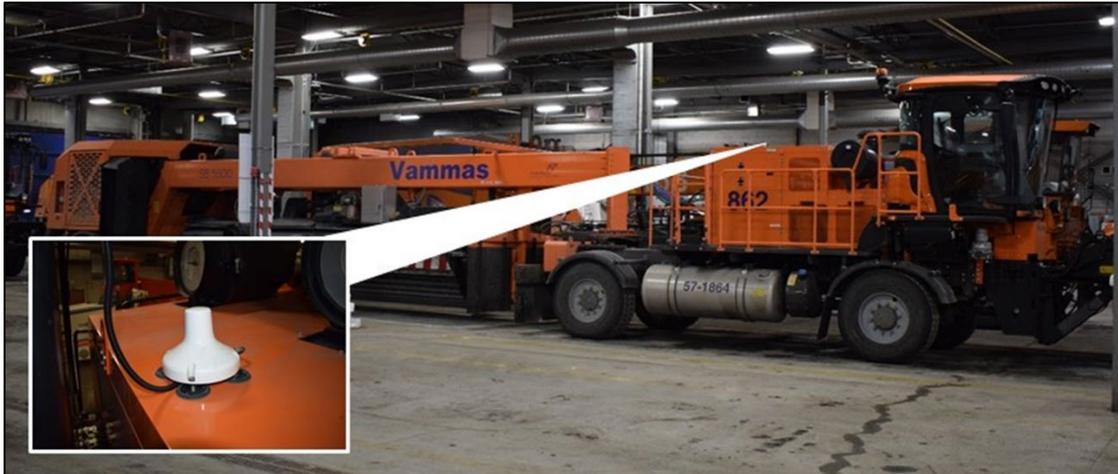
PLOW 862 was a new vehicle and did not have a transponder. Due to an extended delivery wait for a new transponder, PLOW 170's transponder was removed and installed on PLOW 862 on 10 December 2018.

Figure 4. PLOW 862 vehicle in this occurrence. The inset image shows the transponder antenna. (Source: TSB)
