AIR TRANSPORTATION SAFETY INVESTIGATION REPORT A21O0030

UNINTENTIONAL GEAR-UP LANDING ON RUNWAY

Province of Ontario, Ministry of Northern Development, Mines, Natural
Resources and Forestry
Canadair CL-215-6B11 (Series CL-415), C-GOGH
Sault Ste. Marie Airport, Ontario
02 May 2021

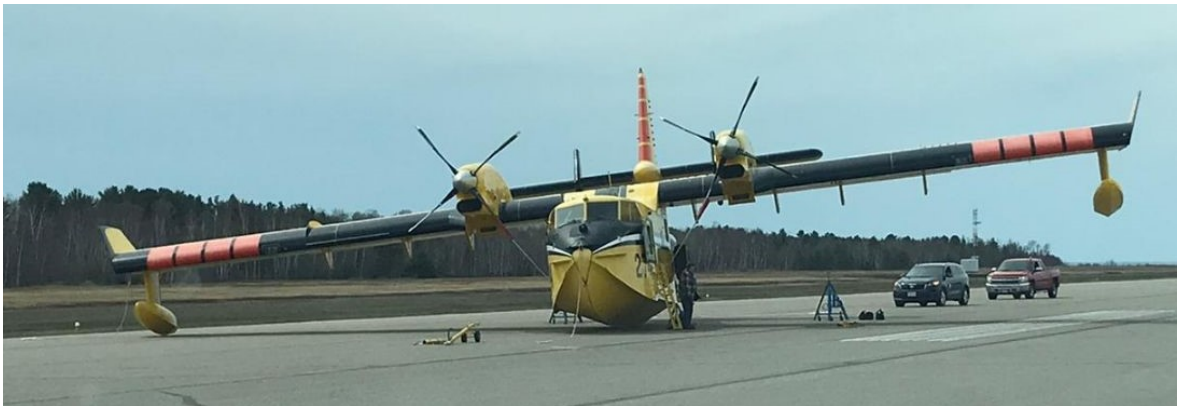
At approximately 1228, the aircraft landed on the centreline of Runway 12 with the landing gear retracted. The aircraft came to a stop on the runway surface with the right wingtip float resting on the ground (Figure 1). There was significant damage to the belly of the aircraft and minor damage to each wingtip float.

Figure 1. Photo of the occurrence aircraft after the gear-up landing (Source: Province of Ontario, Ministry of Northern Development, Mines, Natural Resources and Forestry)
