AIR TRANSPORTATION SAFETY INVESTIGATION REPORT A21O0056

WIRE STRIKE AND COLLISION WITH TERRAIN

Apex Helicopters Inc.
Robinson R44 (helicopter), C-FVPA
Brantford, Ontario
25 July 2021

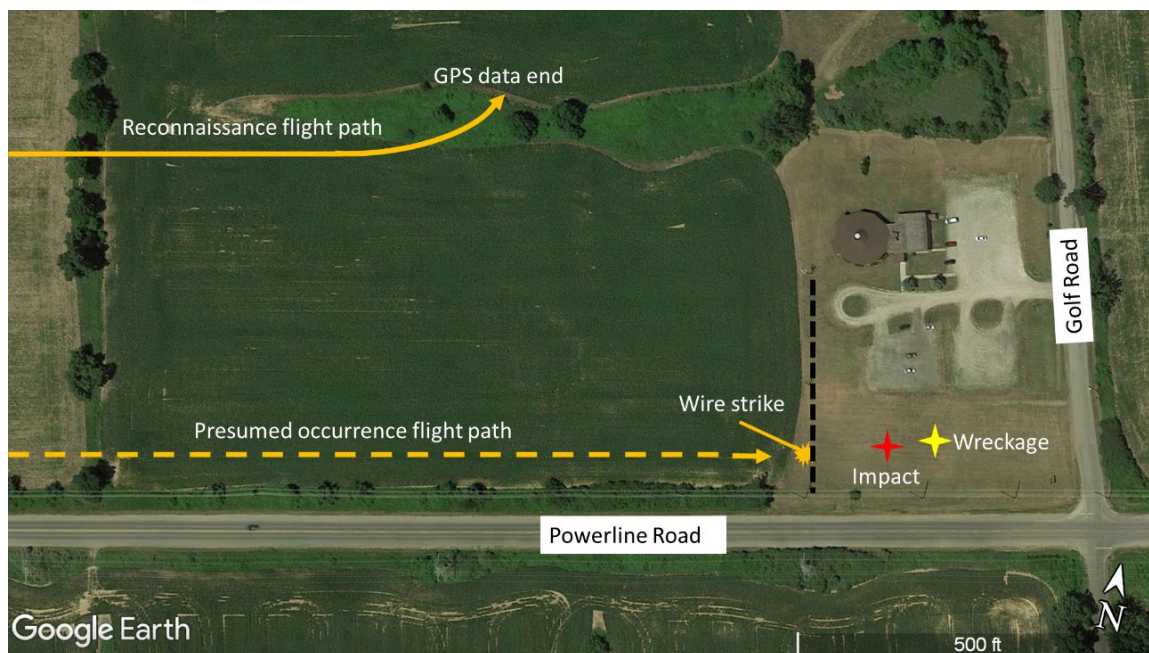
Figure 1. Aerial photo of the occurrence area and accident site showing the reconnaissance flight path (solid line), the presumed occurrence flight path (long-dashed line) and the position of the set of power lines that were struck (short-dashed line) (Source: Google Earth, with TSB annotations)

The helicopter presumably flew parallel to the south edge of the field, on a heading of approximately 077° magnetic (M). At 0659:44, it struck wires at a height of approximately 30 feet AGL. Control of the helicopter was lost, and the helicopter collided with the ground before coming to rest on a grassy field approximately 270 feet beyond the wire strike location.

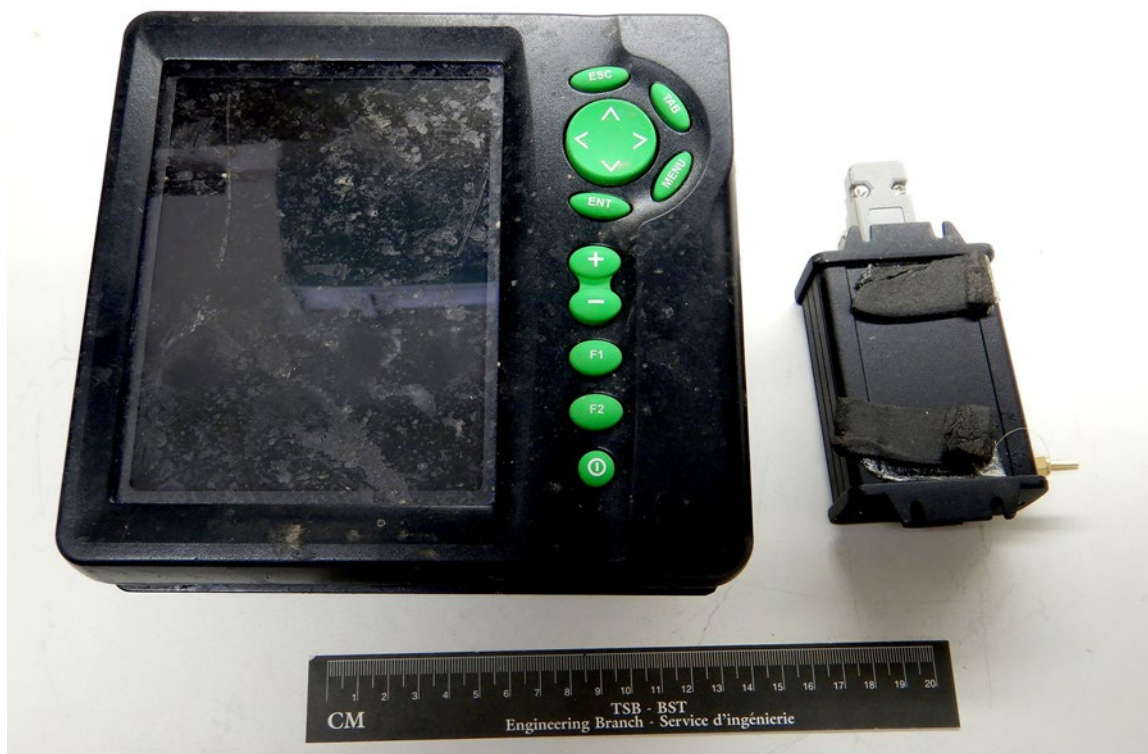
Figure 3. TracMap Flight1 device and GPS antenna recovered from the occurrence helicopter (Source: TSB)

The Flight1 GPS recovered from the occurrence helicopter was found with minor damage to the screen and the outer casing. It was sent to the TSB Engineering Laboratory in Ottawa, Ontario. It functioned normally when it was examined.

During examination of the data, it was noted that there were gaps in the continuity of the data in each of the recorded flights, most often between 10 and 15 seconds long, with some lasting between 4 and 10 minutes. Because there was no evidence of data corruption, internal processing priorities within the software were considered the most likely reason for the gaps, including the missing 1 minute 8 seconds of flight data at the end of the occurrence flight.

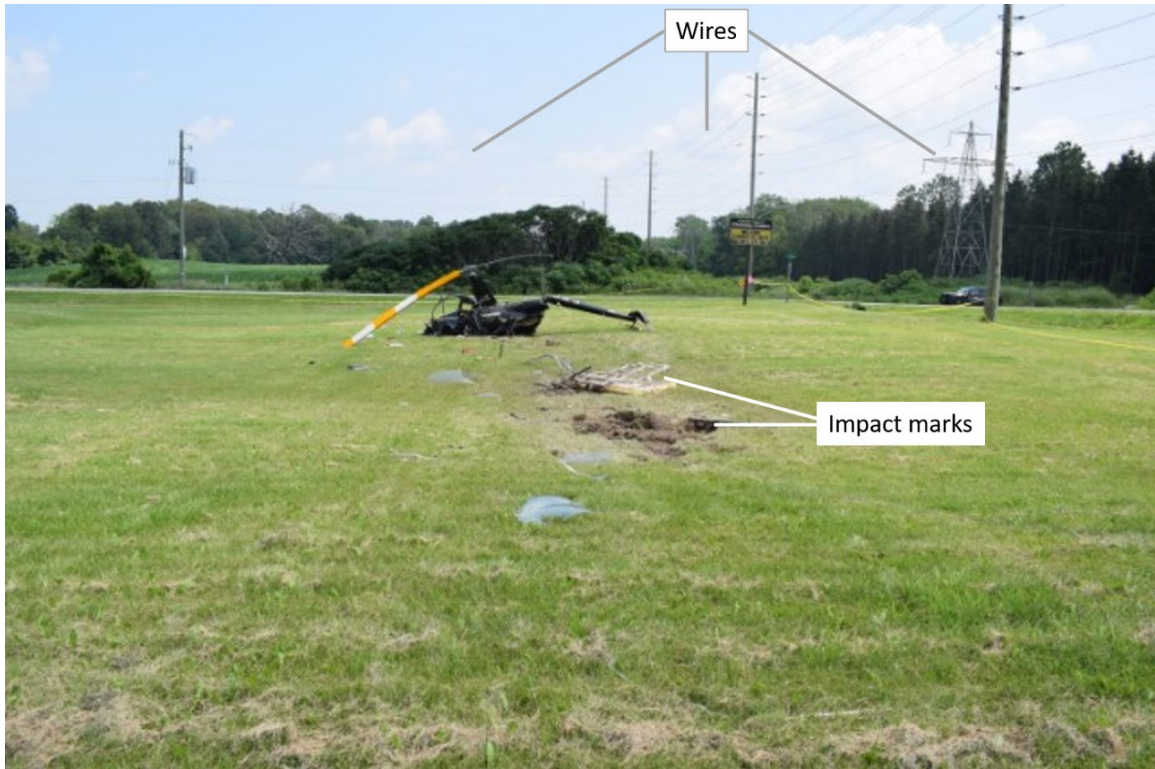
The main wreckage was found approximately 270 feet east of the wires that were struck; the fuselage, main rotor blades, tail boom, and tail rotor remained mostly attached, while the skids, spray bar, and chemical tank became detached on initial contact with the ground (Figure 4).

Figure 4. Photo of the occurrence helicopter wreckage taken beyond the wires that were struck, facing east (direction of flight) and showing the impact marks, two sets of power wires to the right, and a third perpendicular set ahead of the wreckage (Source: TSB)

The top 3 of 4 wires were severed by the helicopter. The lowest wire, which remained intact, was at a height of approximately 25 feet AGL, while the top wire was approximately at 37 feet AGL. Sections of wire were found wrapped around the top of the main rotor mast just below the hub, and at the bottom of the mast pylon. The lowest wire struck appears to have been severed by the skid assembly mounted below the helicopter.

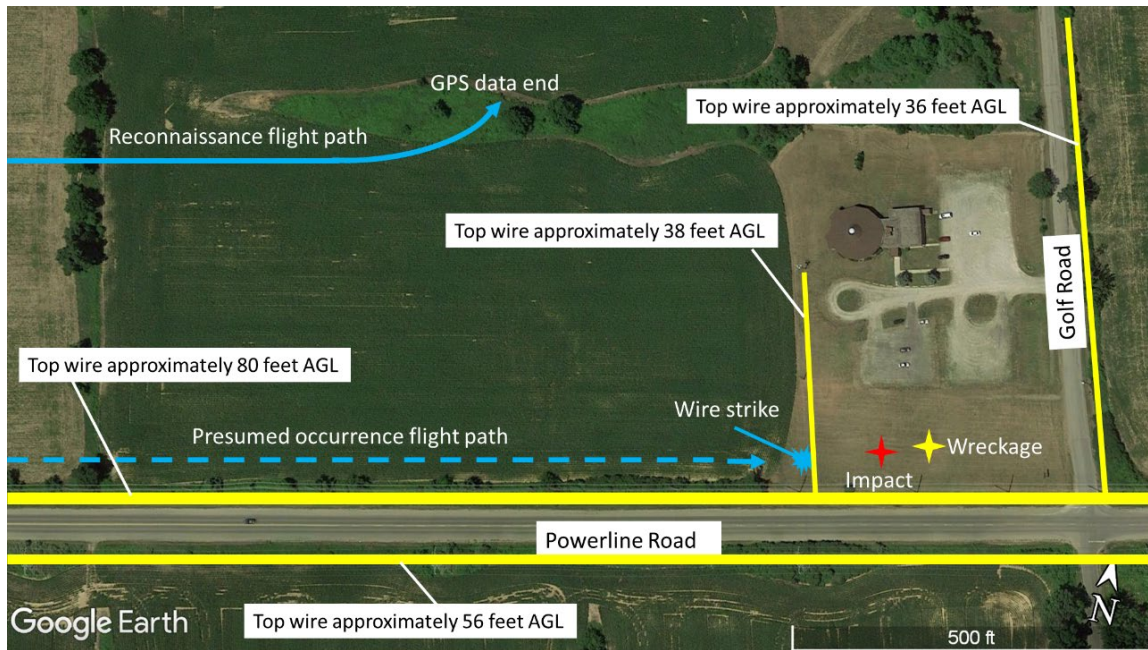
The wire strike occurred near the intersection of Powerline Road and Golf Road, at the boundary between the corn field and a church property located on Golf Road. Wires were running parallel to the occurrence flight path, on either side of Powerline Road, at heights of up to 80 feet AGL. There were also wires along Golf Road, 1000 feet to the east of the occurrence site; these were up to 36 feet AGL and parallel to the wires that were struck (Figure 5).

Figure 5. Site map showing the reconnaissance flight path, the presumed occurrence flight path, and the approximate heights of the top wires in the vicinity (Source: Google Earth, with TSB annotations)

The wires that were struck by the helicopter supplied electricity to the church, and were adjacent to the corn field along the boundary between the properties. The wires originated from a 56-foot tall pole along Powerline Road, and sloped downwards towards the first of two 38-foot tall poles located on the church property and spaced 150 feet apart. These poles were situated along the edge of the corn field, between 10 and 20 feet from the edge of the corn. When viewed from the west, the corn obscured the bases of these poles.

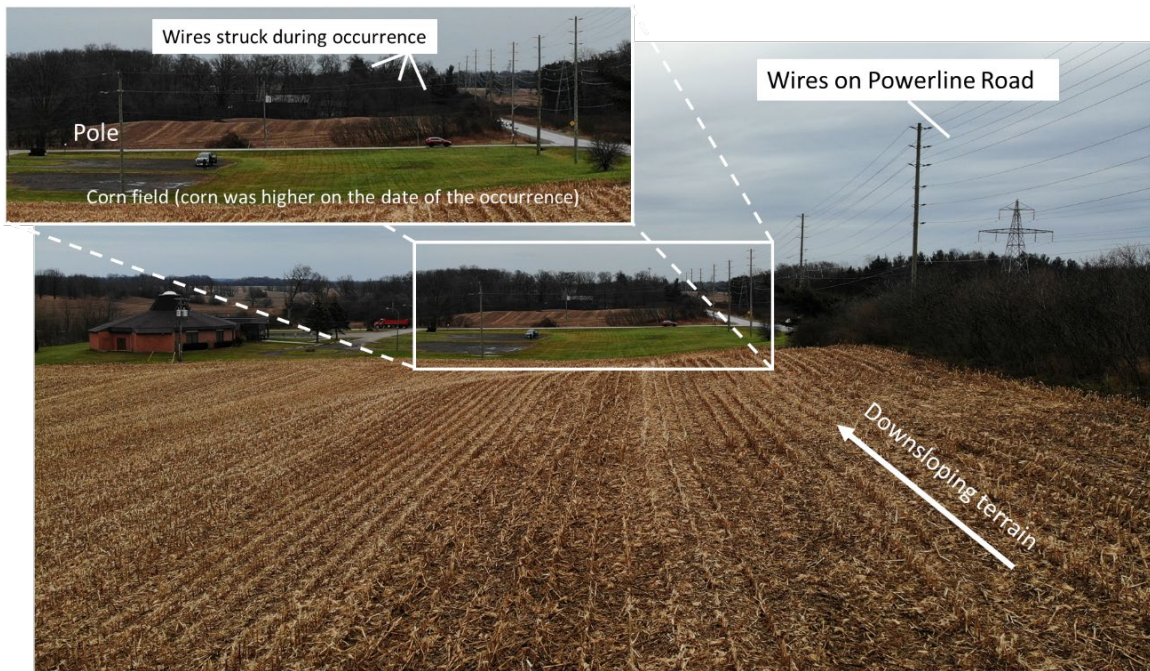
The corn field, which the pilot had presumably been spraying before striking the wires, sloped downwards towards the church property, with a reduction in elevation of at least 30 feet (Figure 6).

Figure 6. Photo showing the pilot's approximate perspective during the spray run, with inset image of magnification of lines. Photo taken after corn field was harvested. (Source of main image and inset: TSB)

The wires that were struck were significantly less prominent. Instead of running along a roadside or the church driveway, they ran along the edge of a corn field, which is not where pilots expect to see them, nor where they focus on scanning for hazards. These wires were lower than the 2 prominent sets of wires running east to west, and the bases of their associated poles were obscured by the corn. Consequently, they were more difficult to detect from the air, especially when viewed from the west.
