AIR TRANSPORTATION SAFETY INVESTIGATION REPORT A22C0027

LOSS OF CONTROL AND COLLISION WITH TERRAIN

Privately registered
Piper Cherokee PA-28-140, C-GLKD
Sioux Lookout Airport, Ontario, 19 NM SSE
29 April 2022

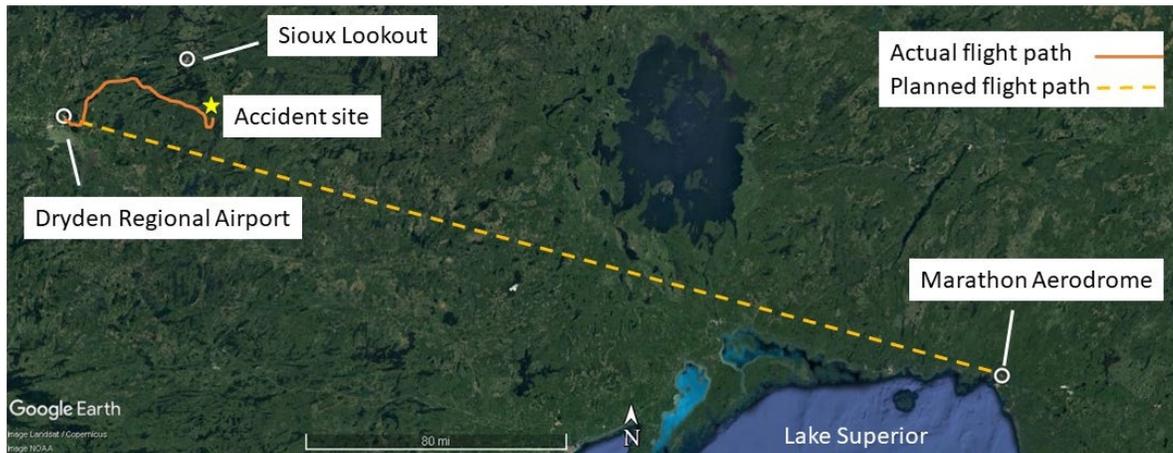
Figure 1. Map showing the flight path and accident location (Source: Google Earth, with TSB annotations)

The aircraft struck trees in a heavily wooded area approximately 19 nautical miles south-southeast of Sioux Lookout, Ontario. The investigation determined that the aircraft entered the forest canopy in a 90° angle of bank, indicating that it had departed controlled flight. The aircraft came to rest approximately 100 feet from where it initially came into contact with trees. There was no post-impact fire.

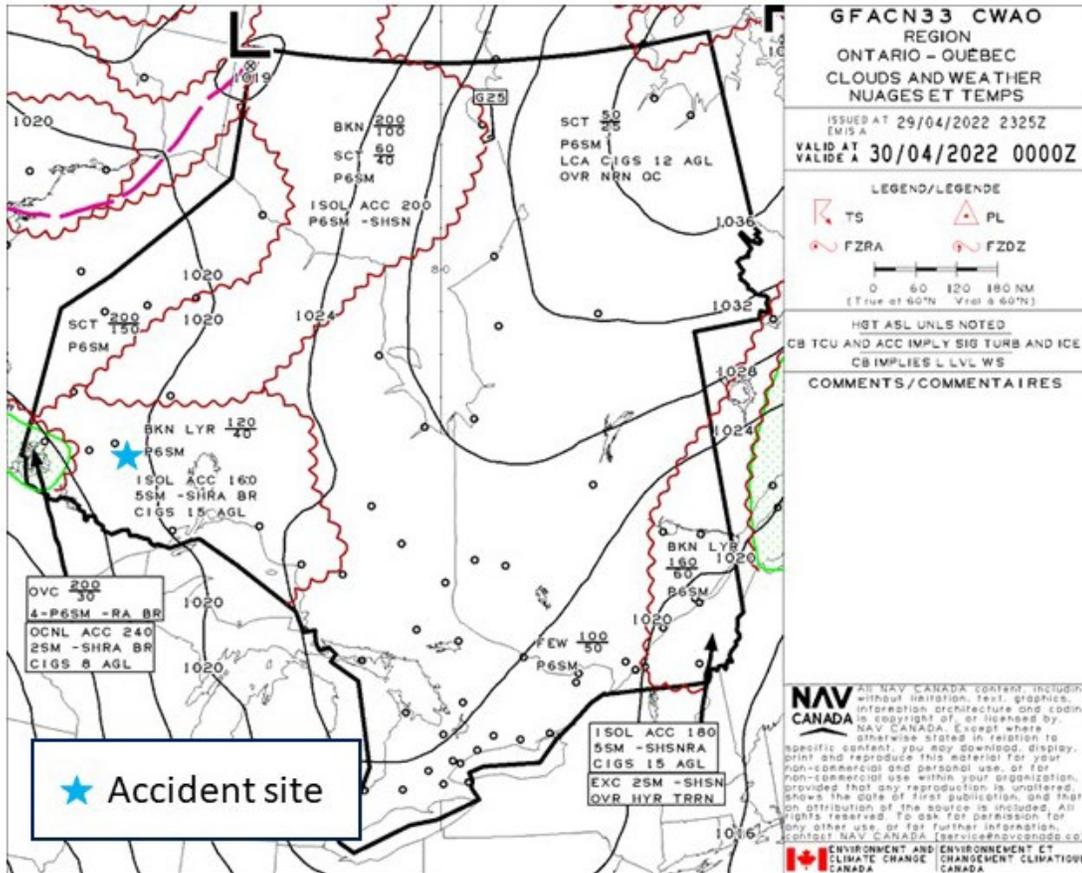
The graphic area forecast for the area around CYHD and CYXL, issued at 1825 on 29 April and valid at 1900, called for broken cloud layers with bases at 4000 feet above sea level (ASL) and tops at 12 000 feet ASL, visibility greater than 6 statute miles (SM), isolated altocumulus castellanus clouds topping at 16 000 feet ASL with visibility of 5 SM in light rain showers and fog, and ceilings of 1500 feet above ground level (AGL) (Figure 2).

Figure 2. Graphic area forecast valid at the time of the occurrence, with the approximate accident location indicated by a star (Source: NAV CANADA, with TSB annotations)
