AIR TRANSPORTATION SAFETY INVESTIGATION REPORT A22P0019

COLLISION WITH TERRAIN

Kootenay Valley Helicopters Ltd.
Airbus Helicopters AS350 B3, C-GWTQ
Nelson, British Columbia, 35 NM N
16 March 2022

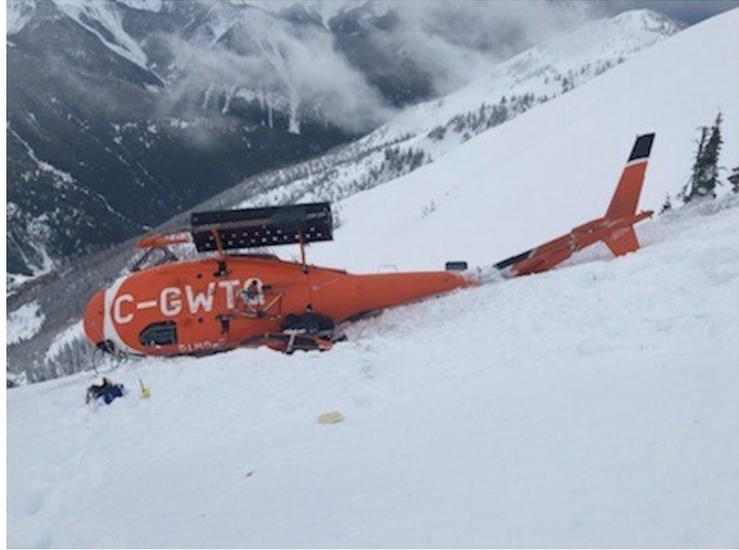
The pilot, with reduced visibility, turned the helicopter to the left. During this manoeuvre the tail rotor contacted either a tree or the surface of the slope; this caused the helicopter to shudder. The high-frequency vibration rapidly worsened and the pilot performed a forced landing. At approximately 1331, the helicopter landed hard on its skids and tipped onto its right (the pilot's) side (Figure 1). The main rotor and blades were fractured and the tail boom was partially severed. The helicopter came to rest about 3 to 5 m downslope of the second explosive charge deployed; the charge detonated approximately 2.5 minutes later, but did not trigger a release of the snowpack.

Snow entered the cabin through the gap where the pocket door had been removed and through several windows that had broken or popped out. The 3 occupants were initially disoriented and shaken, but were not injured. The bombardier was face down in the snow, still secured in the aircraft by his harness, with bags of unprimed ANFO on and around him. The blasting assistant was still belted in the front passenger seat and was disoriented due to being on his side. The pilot secured the electrical and fuel systems, and he, along with the blasting assistant, egressed from the helicopter.

Figure 1. The occurrence aircraft, rolled over on its right side
(Source: British Columbia Ministry of Transportation and Infrastructure)
