AIR TRANSPORTATION SAFETY INVESTIGATION REPORT A22Q0029

CONTROLLED FLIGHT INTO TERRAIN

Airbus AS350 B2 (helicopter), C-GFBW
Sept-Îles Airport, Quebec, 7.5 NM W
17 March 2022

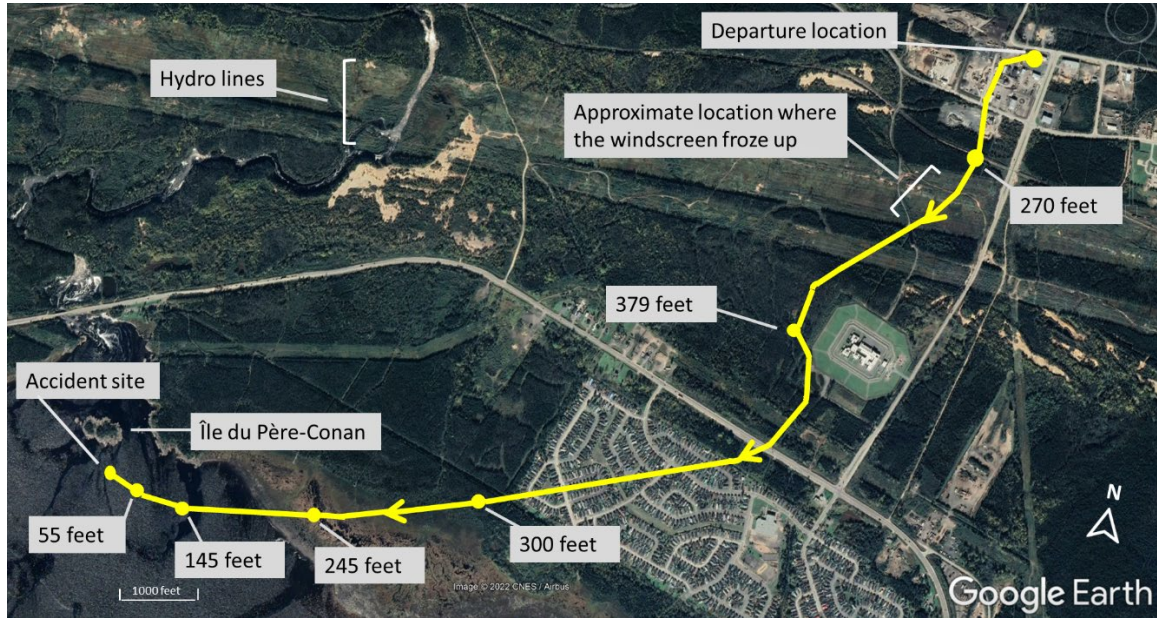
When the aircraft flew over power lines south of CHB4 (Figure 1) at approximately 300 feet above ground level (AGL), the outer surface of the windshield became suddenly covered with frost, except for the lower right corner. Given that forward visibility was limited, the pilot decided to land on the frozen Baie des Sept Îles, a vast open area less than 2 nautical miles away, which he deemed more suitable for a landing under those conditions than the CHB4 heliport.

Figure 1. Aerial view of the route flown by the occurrence helicopter according to the global positioning system, with altitudes above ground level (Source: Google Earth, with TSB annotations)

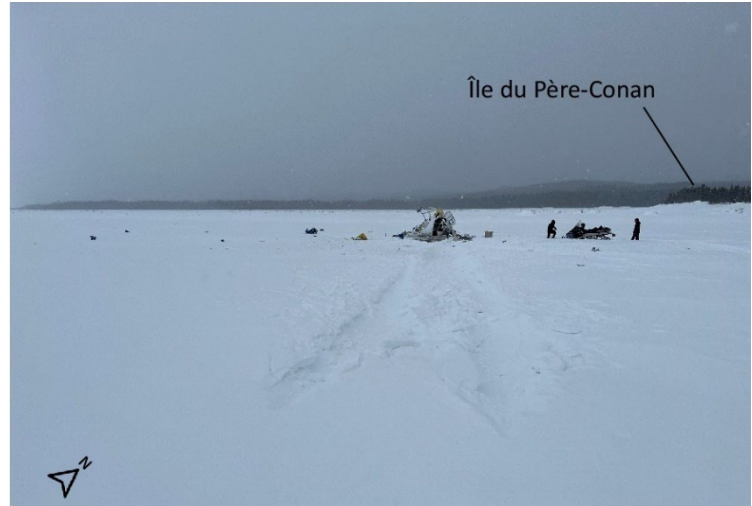
a photo taken by Héli-Boréal, 2 tracks approximately 120 feet long are visible in the snow (Figure 2). The direction of the tracks leading to the fuselage was 292° magnetic (M).

Figure 2. Photo taken the day of the occurrence showing tracks left in the snow by the occurrence helicopter (Source: Héli-Boréal, with TSB annotations)
