AIR TRANSPORTATION SAFETY INVESTIGATION REPORT A22P0067

LOSS OF ENGINE POWER AND FORCED LANDING

Conair Group Inc.
Air Tractor, Inc. AT-802A, C-FFQS
Cranbrook, British Columbia, 20 NM S
02 August 2022

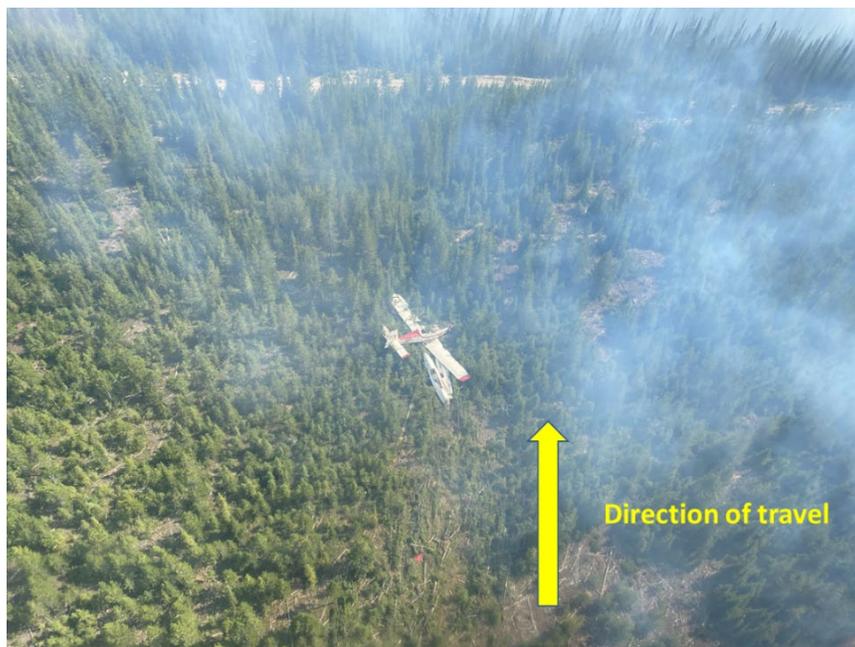
Figure 2. Accident site (Source: Conair Group Inc., with TSB annotation)

The aircraft struck the trees in a near-level attitude. The floats broke off, separated from the fuselage, and rolled upside down, coming to rest near the trailing edge of the right wing. As the fuselage decelerated, it turned approximately 45° to the right but remained upright (Figure 2). There was significant damage to the leading edges of the wings and the fuselage lower skins. Calculations indicate that, at the time of the forced landing, the aircraft was carrying approximately 315 L of fuel.

The aircraft came to rest approximately 200 m from the edge of the Connell Ridge wildfire. In that location, the entire aircraft was at risk of being lost to the fire. However, the shifting winds and continued fire suppression operations in the area allowed for a successful recovery a few days later.

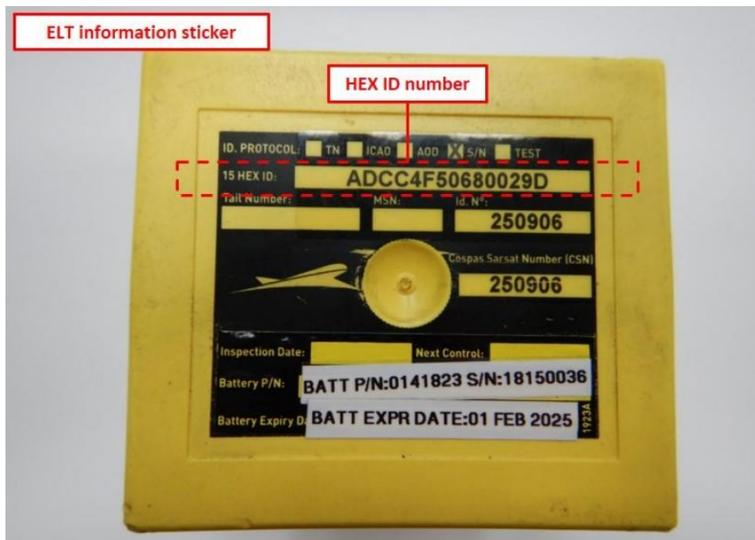
Figure 3. Emergency locator transmitter that was removed from the occurrence aircraft (Source: TSB)

The ELT was found inside the aircraft, secured in the mounting bracket and still connected by coax cable to the antenna. The ELT's fibreglass whip rod antenna, which was approximately 13 inches in length, had been broken off during the forced landing.

The coax cable was observed to be functional and in good condition. The broken antenna also functioned, though its signal strength was diminished due to its damaged condition. The ELT battery pack, mode switch, and G-switch were found to be functional.

The investigation determined that the signal strength from the broken antenna was not sufficient to be received outside of the immediate accident location. Therefore, it was not received by other aircraft or the Canadian Mission Control Centre.

During testing, the 15 Hex ID digital signal received by the testing equipment did not match the external identification sticker at the bottom of the ELT casing. The ELT casing still showed the previous 15 Hex ID from the ELT's original coding for the United States (Figure 3).

- A flight operations briefing on engine failures in general and the accident specifics was introduced to initial and recurrent pilot training.
- All AT-802 pilots received low-level engine failure training in the AT-802 simulator.
- The AT-802 maintenance team worked with Perkins Technologies to implement a new alarm from the Data Acquisition Alarm Monitor system. Using historical data from previous momentary power fluctuations, an alarm was created that will alert the pilot when the engine N_g value is above 90% with a corresponding fuel flow of 190 L/h or less. The software update was applied to the AT-802 Fireboss fleet first. Once the update is ready, it will also be installed on the AT-802 wheeled fleet.
- A fleet campaign has been implemented to check all fleet emergency locator transmitters for labels with an incorrect Hex Id. Any incorrect Hex Id will be corrected.

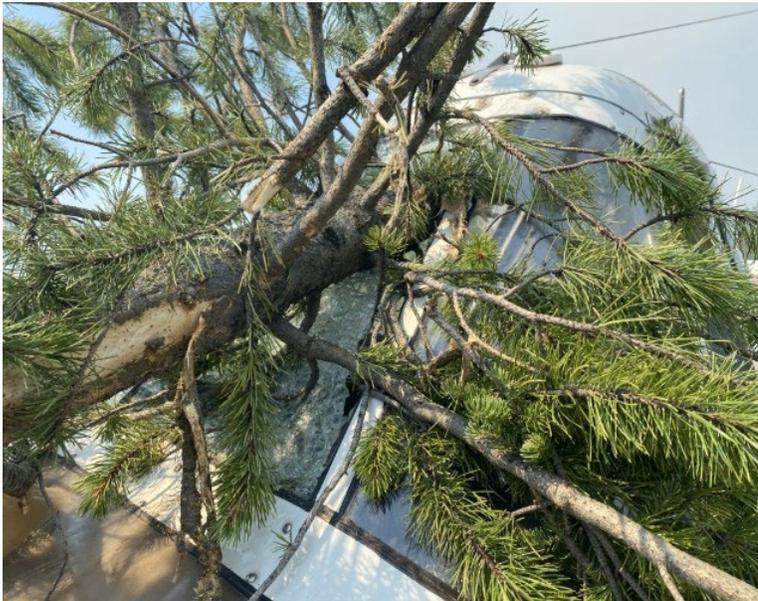
Figure 4. Tree protruding through the front windscreen and into the cockpit of the occurrence aircraft after its collision (Source: Conair Group Inc.)

As the aircraft descended into the trees and toward the ground, a small tree was cut, and it penetrated the windscreen, grazing the pilot's helmet. The pilot was covered in shards of glass from the shattered windscreen. The aircraft came to rest approximately 200 m from the edge of the forest fire.

The combination of the aircraft's thick windscreen and the pilot's flight helmet minimized the pilot's injuries when the tree penetrated the cockpit.

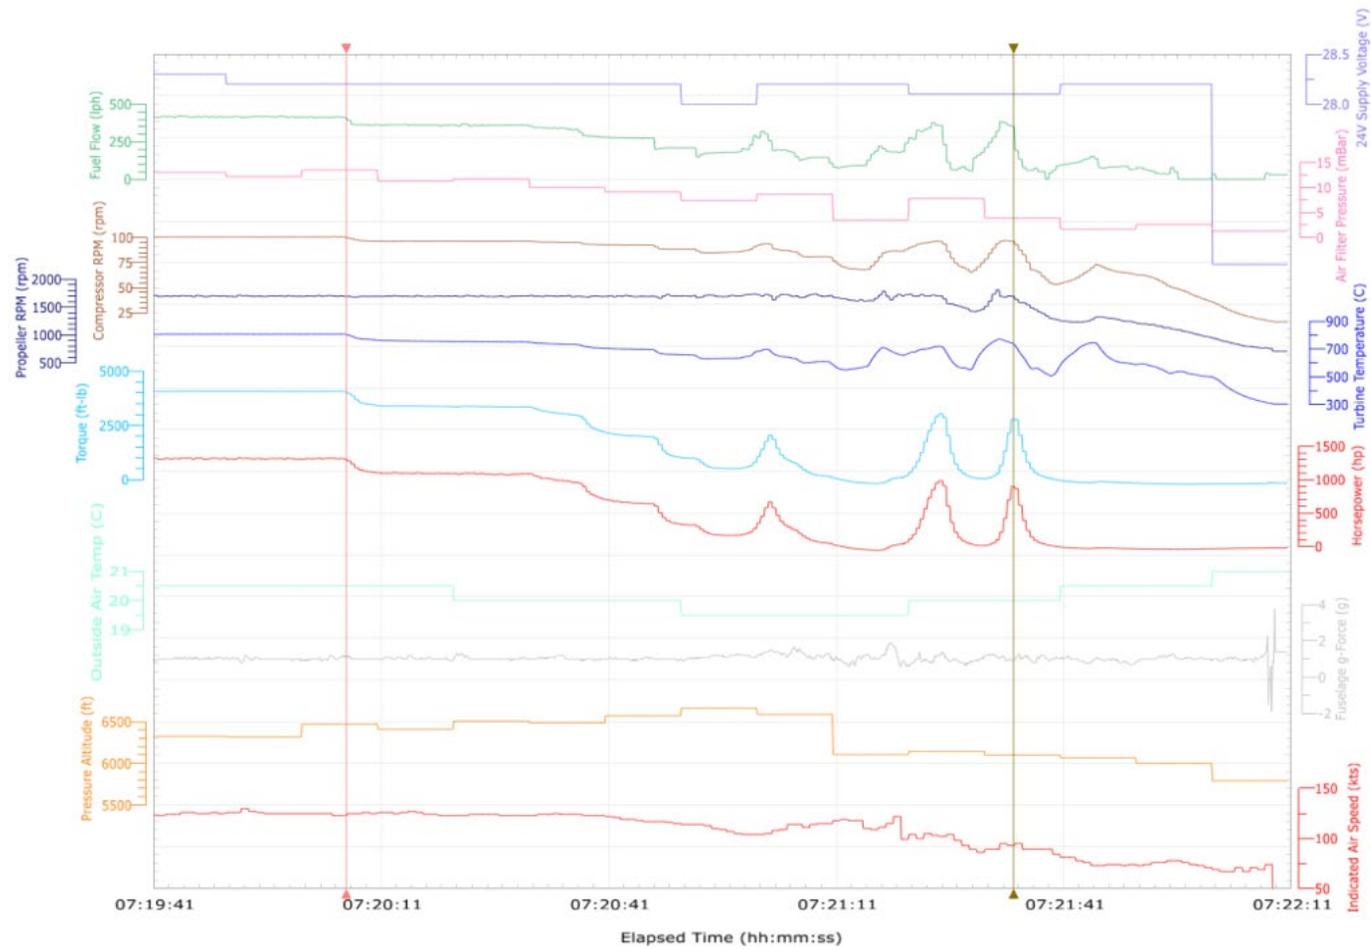
Appendix A – Time history plot of engine failure event

⁶ Flight data collected shows that the fuel flow dropped from 360 L/h to 172 L/h followed by an engine torque drop from 2928 to 1698 pound-foot.

In July 2022, the occurrence aircraft's FCU was replaced by maintenance staff after the aircraft had suffered a series of momentary power reductions in flight. The aircraft had accumulated approximately 13.6 flight hours with the replacement FCU when it suffered a significant power reduction and eventual flameout during the occurrence flight, resulting in a forced landing (Appendix A).
