AIR TRANSPORTATION SAFETY INVESTIGATION REPORT A22W0078

COLLISION WITH TERRAIN

Arty's Air Service Ltd.
Air Tractor, Inc. AT-502B, C-FJVL
Bawlf (Blackwells) Aerodrome (CFR2), Alberta, 18 NM S
12 September 2022

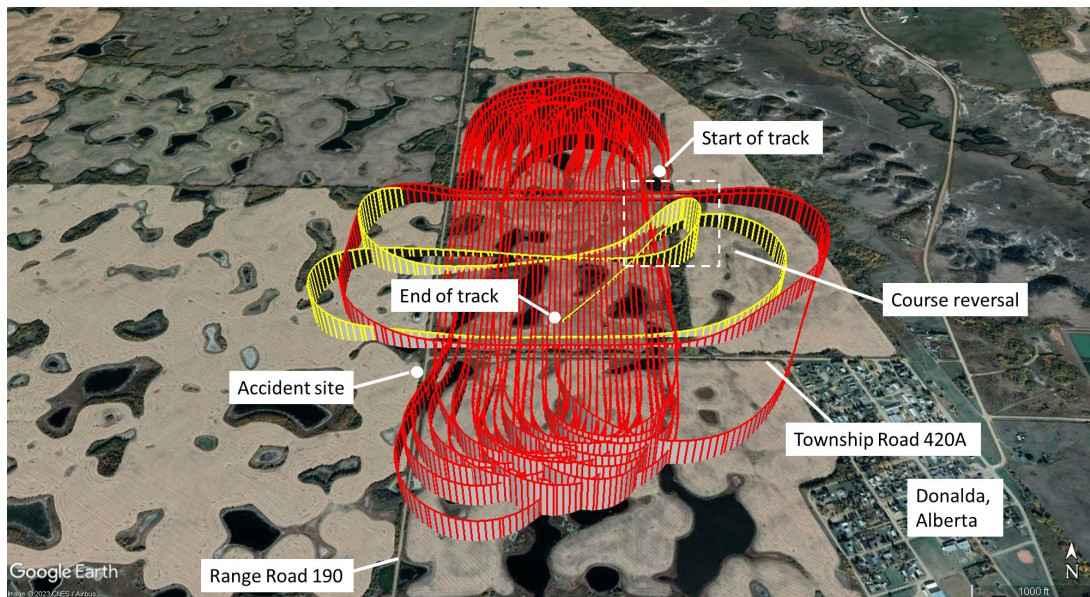
2 full east–west passes to cover off the ends of the field. All of the turns conducted during the application of chemical mixture were left turns and were consistent with altitude gains of ± 300 feet above ground level (AGL). On the third-to-last turn in the middle of the field, the pilot conducted a right course reversal with a tight radius and a steep climb, resulting in an altitude increase of more than 500 feet AGL (Figure 1).

Figure 1. Occurrence flight path based on global positioning system data; the last 1.5 minutes of the recorded flight path are in yellow; the dashed box indicates the course reversal (Source: Google Earth, with TSB annotations)

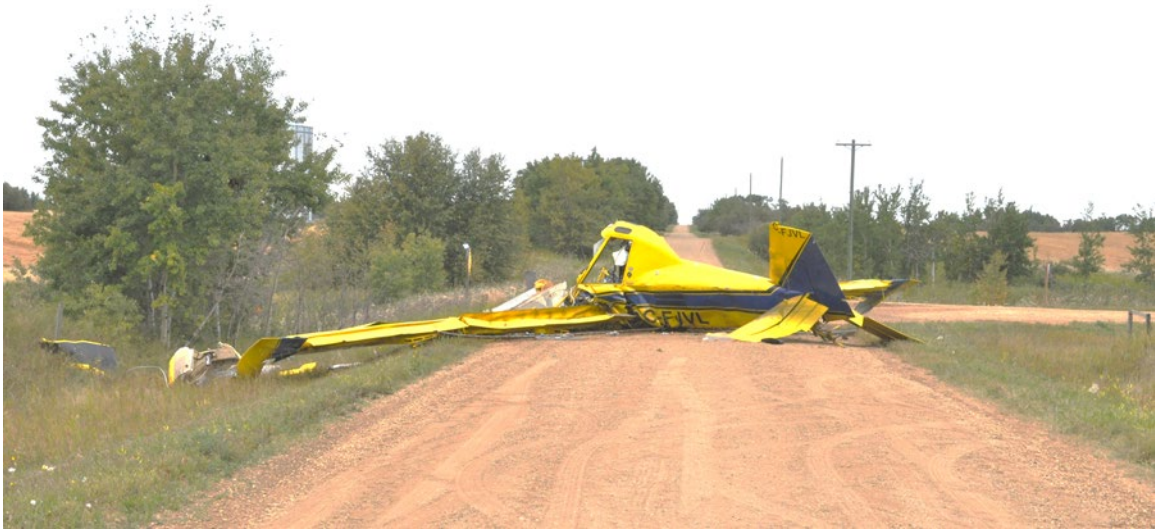
The aircraft was destroyed on impact. All major components of the aircraft were accounted for at the accident site. Based on the examination of the wreckage, the aircraft struck the ground in the middle of a rural gravel road in a vertical, nose-down, attitude (Figure 2). The bend signatures on the propeller blades indicate that the engine was developing power at the time of impact.

Figure 2. Accident site looking north along Range Road 190 (Source: TSB)

The leading edges of the wings had been flattened as they struck the road bed. The movement of fuel in the wing tanks caused hydroforming of the wing skins. The rivets attaching the upper wing skins sheared, rupturing the fuel tanks and allowing the fuel to spill. The empennage was relatively intact, but the vertical and horizontal stabilizers were bent forward. The parts that came off the aircraft during the impact were contained in the ditches on either side of the road, within a 65-foot radius of the point of impact.
