AIR TRANSPORTATION SAFETY INVESTIGATION REPORT A23P0003

CONTROLLED FLIGHT INTO TERRAIN

Summit Helicopters Ltd.
Bell Helicopters Textron Inc. 407 (helicopter), C-GTHU
Terrace, British Columbia, 15 NM NNW
04 January 2023

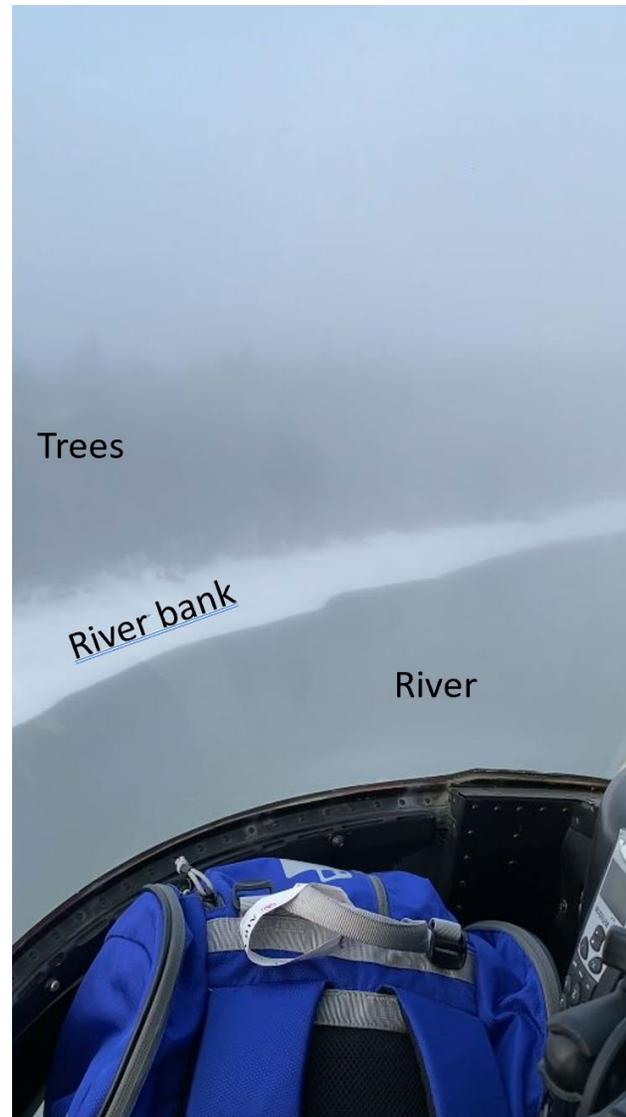
Figure 1. View out of the front of the helicopter, along the Kitsumkalum River (Source: Passenger, with permission)

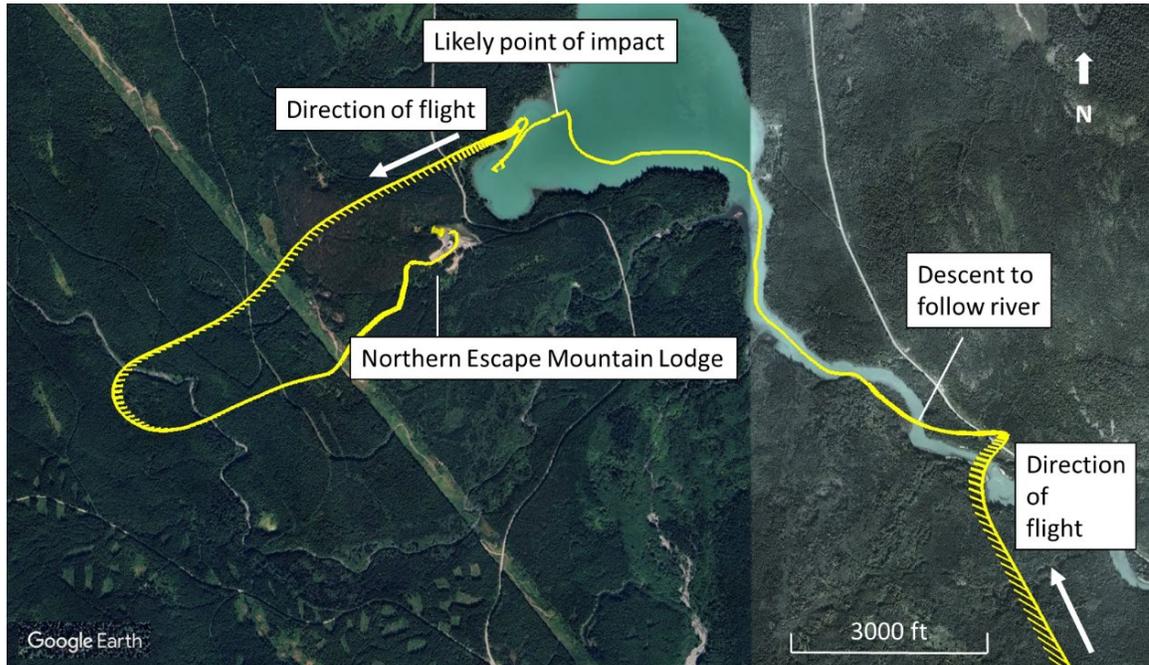
started to experience significantly reduced visibility due to the fog. The helicopter's ground speed at this time varied between 17 knots and 26 knots, and its height varied between 20 feet and 100 feet above the lake surface. The helicopter's track then changed more than 90° toward the west (Figure 2).

Figure 2. Occurrence helicopter's flight path (Source: Google Earth, with TSB annotations based on ForeFlight data)

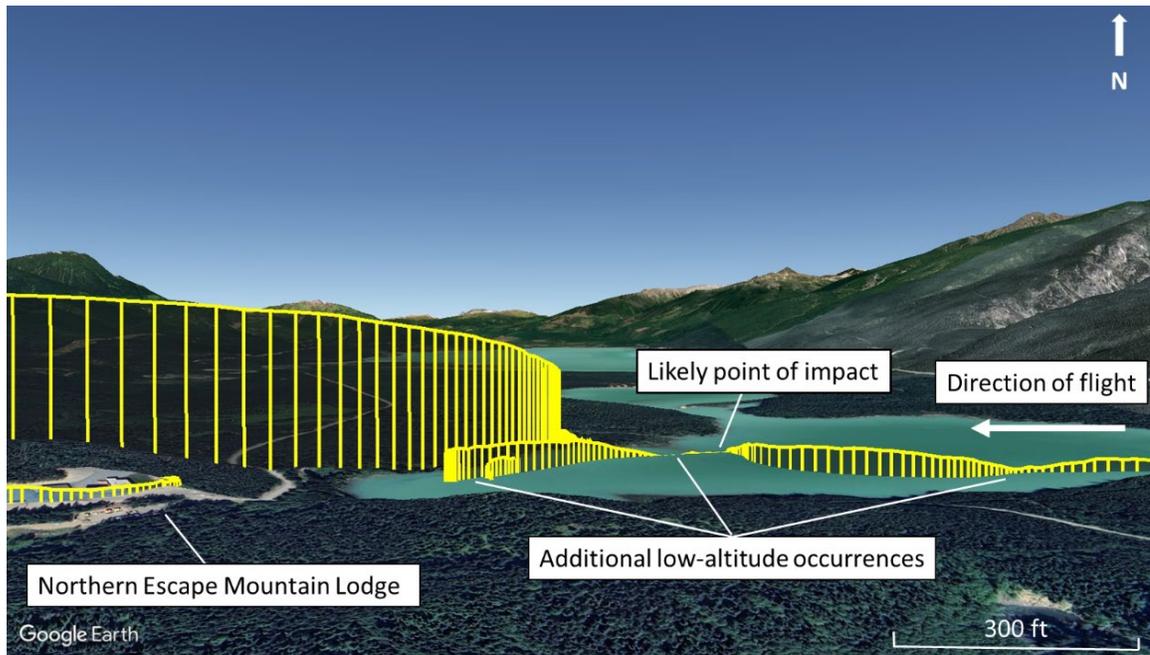
As the change in track was being completed, the altitude of the helicopter decreased inadvertently while the pilot temporarily lost visual reference with the frozen surface of the lake, and contact with the surface was made (Figure 3) at a ground speed of about 4 knots. The pilot felt the contact with the surface but managed to keep the helicopter flying. The pilot then continued flying to the west using the north shore of the lake for reference. Approximately $\frac{1}{5}$ NM west of the point of surface contact, the helicopter entered an unintentional descending turn to the left through about 180°. Because of the helicopter's low ground speed, its track change was not displayed on the ForeFlight application that the pilot was using to assist him in navigating.² This led the pilot to fly back toward the east briefly until the application began to indicate the correct direction of flight.

Figure 3. Occurrence helicopter's altitude while flying over Lake Treston (Source: Google Earth, with TSB annotations)

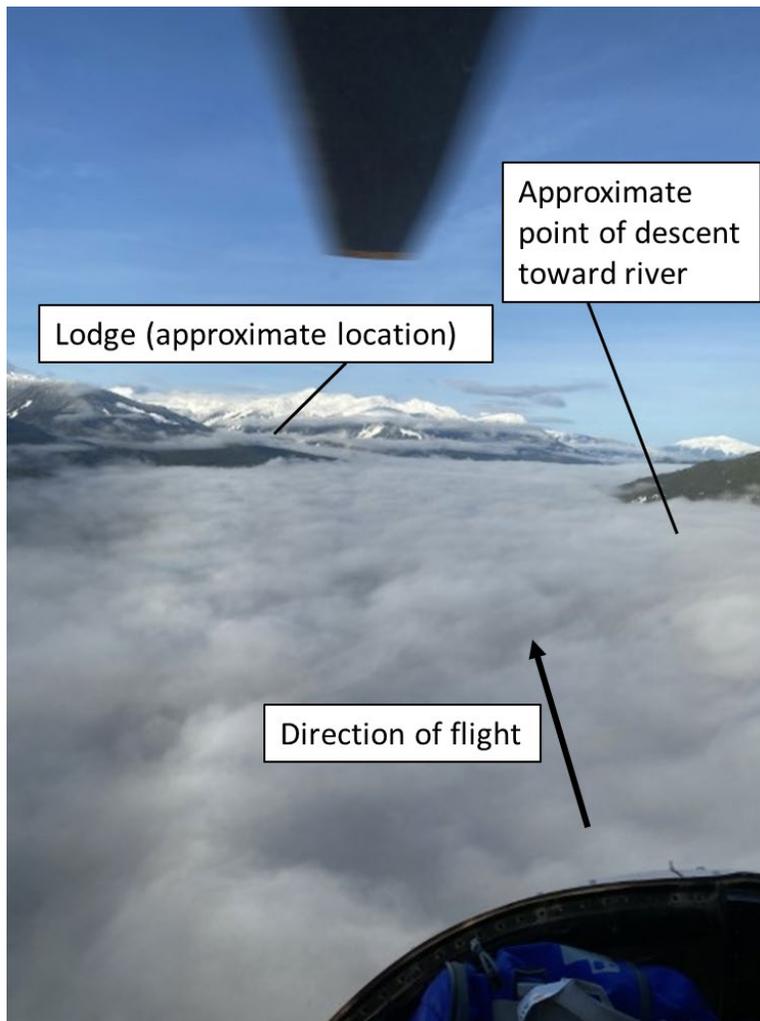
Figure 4. View of the weather from the occurrence helicopter en route to the lodge (Source: Passenger, with permission and with TSB annotations)

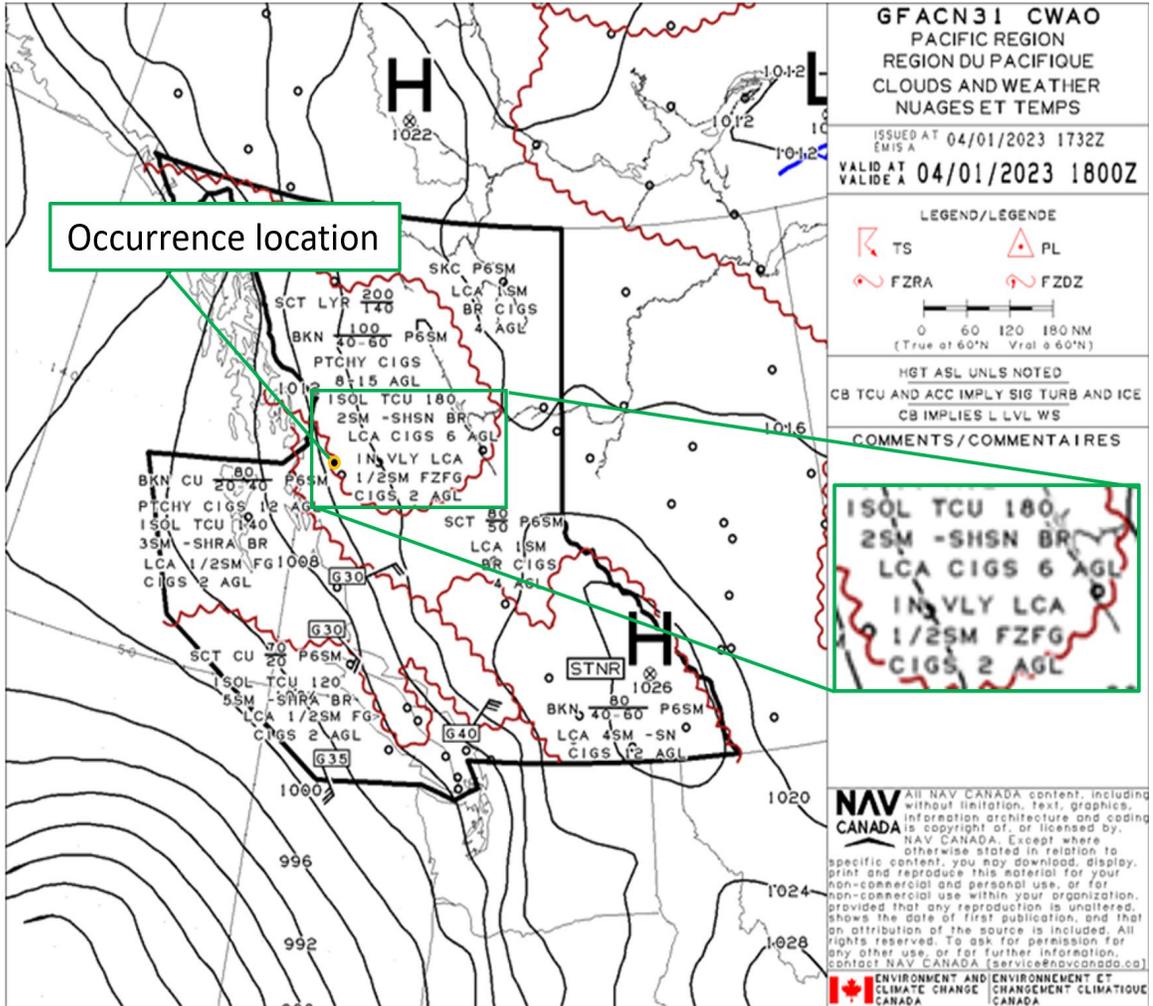
Appendix A – Graphic area forecast

The graphic area forecast (GFA) for the Pacific Region issued at 0932 and valid at 1000 (Appendix A) indicated that for the greater Terrace, BC, area, the following conditions could be experienced:

A post-occurrence review of the weather forecast information found that it had predicted the environmental conditions that were experienced by the pilot. The graphic area forecast noted the possibility of freezing fog with a visibility of ½ statute mile (SM) and ceilings of 200 feet above ground level in the mountain valleys. In addition, when the risk assessment data were reviewed, it was found that the weather (specifically, the possibility of valley fog) was not entered as a risk consideration for the flight. Only winter operations was added as a risk factor.
