# AIR TRANSPORTATION SAFETY INVESTIGATION REPORT A23P0091

## COLLISION WITH TERRAIN

Air Nootka Ltd.  
De Havilland DHC-2 Mk. I (Beaver), C-FZVP  
Gold River Water Aerodrome, British Columbia  
28 July 2023

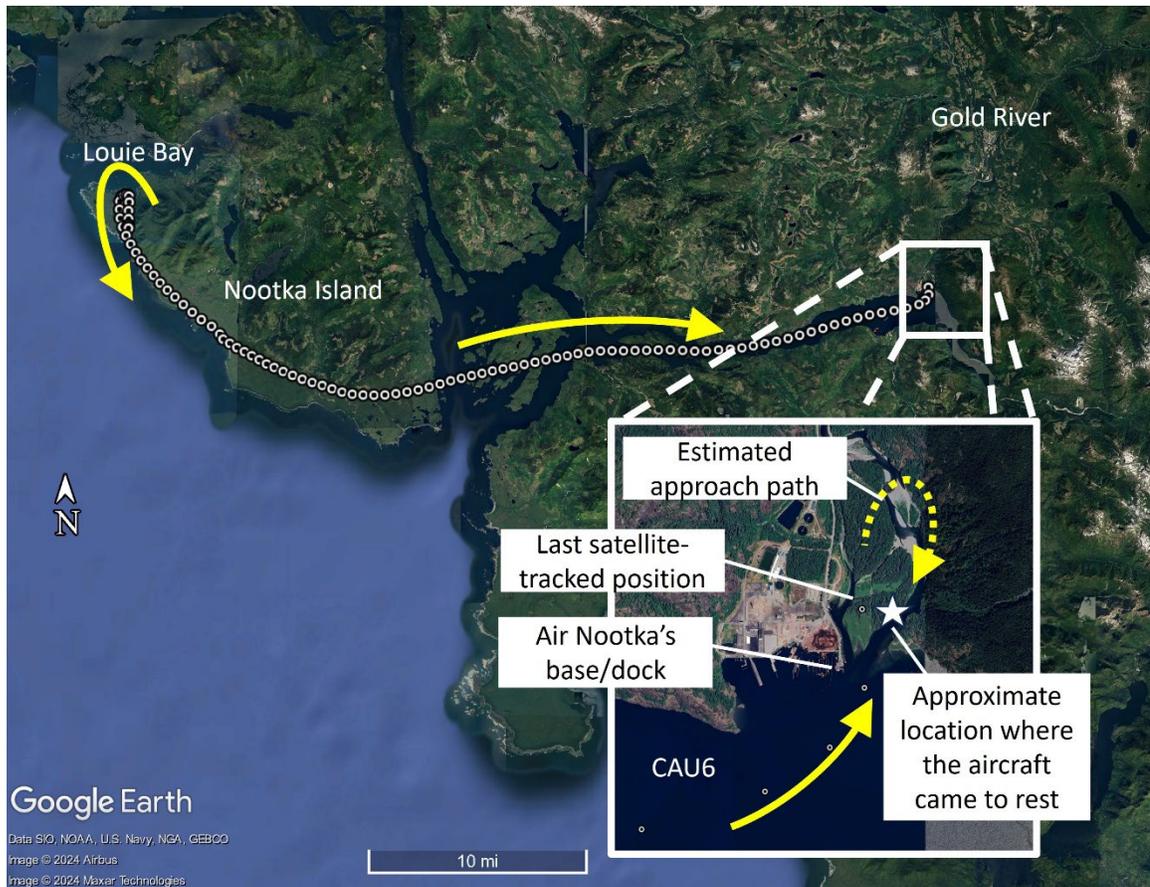
river, coming to rest approximately 75 feet from the river (Figure 1). There was no post-impact fire. The pilot received serious injuries, was extracted by local firefighting personnel, and attended to by local paramedics. He was then airlifted to hospital by a search and rescue helicopter.

Figure 1. Recorded and estimated flight track of the occurrence aircraft (Source: Google Earth and Spidertracks data, with TSB annotations)

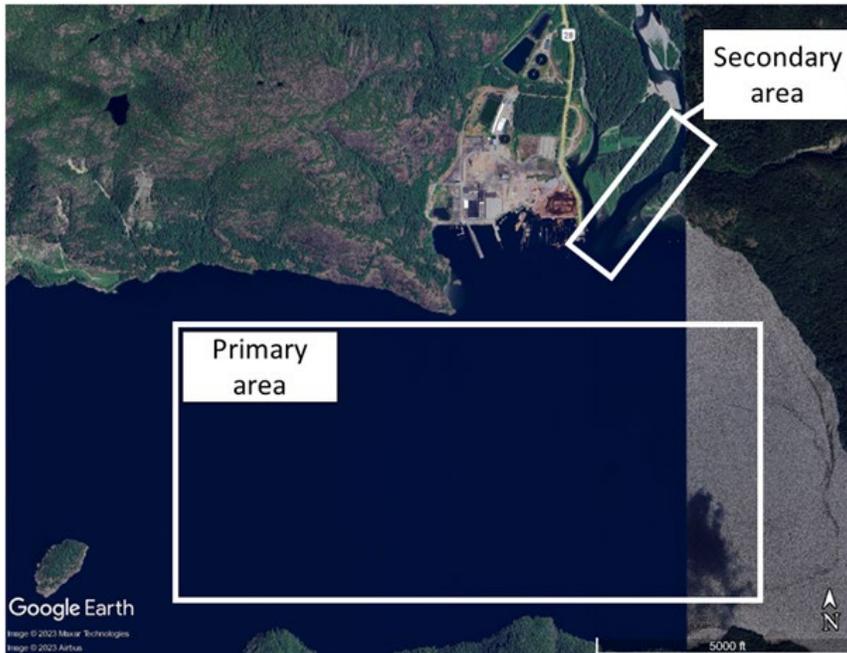
When the sea state is undesirable, the operator’s recommendation for takeoff and landing is to use the southwest portion of the Gold River mouth (marked as the secondary area in Figure 2), which provides approximately 1700 feet of surface. This secondary area may be shielded from the winds affecting the inlet, but the winds aloft in this area, as noted by the operator, have been observed to be unpredictable (Figure 2).

Figure 2. Gold River Water Aerodrome operating areas (Source: Google Earth, with TSB annotations based on operator description)

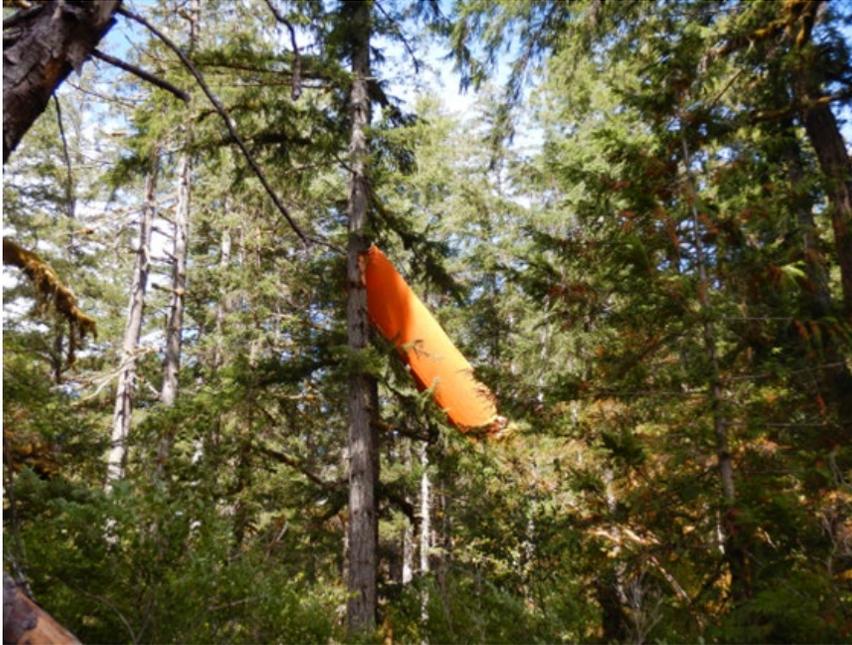
Based on examination and photographs of the site, the aircraft was proceeding westbound when it struck the trees. The aircraft's right wing separated from the aircraft and lodged in a tree (Figure 3).

Figure 3. Occurrence aircraft's right wing lodged in a tree (Source: RCMP)

The aircraft continued into the wooded area while rolling to approximately 90° of bank before impacting a large tree and coming to rest. The damage to the aircraft and the wreckage trail were indicative of a steep angled descent with low forward velocity, consistent with a stall.

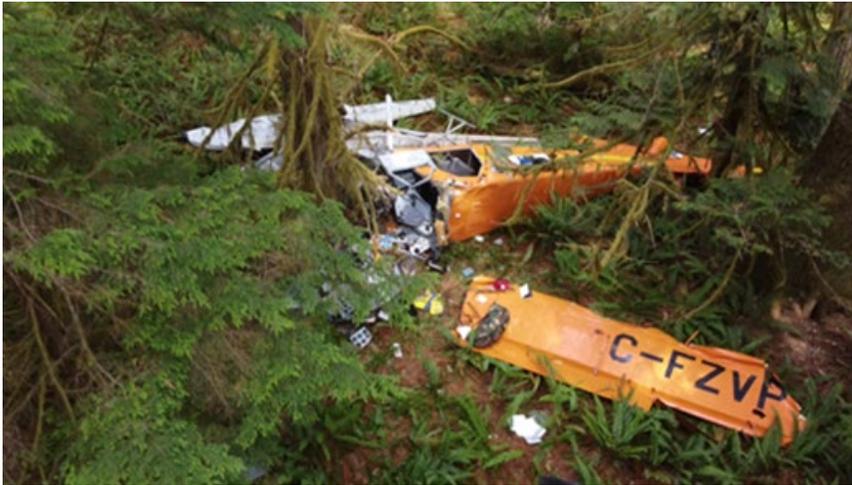
The 3-blade propeller was significantly damaged, with 1 blade being ejected from the propeller assembly. All blades showed chordwise scratches with bending patterns consistent with an engine producing power at the time of impact.

Many of the flight instruments and engine gauges were significantly damaged as a result of the impact, and their examination provided little information useful to the investigation. Flight controls and associated linkages were examined, and no indications of failure before impact were noted. The observed damage was either consistent with impact or attributable to the recovery of the aircraft. There were no indications of a loss of control due to mechanical failure before impact.

Although the aircraft was significantly damaged, all major components were accounted for at the accident site (Figure 4).

Figure 4. Aircraft fuselage, floats, and left wing (Source: TSB)
