MARINE INVESTIGATION REPORT M12H0012

GROUNDING

**TANKER NANNY
CHESTERFIELD NARROWS, NUNAVUT
25 OCTOBER 2012**

Report Number M12H0012

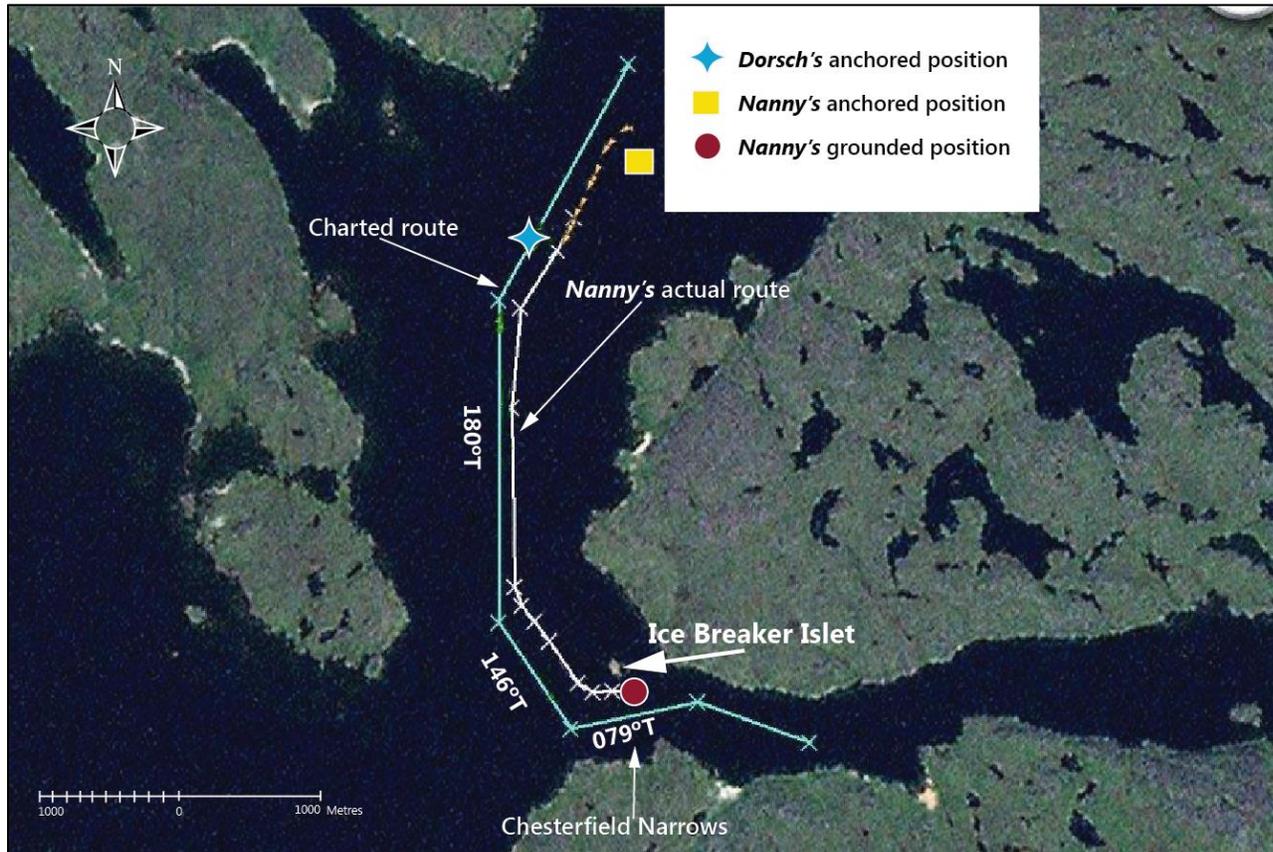
Figure 1. *Nanny's* actual route and charted route (Source: exactEarth, with modifications by the Transportation Safety Board of Canada)

2 minutes later, the master altered course towards 180°T. The vessel then proceeded parallel to the charted course line, but off it by about 0.05 nm (Figure 1). Shortly afterwards, the OOW plotted the vessel's position on the chart and then sat in the chair by the port radar. Over the next 15 minutes, no other positions were plotted or noted on the chart, and the *Nanny* continued to proceed off the charted course line, but roughly parallel to it.

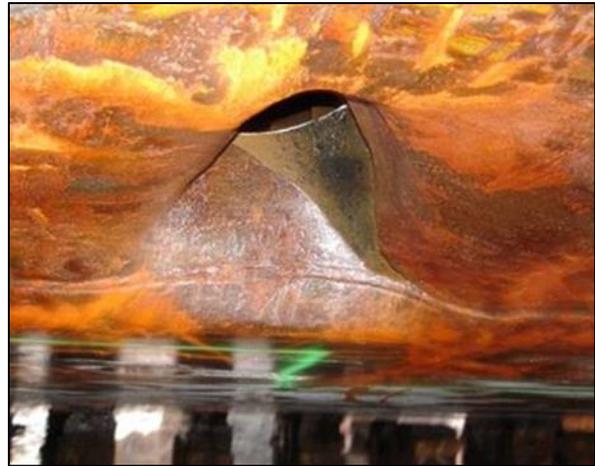
The hull bottom plating in the bow thruster compartment and the machinery space were indented, as was the forepeak water ballast tank. Port and starboard water ballast tanks No. 1 through 5 and starboard water ballast tank No. 6 were also indented.

Some of these compartments were set up as much as 150 mm in places, with many tripped stiffeners and brackets. The port and starboard bilge keels were set up along their entire length. Ballast tank No. 2C was holed when the vessel came off the shoal during strong winds on 27 October (Photo 3).

Photo 3. Hole in No. 2C ballast tank

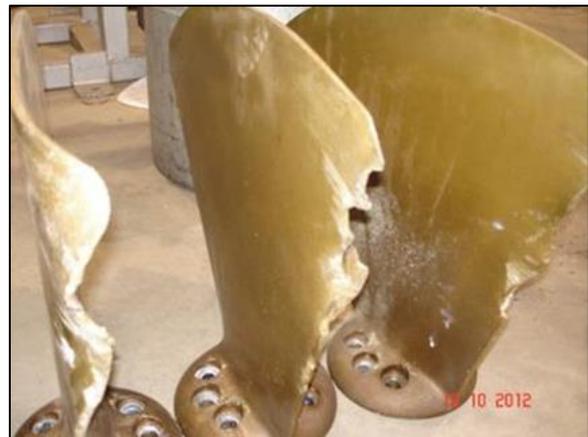
The bow thruster propeller was also damaged; it was bent, and the crown and pinion gears were stripped. The driving-shaft seal and electric motor were set up approximately 60 mm, and the free-end cover was shattered into 4 pieces.

Further inspections undertaken after the vessel arrived in St. John's in early November found that the bow thruster propeller blades had sustained extensive mechanical damage, most likely caused by rocks being sucked through the thruster tunnel after the grounding and jamming the blades (Photo 4). The main propeller and stern thruster propellers were also found to have sustained some mechanical damage.

Photo 4. Bow thruster propeller blades

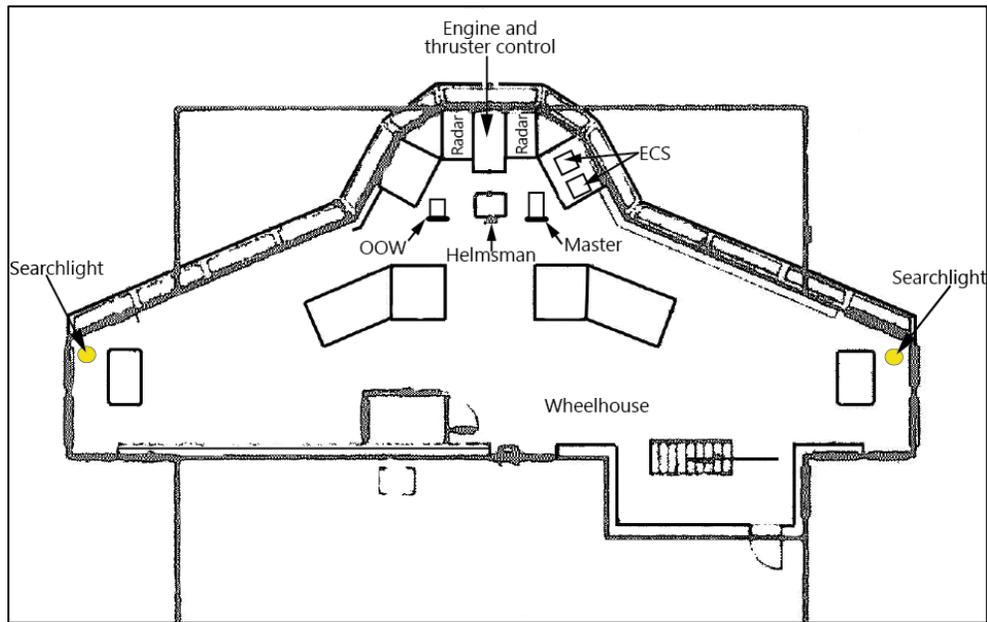
On the *Nanny*, the ECS monitors were not positioned in the immediate field of view of the officer at the starboard radar, nor were they in a centralized position to enable 2 bridge officers to make use of them (Figure 2). In contrast, on the *Dorsch*, the 2 ECS monitors were located close to the starboard radar and in line with it, putting them in the immediate view of the bridge officer at that station, and allowing for cross-checks between radar and ECS data.

Figure 2. Bridge layout on the *Nanny*
