Transportation
Safety Board
of Canada

MARINE TRANSPORTATION SAFETY INVESTIGATION REPORT M19C0054

STRIKING OF A MOORING DOLPHIN

Roll-on/roll-off ferry *Apollo*
Matane, Quebec
16 March 2019

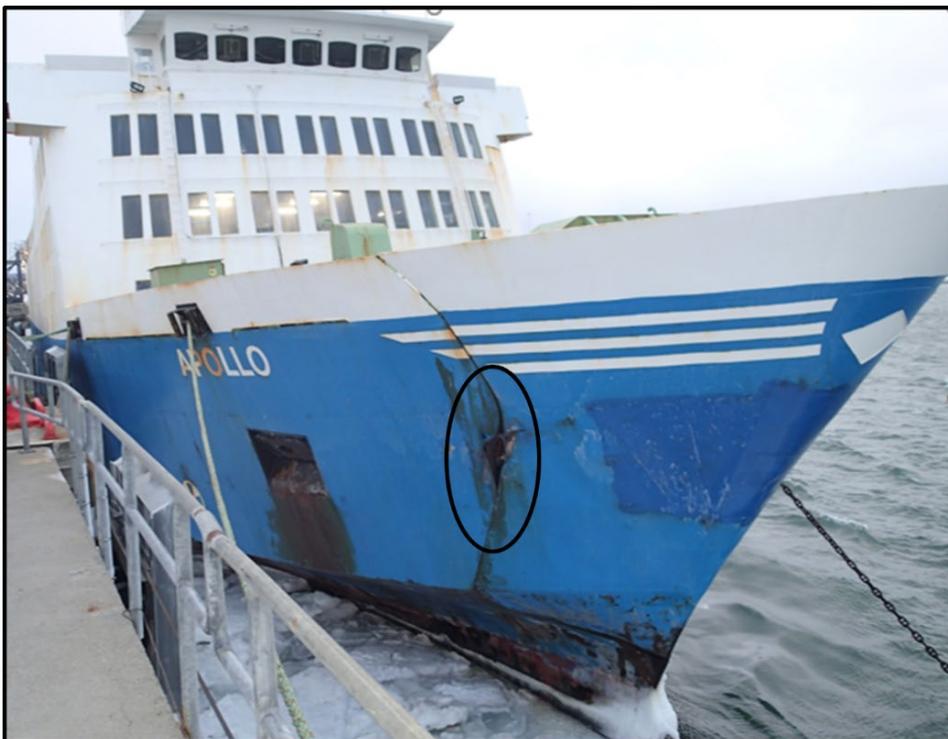
The *Apollo* was damaged where the bow visor and the hull connect (figures 4 and 5). The shell plating was pushed in and dented over about 1 m, which resulted in a gap between the bow visor and the hull about 0.3 m wide at its maximum. There was also structural buckling around this area. The STQ permanently removed the *Apollo* from service on 19 March 2019 as a result of the damage caused by the striking.

Figure 4. Damage to the *Apollo* (circled) (Source: TSB)

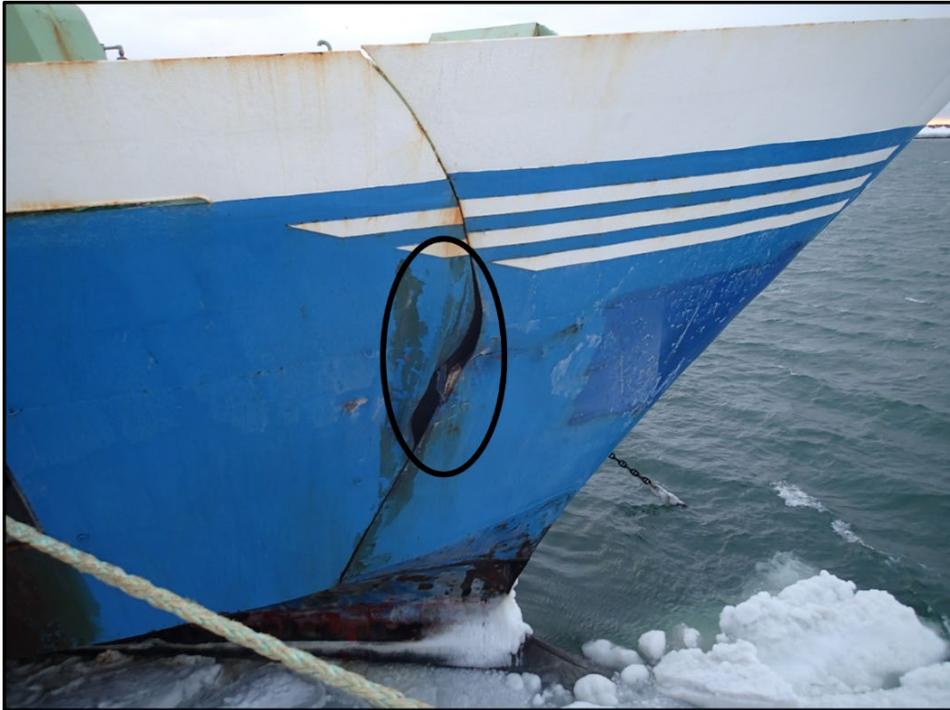
Figure 5. Damage to the Apollo (circled) (Source: TSB)

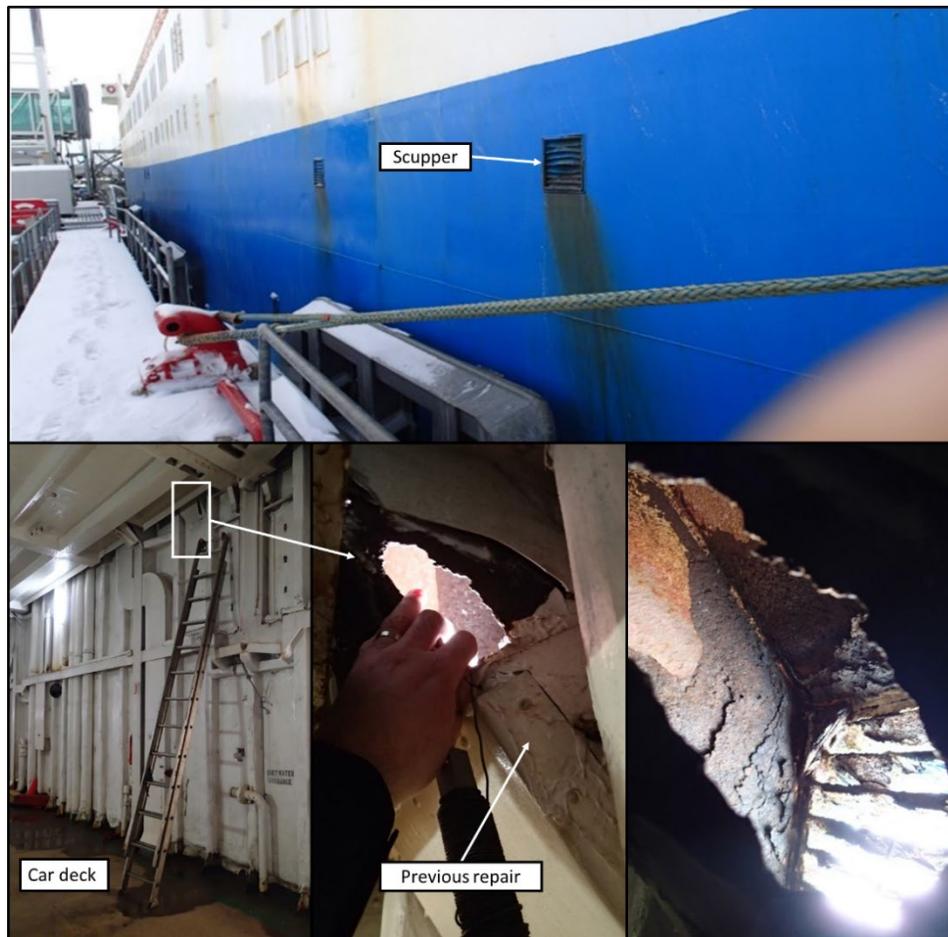
Figure 6. Scupper rusted through to car deck (Source: TSB)

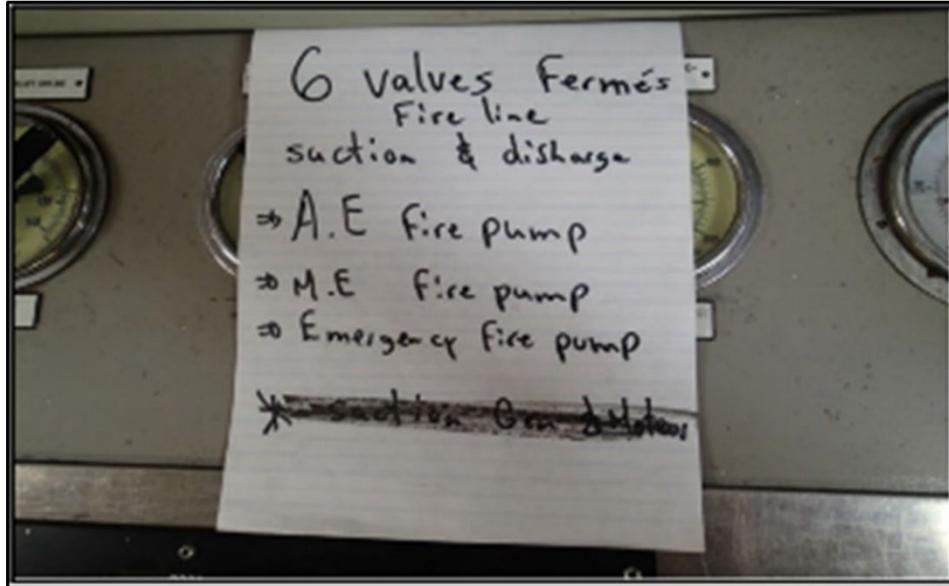
- The suction and discharge valves for the main and emergency fire pumps were being kept closed to avoid sea water ingress in different compartments from the fire main, which had corroded in various places throughout the vessel. A notice to the

Figure 7. Photograph of notice posted in engine control room. "A.E" refers to the auxiliary engine room and "M.E" refers to the main engine room (Source: TSB)

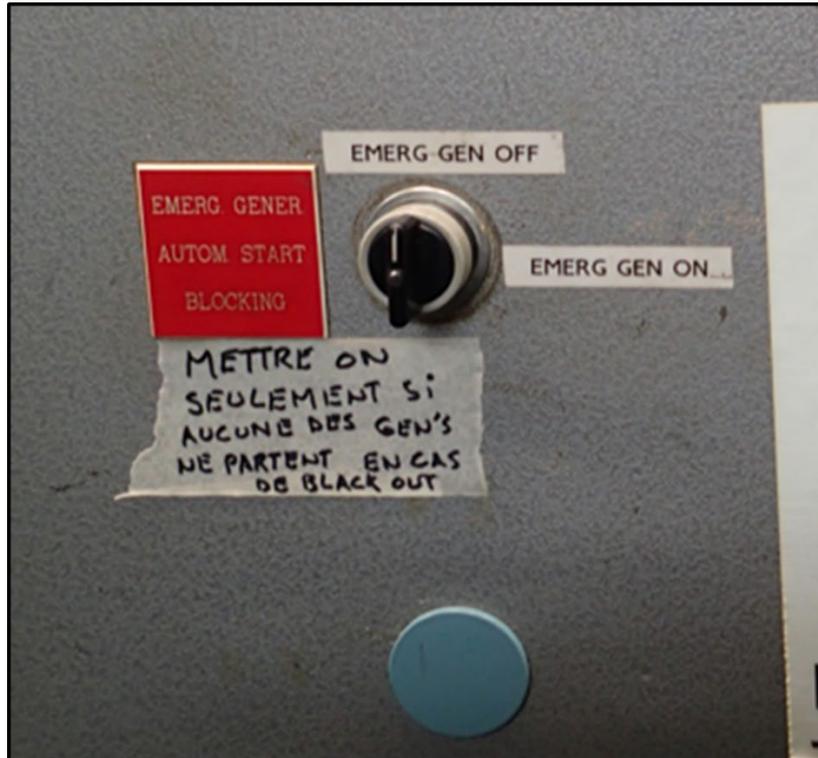
- The switch for the emergency generator set's automatic start was kept in the "OFF" position, and a note handwritten on masking tape next to the switch stated "METTRE ON SEULEMENT SI AUCUNE DES GEN'S NE PARTENT EN CAS DE BLACK OUT" ([translation] "Turn switch on only if no main generator starts in case of a blackout") (Figure 8).

Figure 8. Emergency generator set switch (Source: TSB)

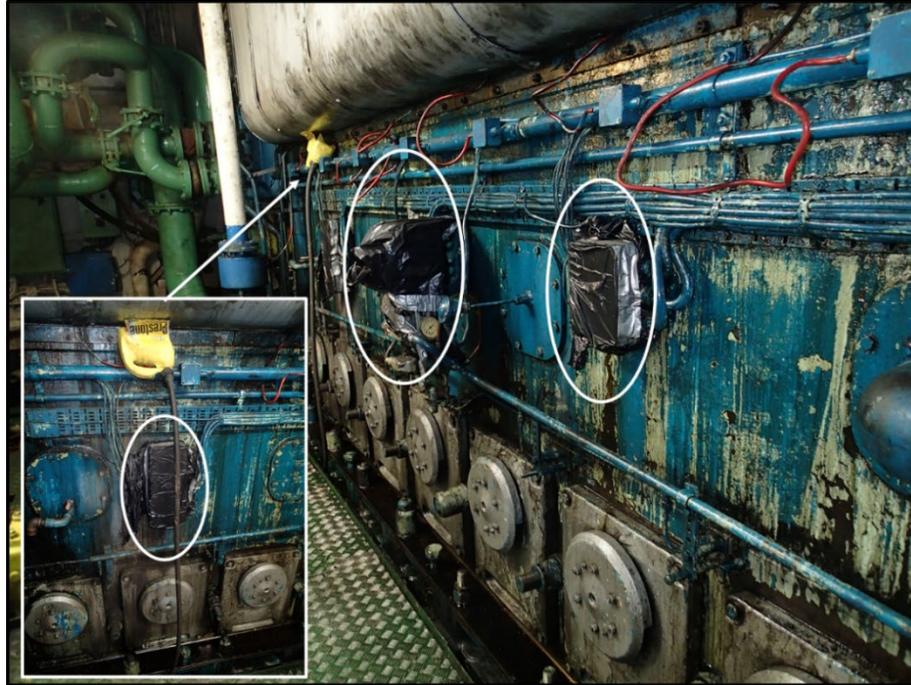
- The starboard main engine was streaked with oily residue, and a number of electrical components had been covered with plastic bags to protect them from oil and water leaks. An empty plastic container with a hose attached to it had been affixed to one side of the engine to redirect leaking oil into the bilges (Figure 9).

Figure 9. Starboard main engine (Source: TSB)

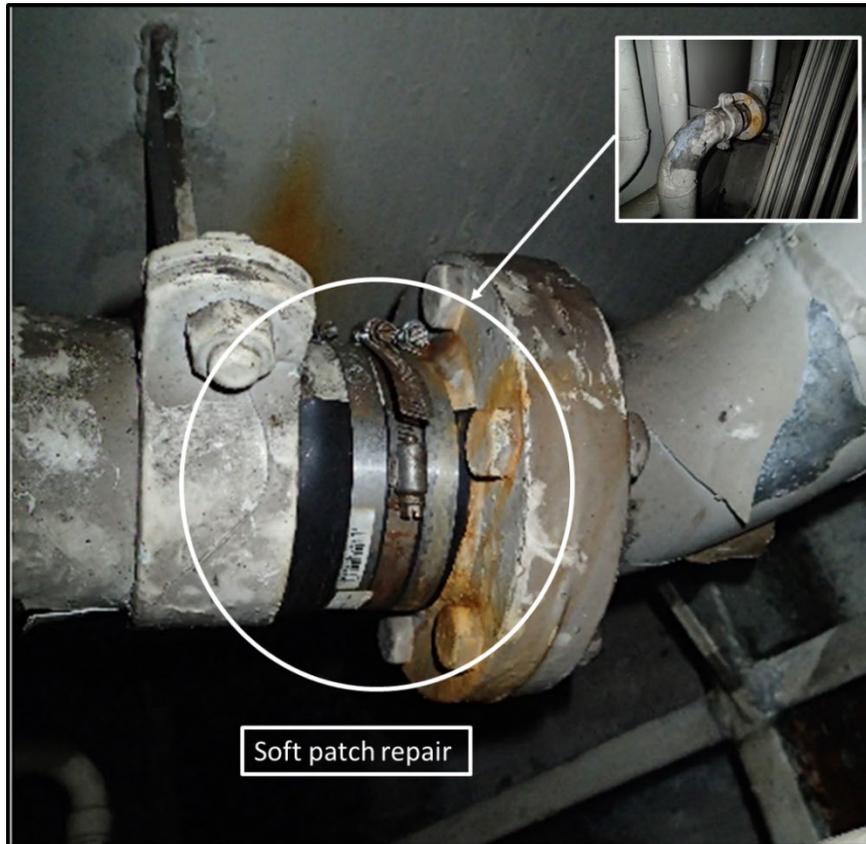
- Soft patch repairs had been made on pressurized sea water lines in the engine room and adjacent watertight compartments (Figure 10).

Figure 10. Soft patch repair on sea water line (Source: TSB)

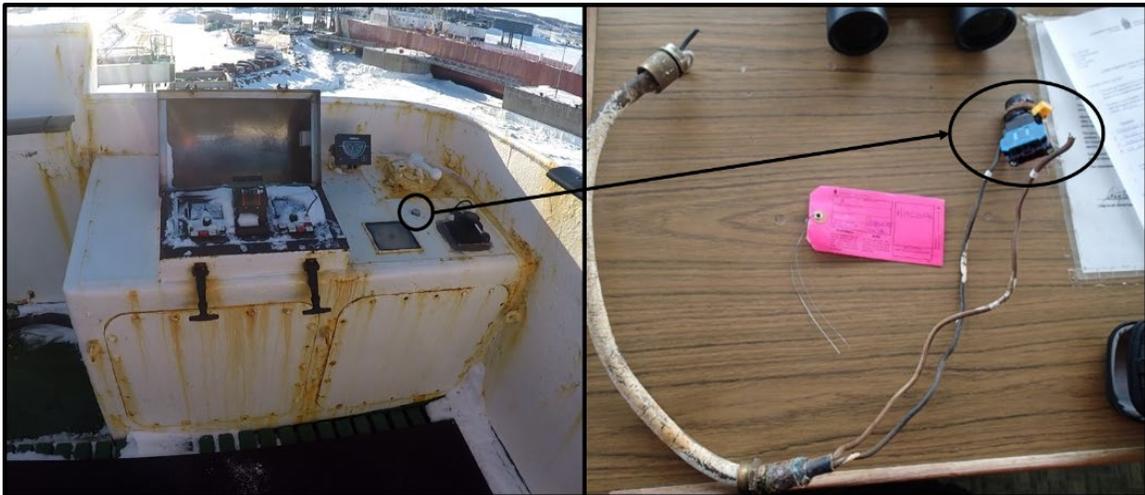
Figure 14. Button on starboard bridge wing console (left); button assembly and broken wire (right)
(Source: TSB)

The examination found that 1 of the 2 electrical wires connected to the bow thruster's button assembly was broken, meaning that the button would not activate the bow thruster on the starboard bridge wing console. The examination noted that the wire was partially covered with verdigris at its broken end and had 6 gouges and missing material around its breaking point, which were likely made by a wire-stripping tool used at some point in the past. The gouges reduced the outside diameter of the wire, diminishing its mechanical strength. The wire showed ductile overstress and shear fatigue, as it had also been subject to vibration over time because it was not properly secured. Finally, it was noted that the broken wire was a single-strand tinned copper wire rather than the stranded copper wire required by regulation.

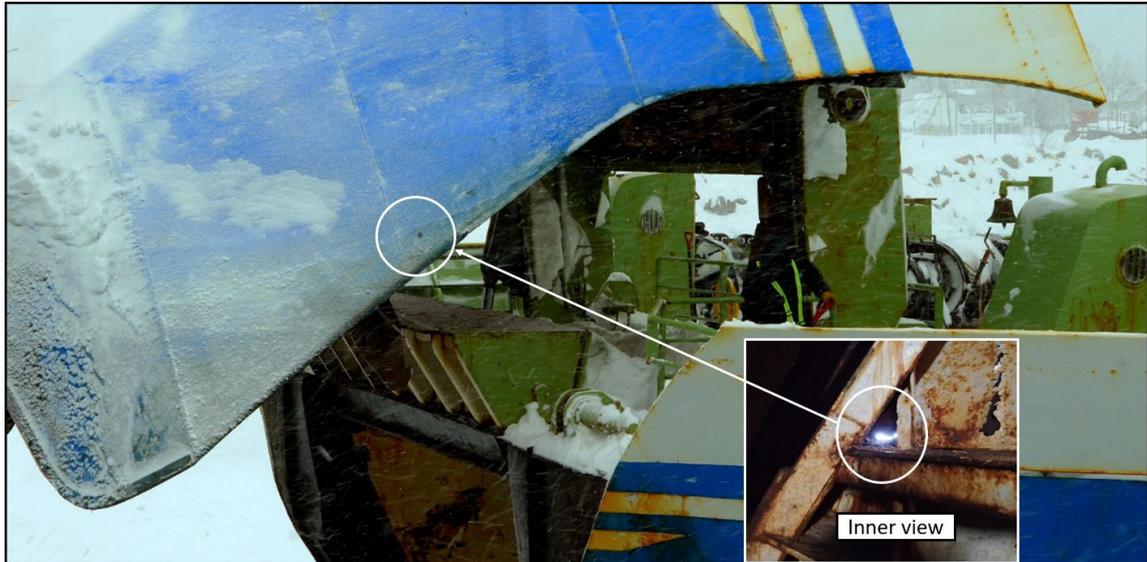
Figure G1. Breach rusted through the bow visor (Source: TSB)

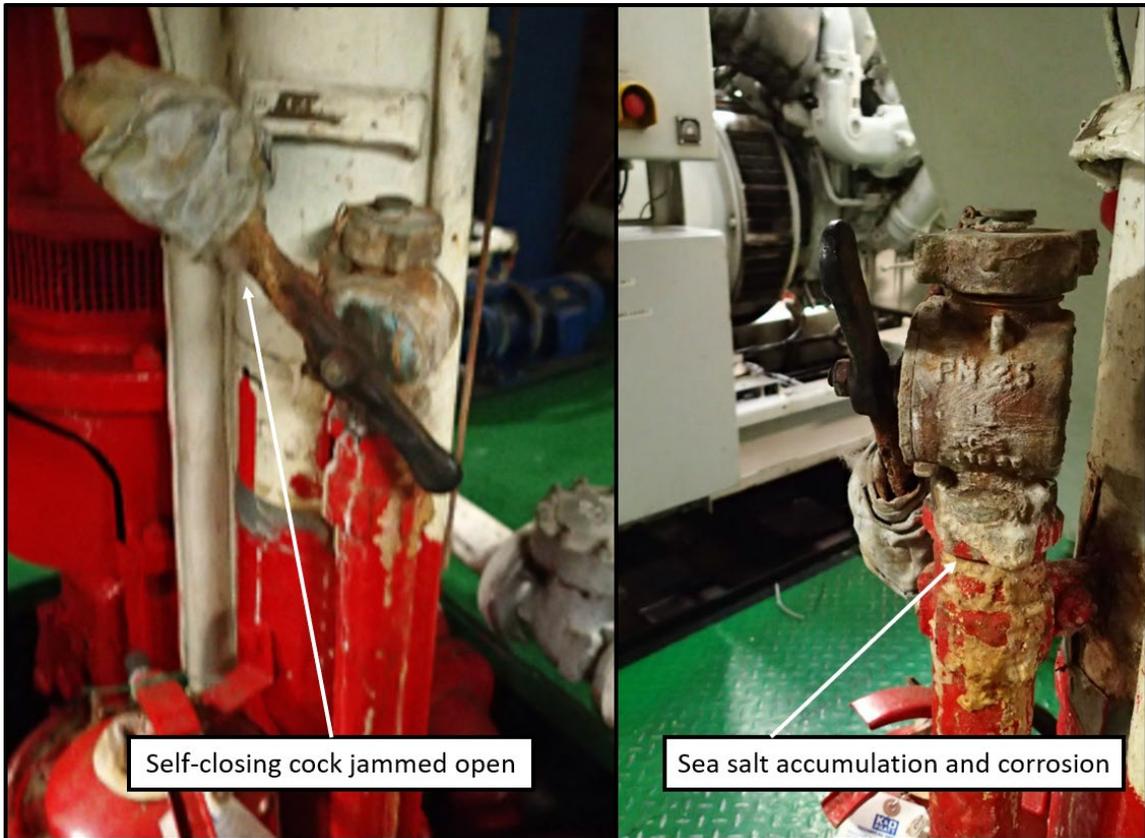
- The self-closing cocks on 2 of the sounding pipes for the vessel's double-bottom tanks were jammed open due to the presence of rust and salt residue (Figure G2).

Figure G2. Self-closing cock on double-bottom tank jammed open (Source: TSB)

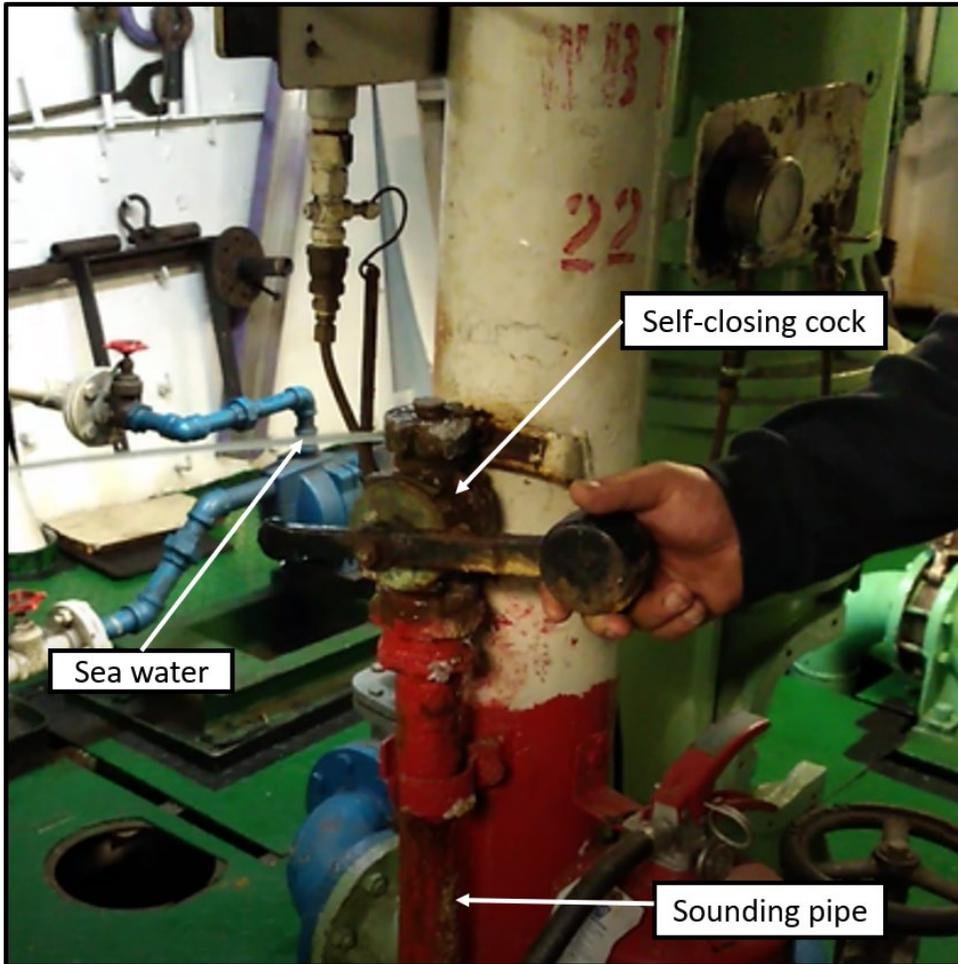
- One of the vessel's double-bottom ballast tanks (No. 22) was pressurized and water continuously shot out of it into the engine room when the sounding pipe was open (Figure G3).

Figure G3. Sea water shooting from open sounding pipe (Source: TSB)

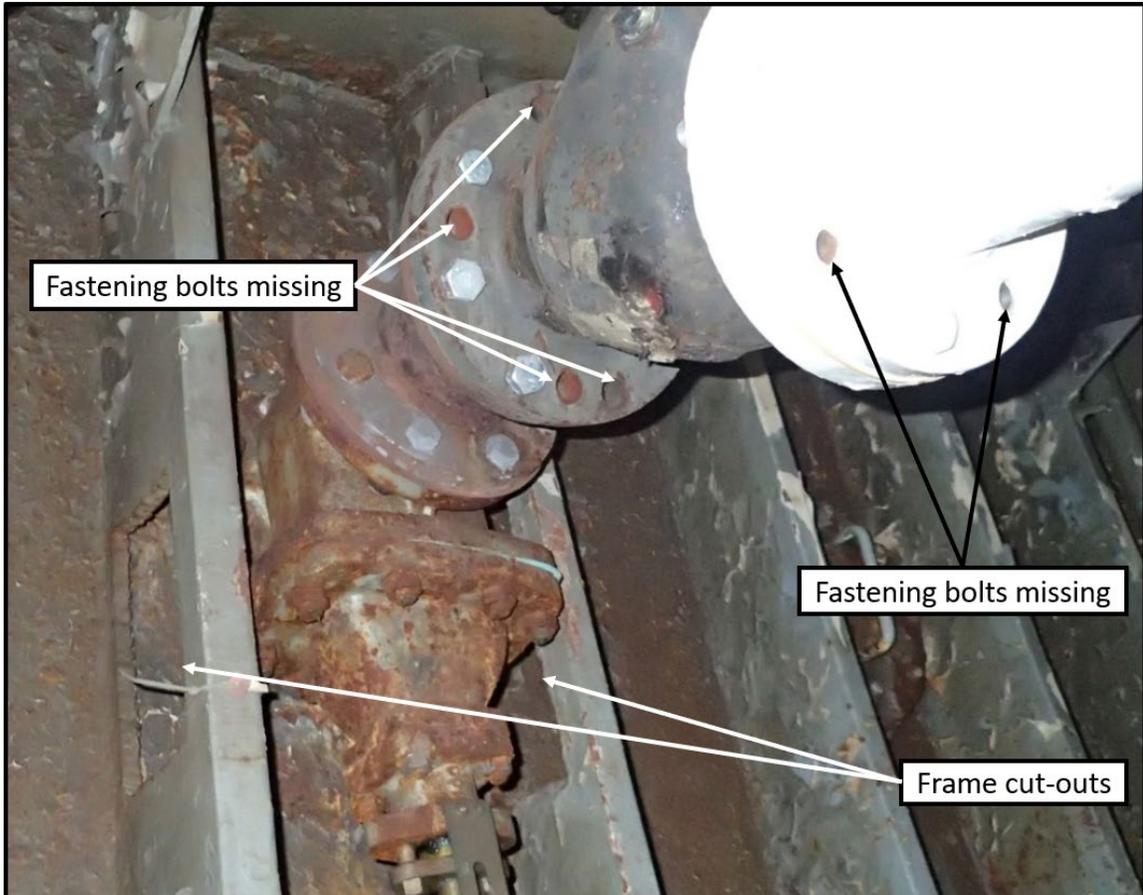
- At least 3 of the ship-side transverse frames had been altered by cut-outs (Figure G4).
- The valves used for discharging sea water overboard were missing some of the bolts that secured the valves ship-side (Figure G4).

Figure G4. Cut-outs in transverse frames and missing bolts on ship-side valves (Source: TSB)

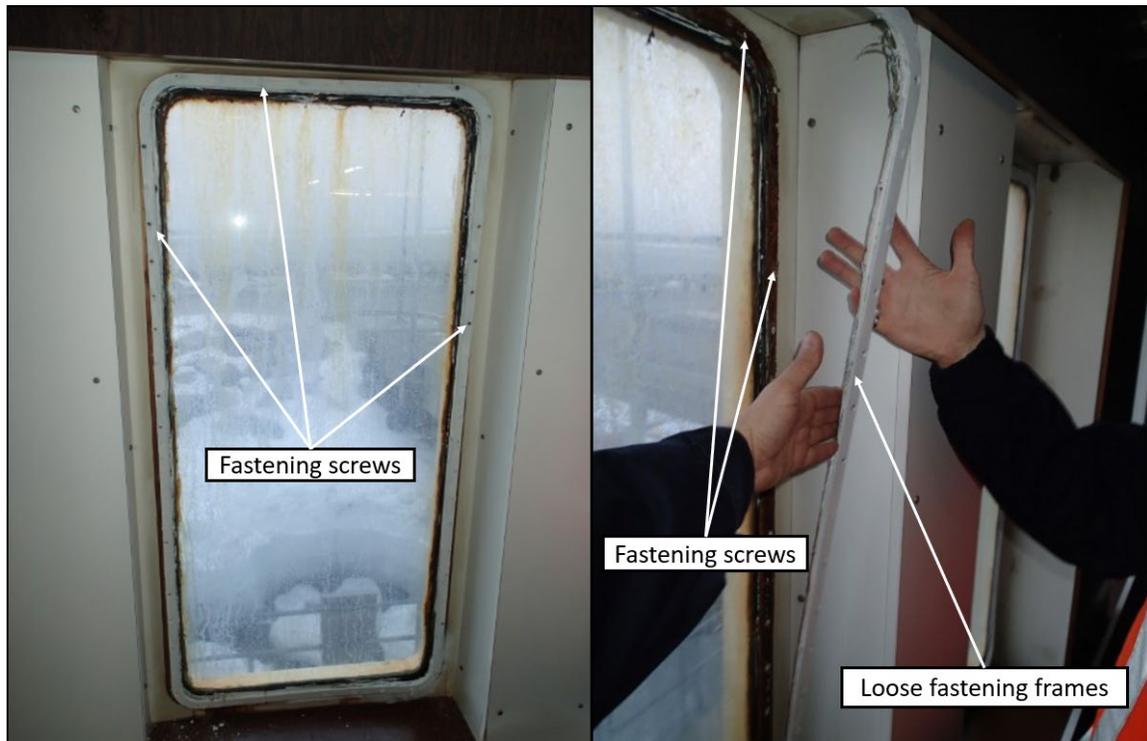
- The aluminum frames used to fasten tempered glass windows located below the vessel's downflooding point were corroded around the screw holes and, in some places, the frames were no longer attached to the surrounding structure (Figure G5).
- The tempered glass windows were no longer watertight and there was salt residue on the inside of a number of the windows and window frames where leaks had occurred (Figure G5).

Figure G5. Corroded aluminum window frames (Source: TSB)

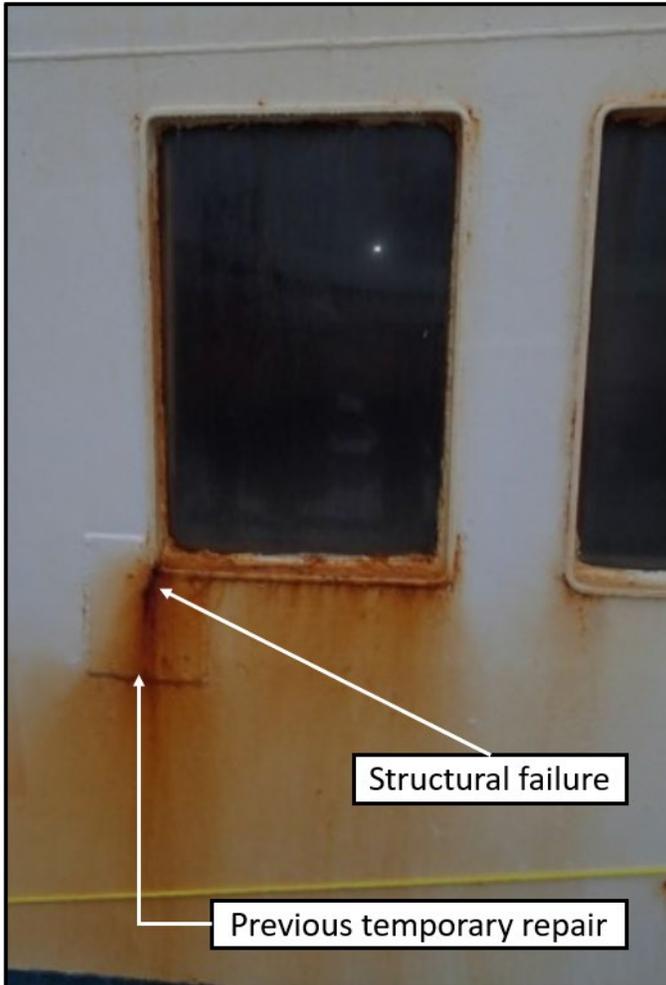
- The vessel's superstructure had a crack of approximately 10 cm that extended from the lower corner of one of the windows (Figure G6). At some point in the past, a plate had been welded over the crack, but the temporary repair had since failed.

Figure G6. Crack in superstructure with failed repair (Source: TSB)

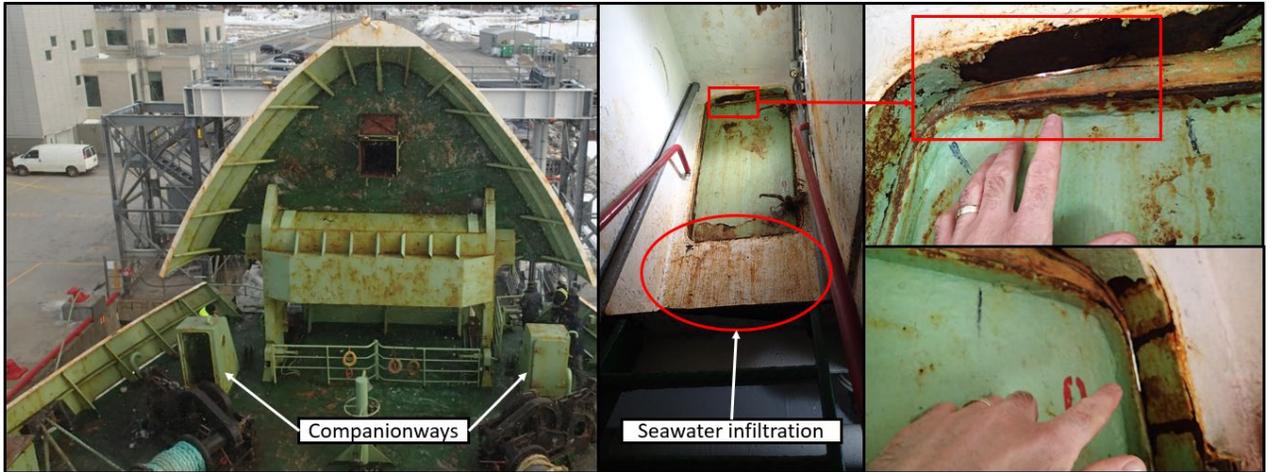
- A combination of rust and deteriorated rubber seals had resulted in the doorframes and doors in the companionways on the foredeck no longer being watertight (Figure G7).

Figure G7. Companionways (left) and rusted doors and doorframes in companionways (right) (Source: TSB)

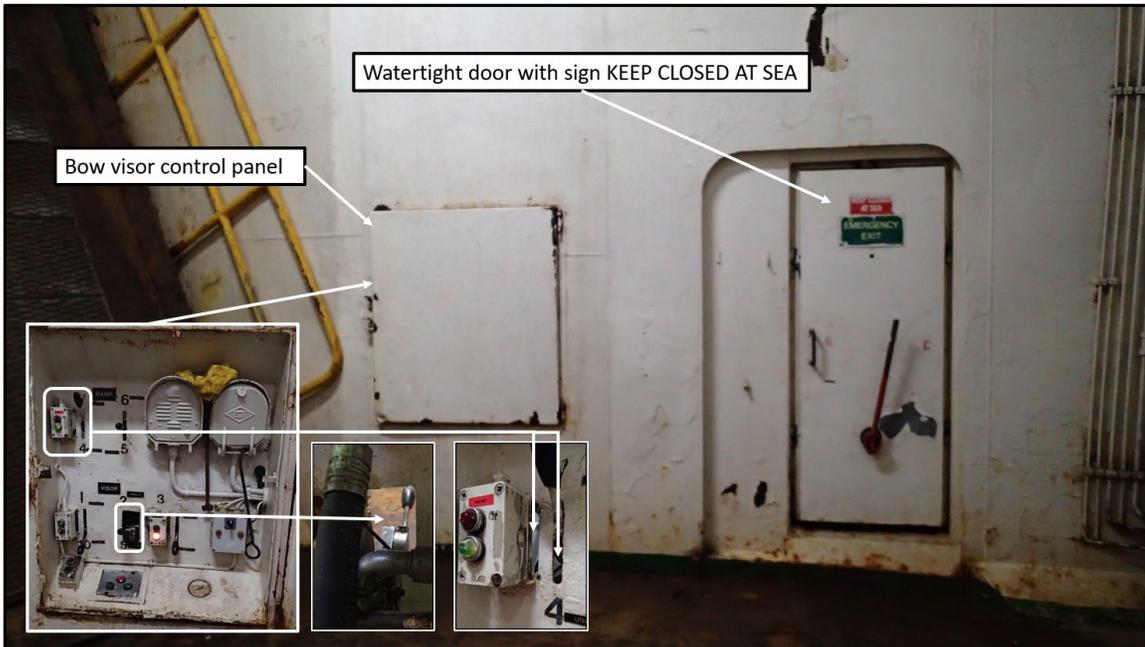
- Multiple cut-outs had been made through a longitudinal bulkhead that was intended to be watertight to allow for the installation of equipment in the bow visor control panel (Figure G8).

Figure G8. Cut-outs in longitudinal watertight bulkhead (Source: TSB)

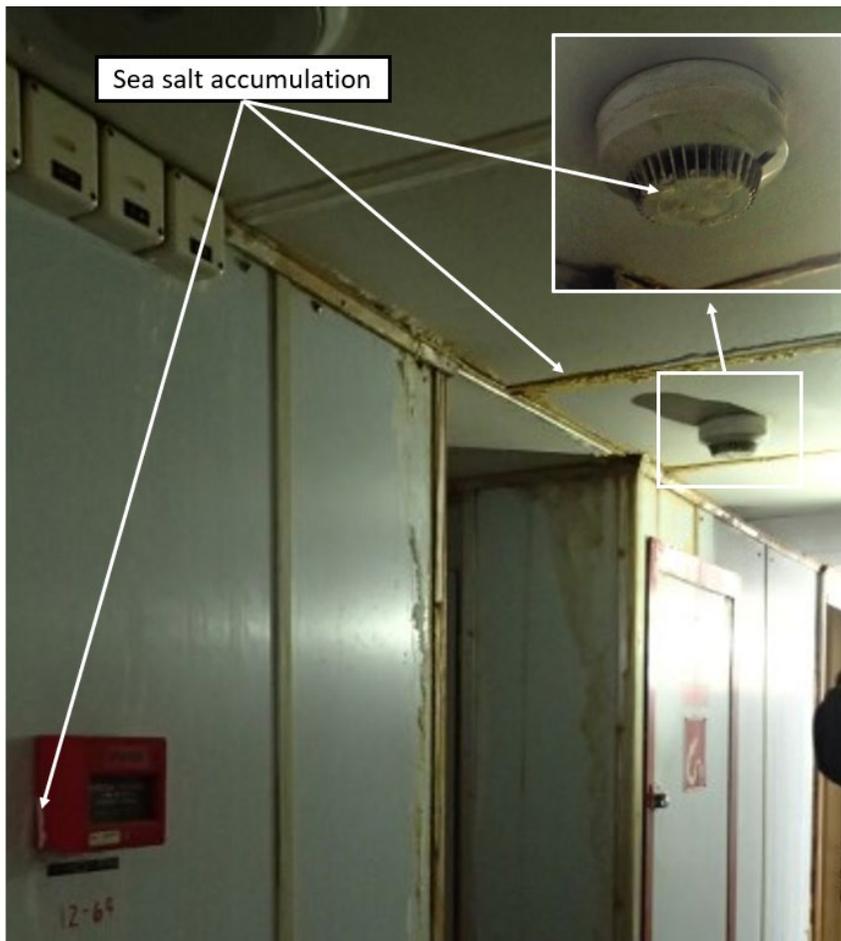
Figure G9. A damaged detector (Source: TSB)

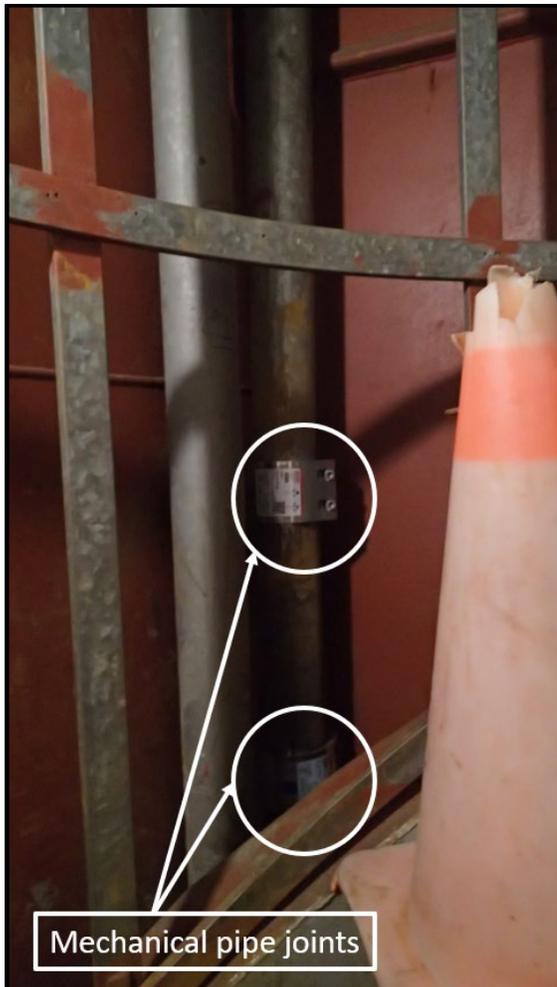
Figure G10. Mechanical pipe joints (Source: TSB)

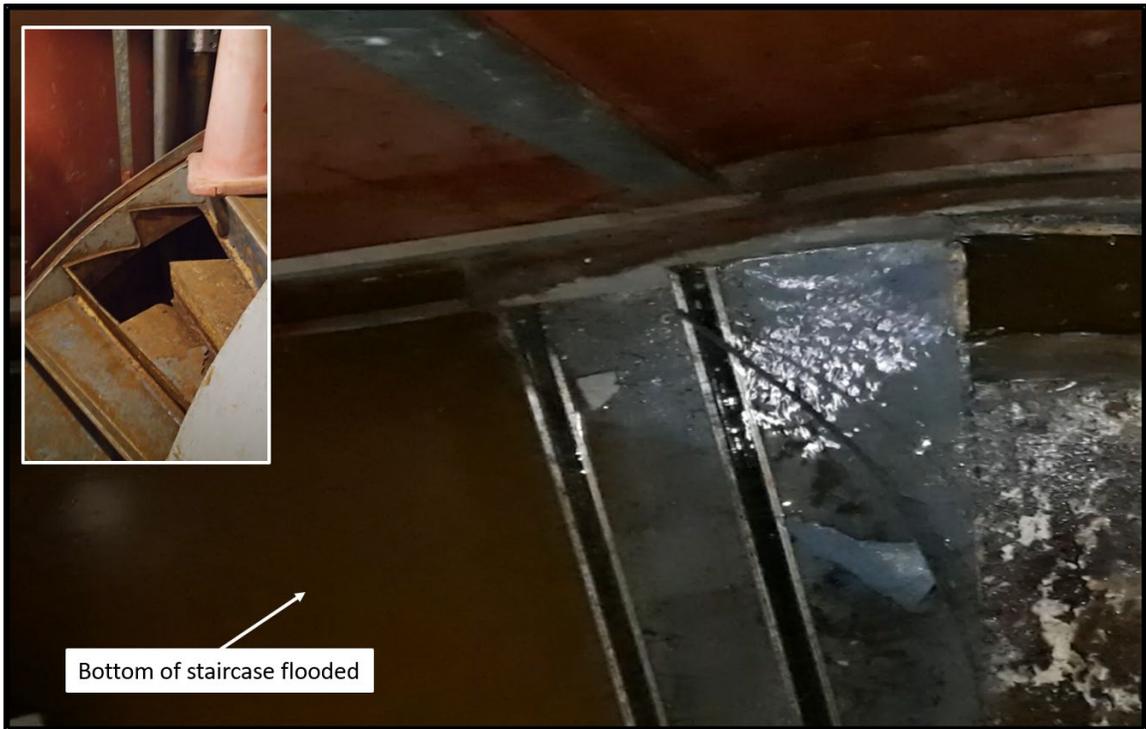
Figure G11. Water leaking into the staircase on deck 2 with inset image showing a hole in the same staircase (Source: TSB)

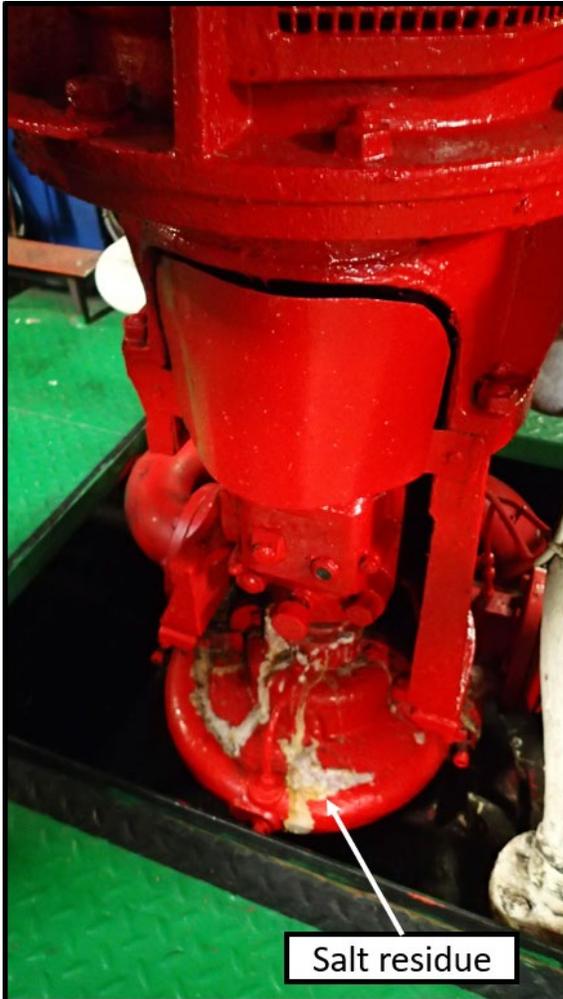
Figure G12. Salt residue from a leaking gland on the emergency fire pump (Source: TSB)

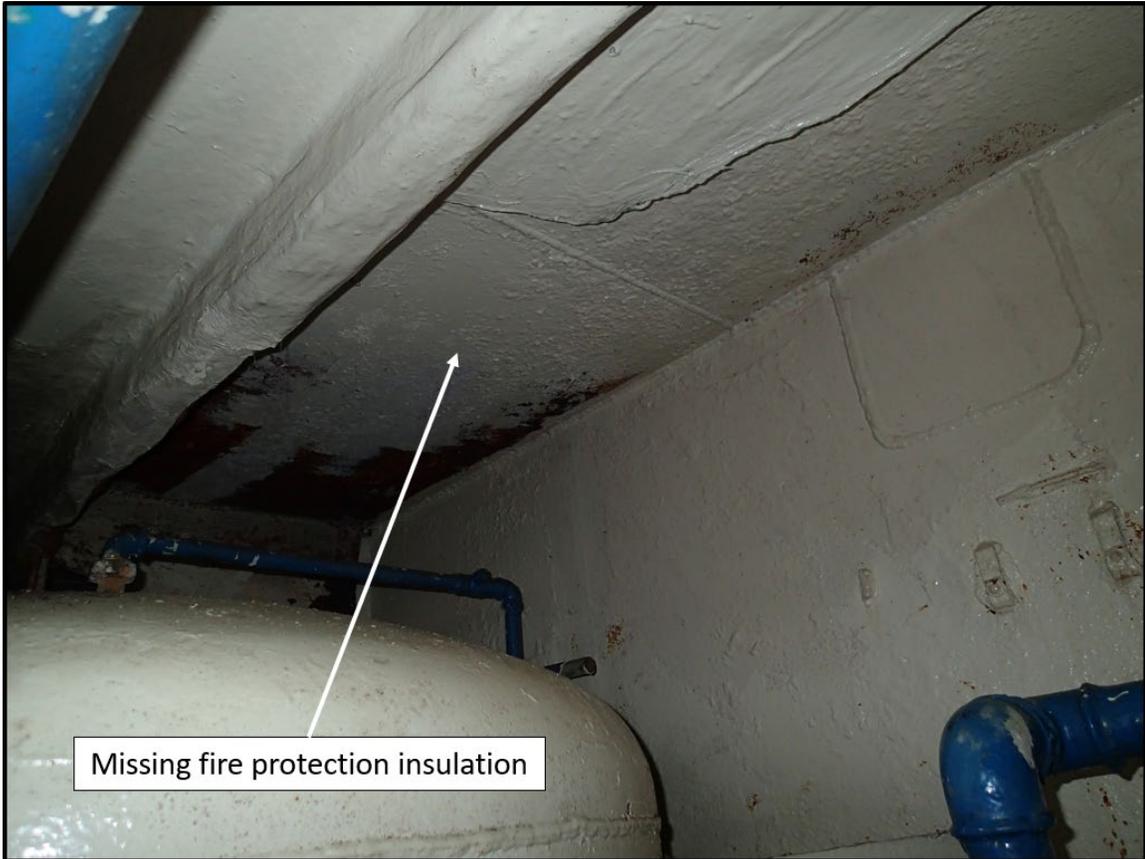
- Some of the bulkheads in the engine room that were intended to be fire resistant did not have the required fire protection insulation to prevent fire propagation (Figure G13).

Figure G13. Missing fire protection insulation in the engine room (Source: TSB)

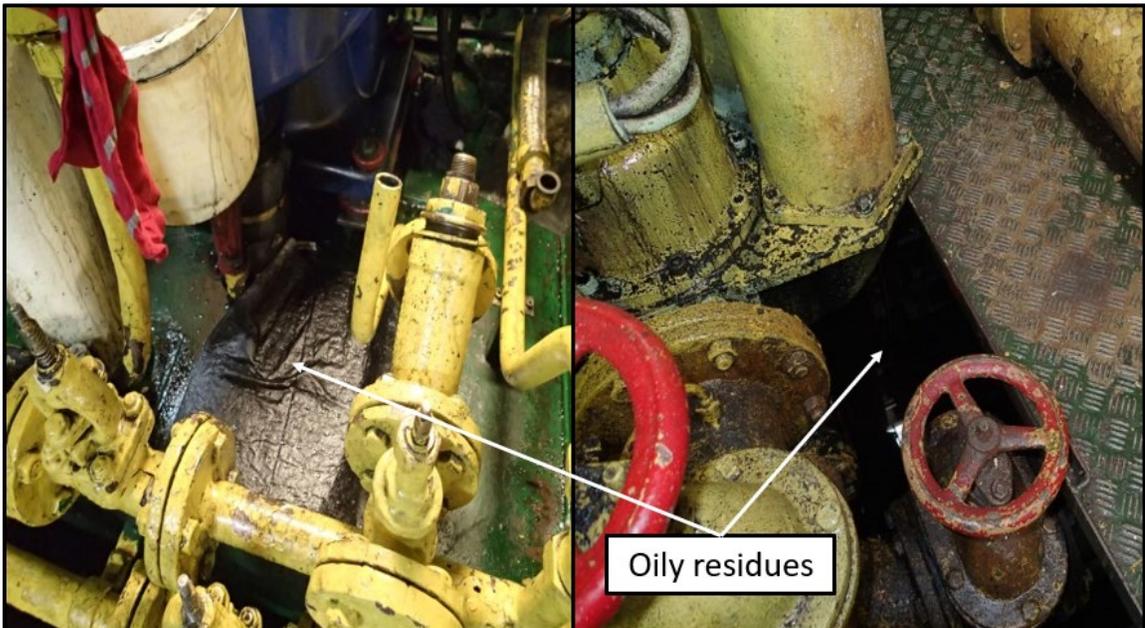
- Oil residue was present throughout the main and auxiliary engine rooms, as were contaminated rags and oil absorbent pads, which are all fire hazards (Figure G14).

Figure G14. Presence of oily residue in the engine room bilges (Source: TSB)

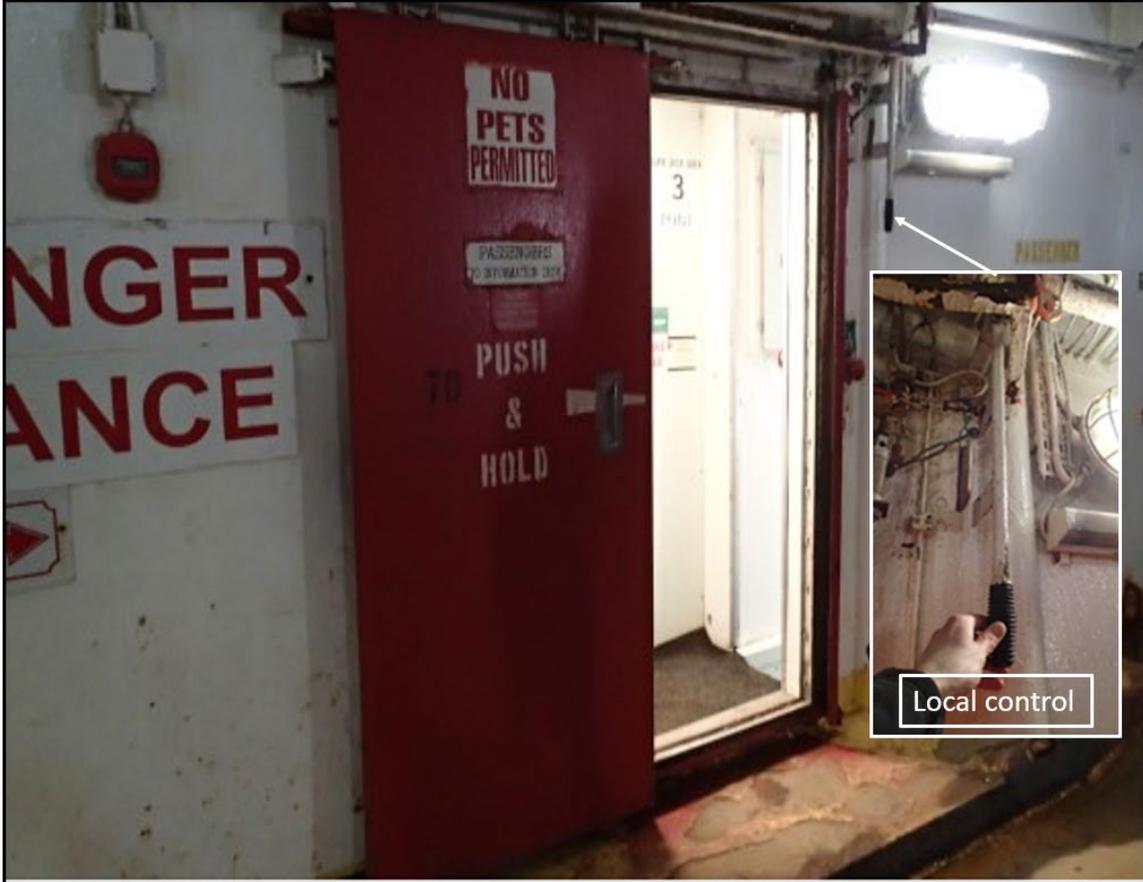
- Several of the sliding semi-watertight⁹⁸ fire resistant doors on the vehicle deck did not open and close reliably when the vessel was trimmed (Figure G15) and several of the local control mechanisms were no longer operational.

Figure G15. Semi-watertight pneumatically-operated sliding fire door on the car deck (Source: TSB)

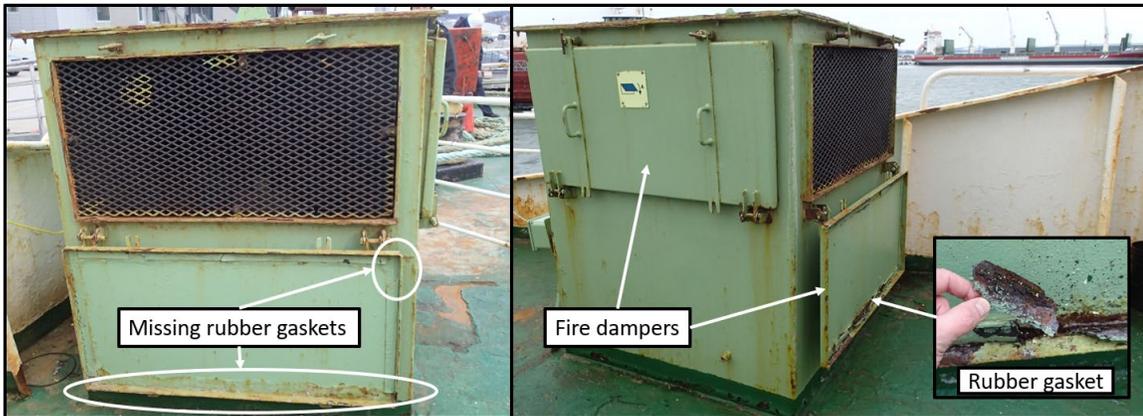
- Some of the rubber gaskets around the fire dampers on the vessel's air intake ducts no longer formed an airtight seal when the damper was closed (Figure G16).

Figure G16. Air intake ducts (Source: TSB)

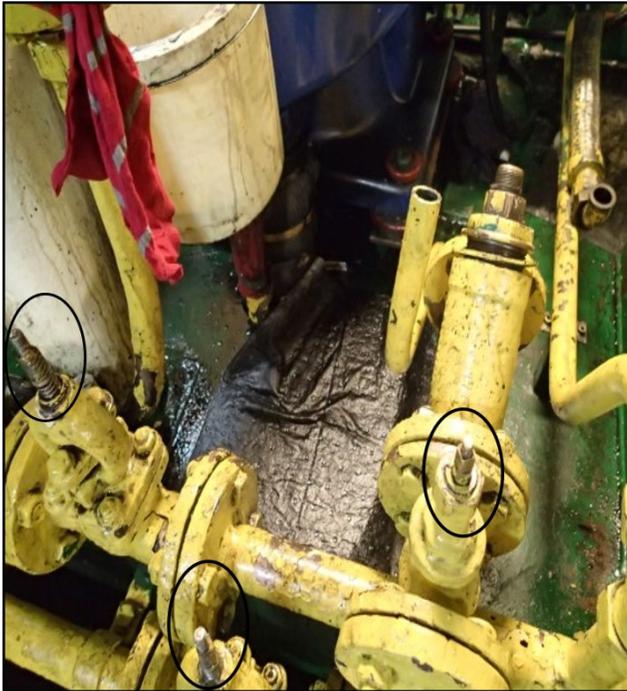
Figure G17. Isolating valves without hand wheels (Source: TSB)

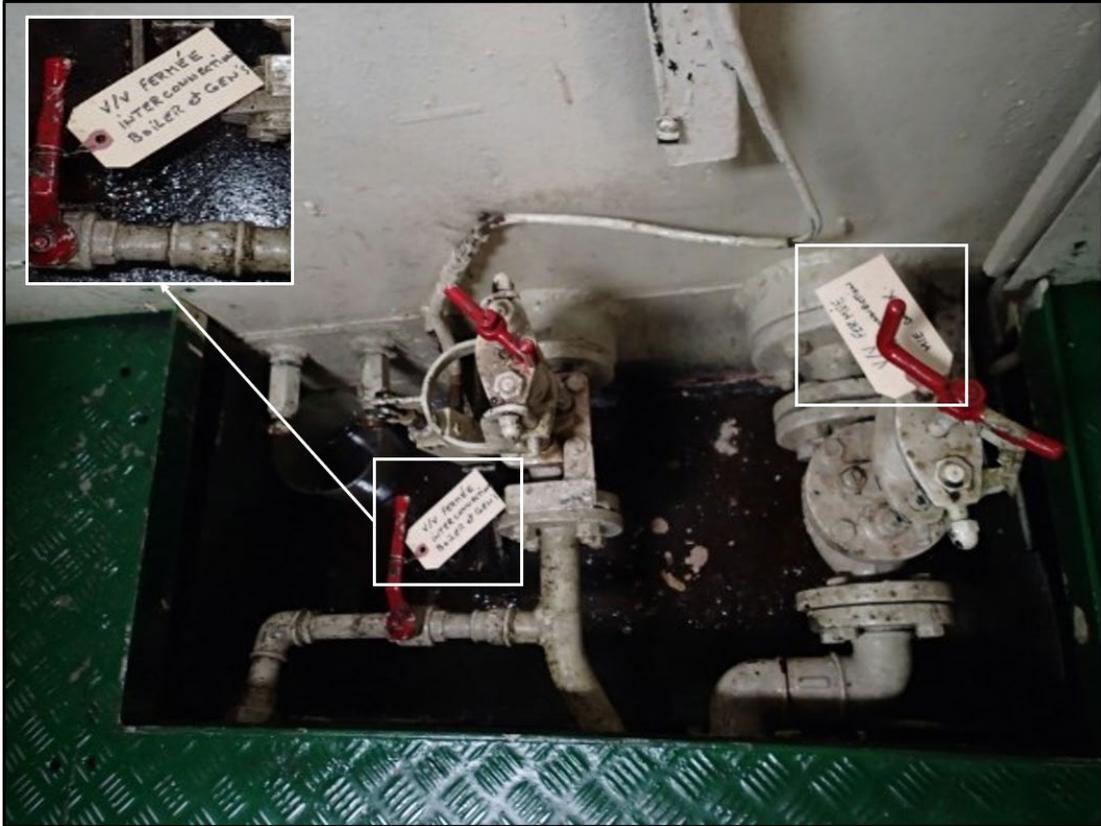
- Some isolating valves had permanent nameplates to indicate their function while others had temporary paper tags that were more susceptible to being accidentally torn off or rendered illegible by leaks, spills, etc. (Figure G18).

Figure G18. Paper tags marking isolation valves (Source: TSB)

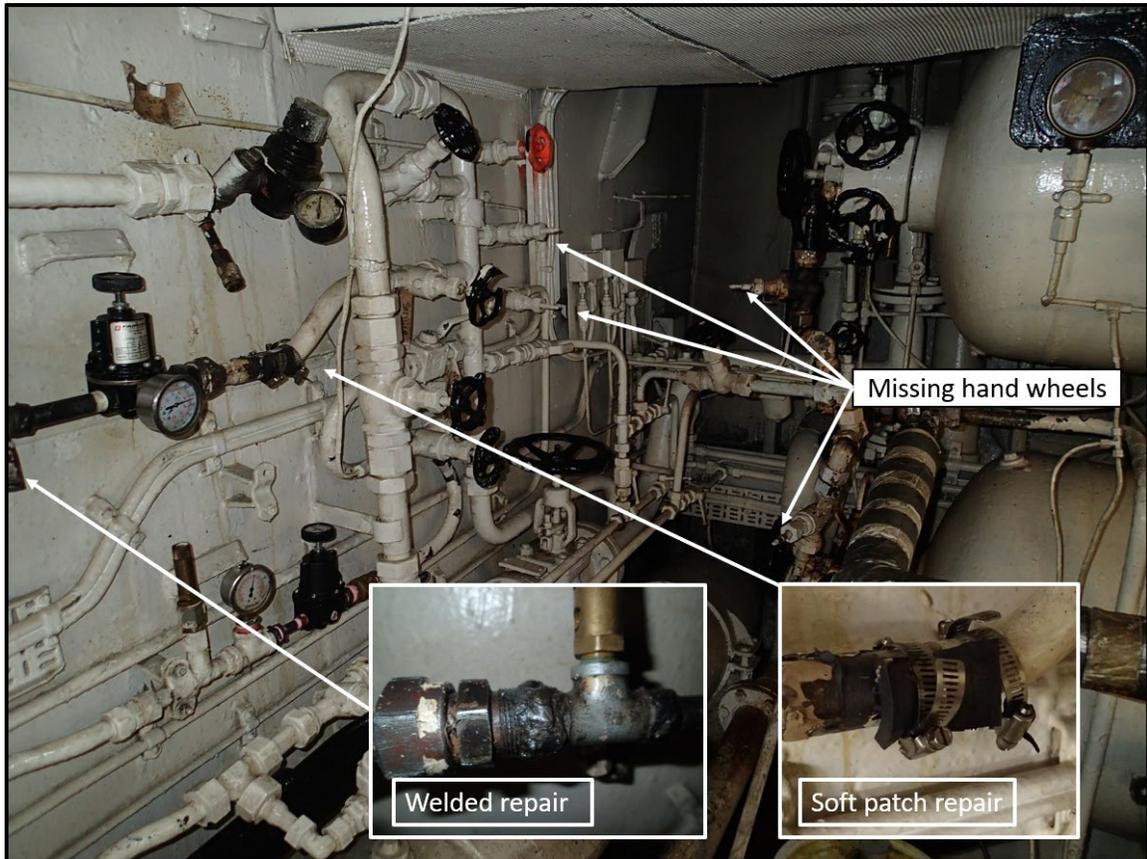
- One of the vessel's pressurized air lines had welded repairs and soft-patch repairs along it (Figure G19).

Figure G19. Welded repair and soft-patch repair on air line (Source: TSB)

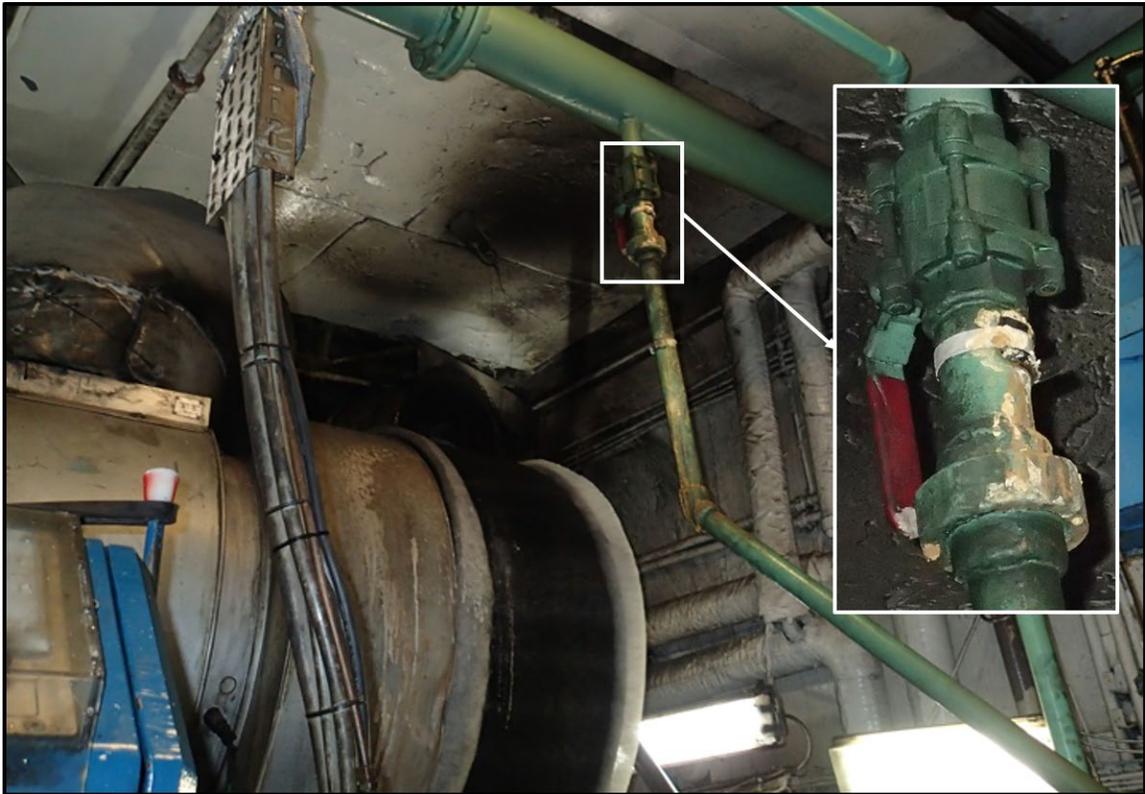
- A section of the fire main in the engine room above one the main engines had salt residue where it had leaked around a soft-patch repair (Figure G20).

Figure G20. Salt residue around soft-patch repair on fire main (Source: TSB)
