Transportation
Safety Board
of Canada

MARINE TRANSPORTATION SAFETY INVESTIGATION REPORT M19C0054

STRIKING OF A MOORING DOLPHIN

Roll-on/roll-off ferry *Apollo*
Matane, Quebec
16 March 2019

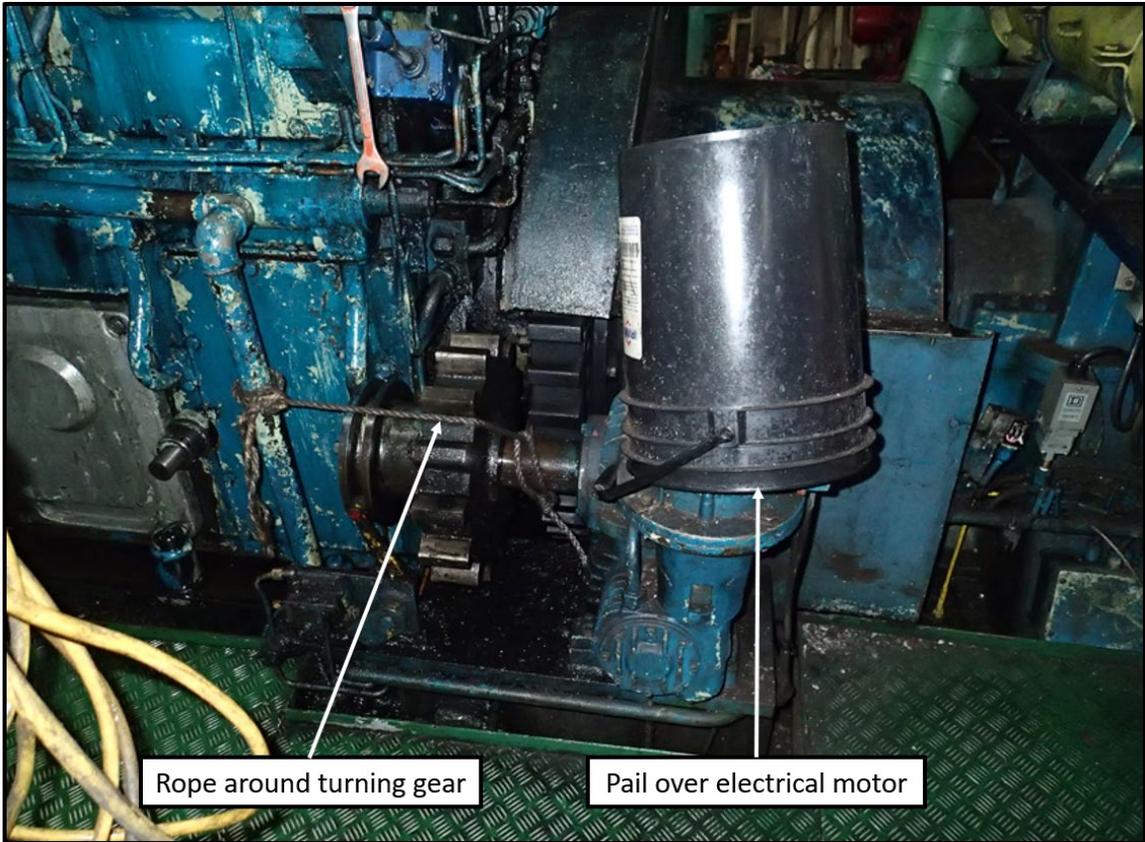
- A pail had been placed over the turning gear electrical motor to protect it from leaks (Figure G21).

Figure G21. Pail in place to protect from leaking pipe and rope around main engine's turning gear (Source: TSB)

- A rope had been fastened around the main engine's turning gear to prevent the gear from slipping (Figure G21).

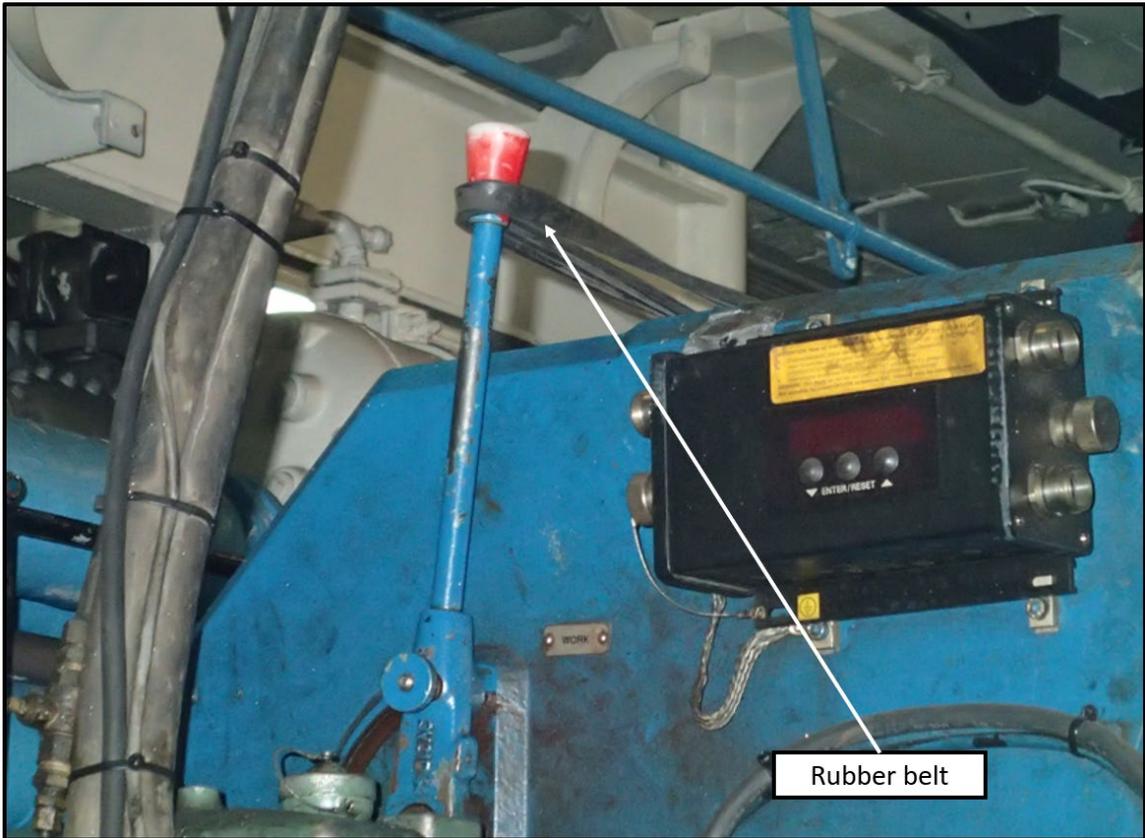
Figure G22. Rubber belt holding lever (Source: TSB)

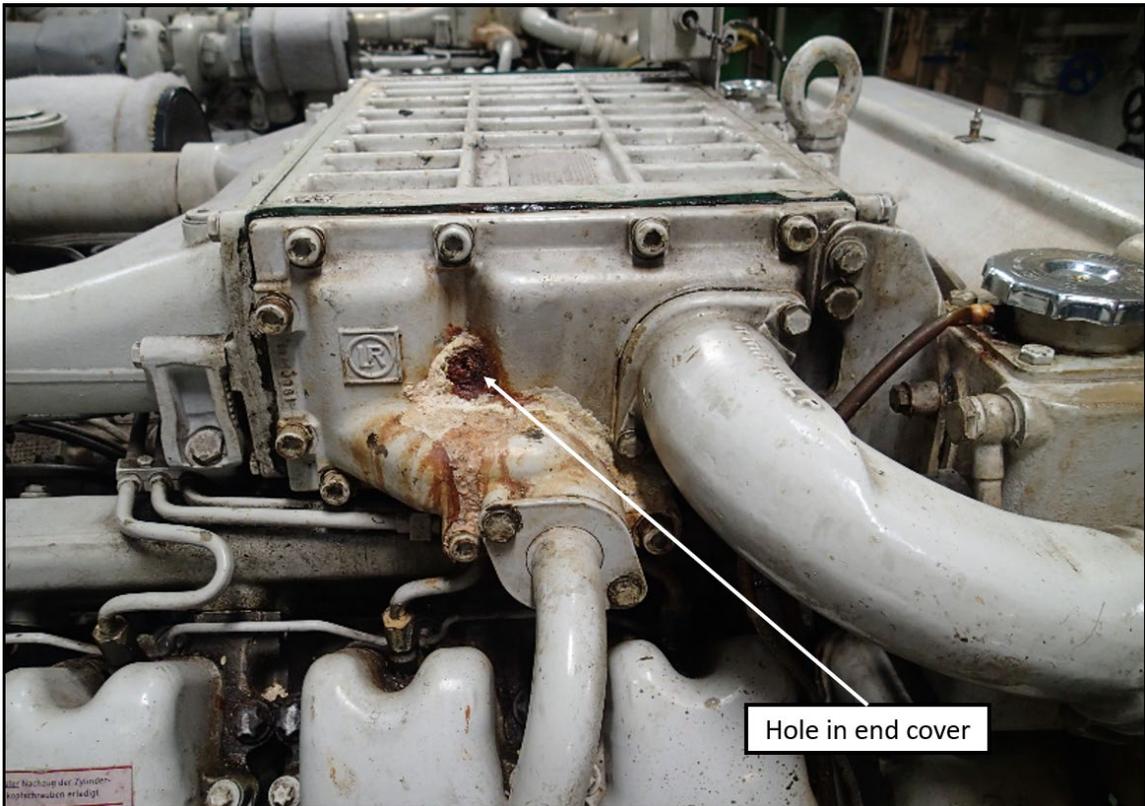
- Corrosion perforations had rusted through the end covers for the intercoolers on the 3 auxiliary diesel engines, and there was rust and salt residue around the holes where sea water had leaked out. The intercoolers use sea water to cool the intake air coming from the turbo compressor and going into the cylinders to increase the engine output (Figure G23).

Figure G23. Perforation in the end cover of an intercooler for one of the auxiliary diesel engines (Source: TSB)

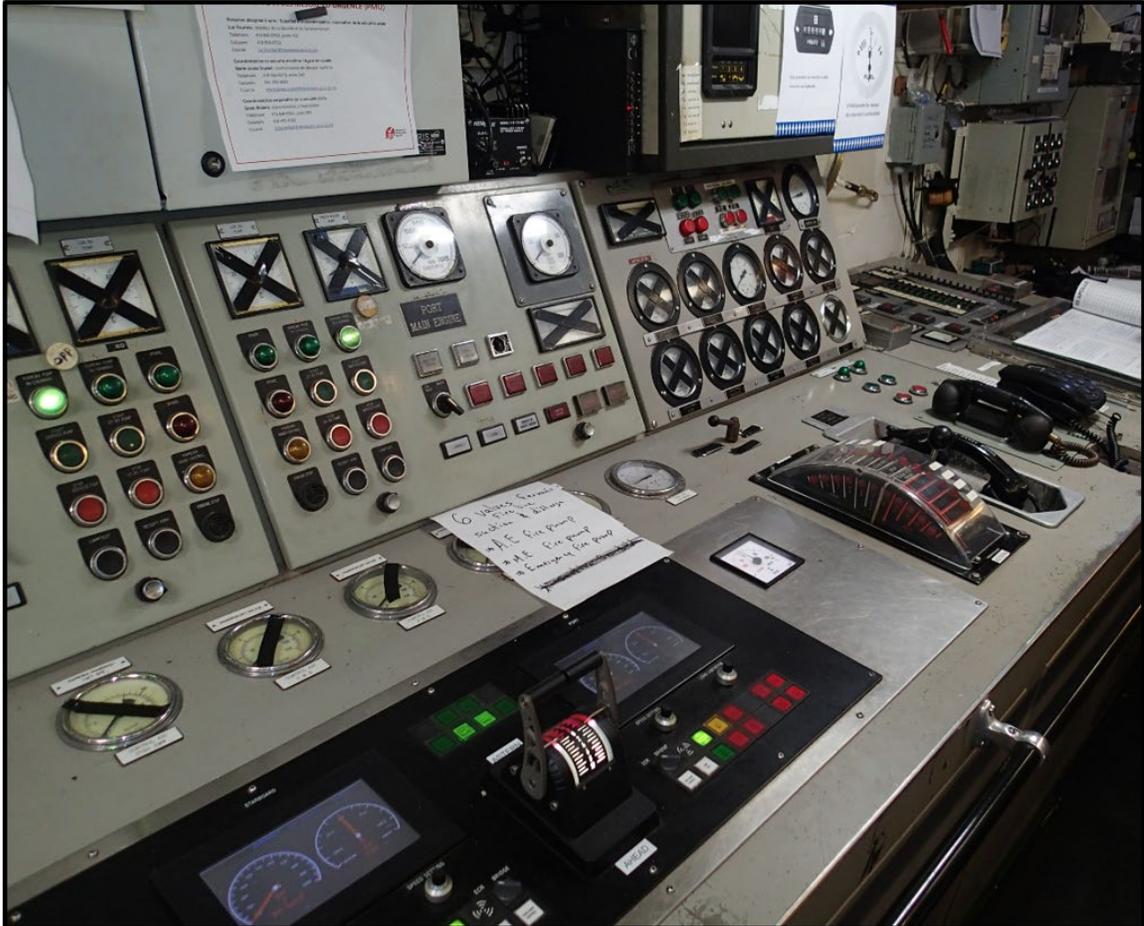
- The main panel in the engine control room contained redundant indicators and switches left over from equipment that had been replaced or was no longer in use (Figure G24).

Figure G24. Unused indicators and switches in engine control room (Source: TSB)

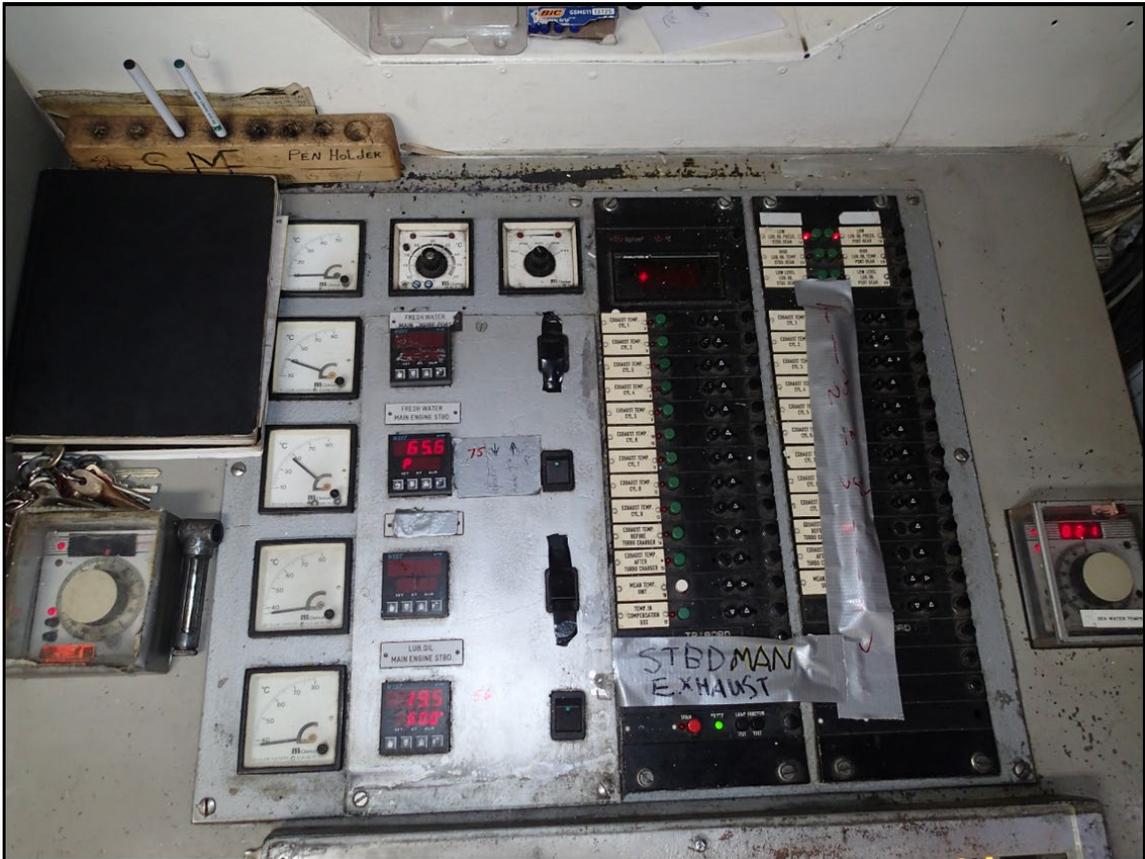
- Some active indicators and switches in the engine control room were covered over with duct tape (Figure G25).

Figure G25. Active indicators and switches beneath duct tape (Source: TSB)

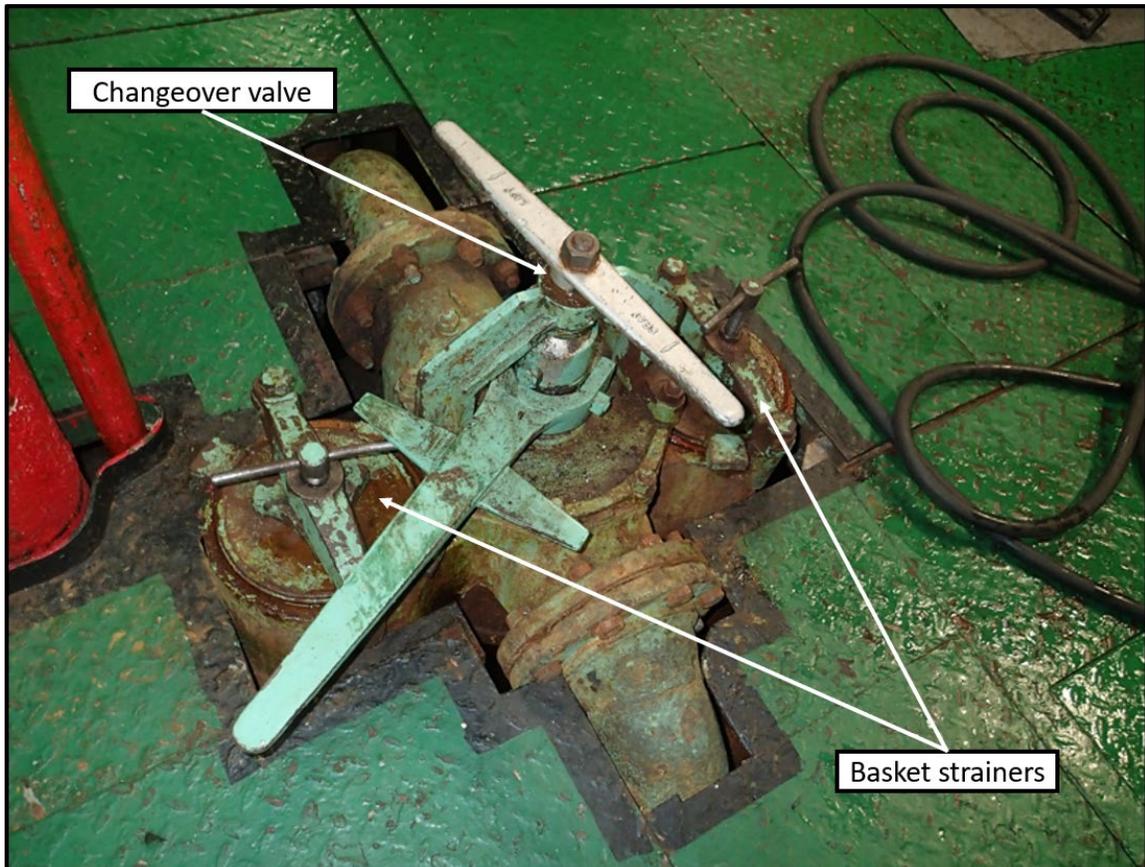
- The changeover valve for a duplex strainer on a cooling line for auxiliary machinery was leaking (Figure G26).

Figure G26. Leaking changeover valve on duplex strainer (Source: TSB)

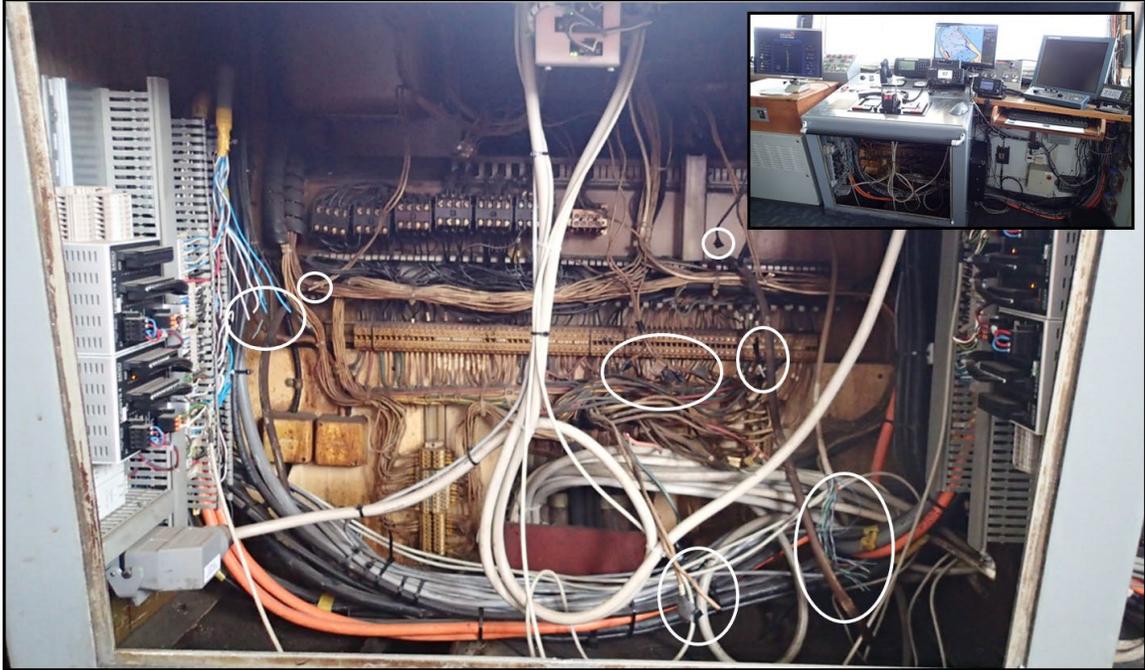
Figure G27. Redundant electrical wires in bridge console (Source: TSB)

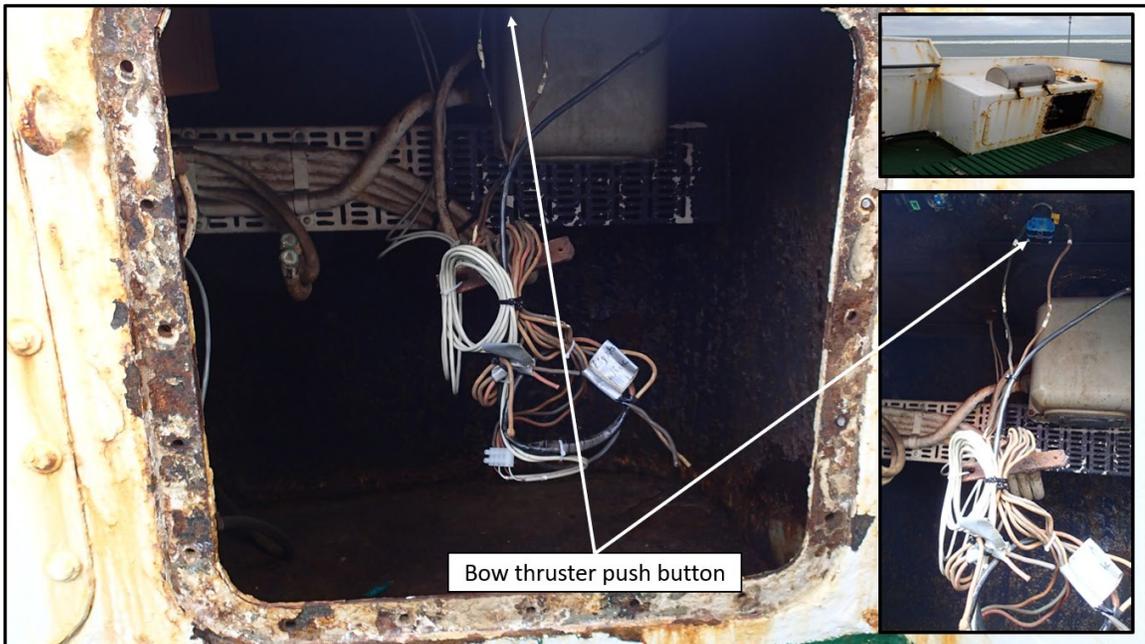
- The starboard bridge wing console contained electrical wiring that was not properly secured with wiring clamps (Figure G28).

Figure G28. Loose wires suspended in the starboard bridge wing console (Source: TSB)

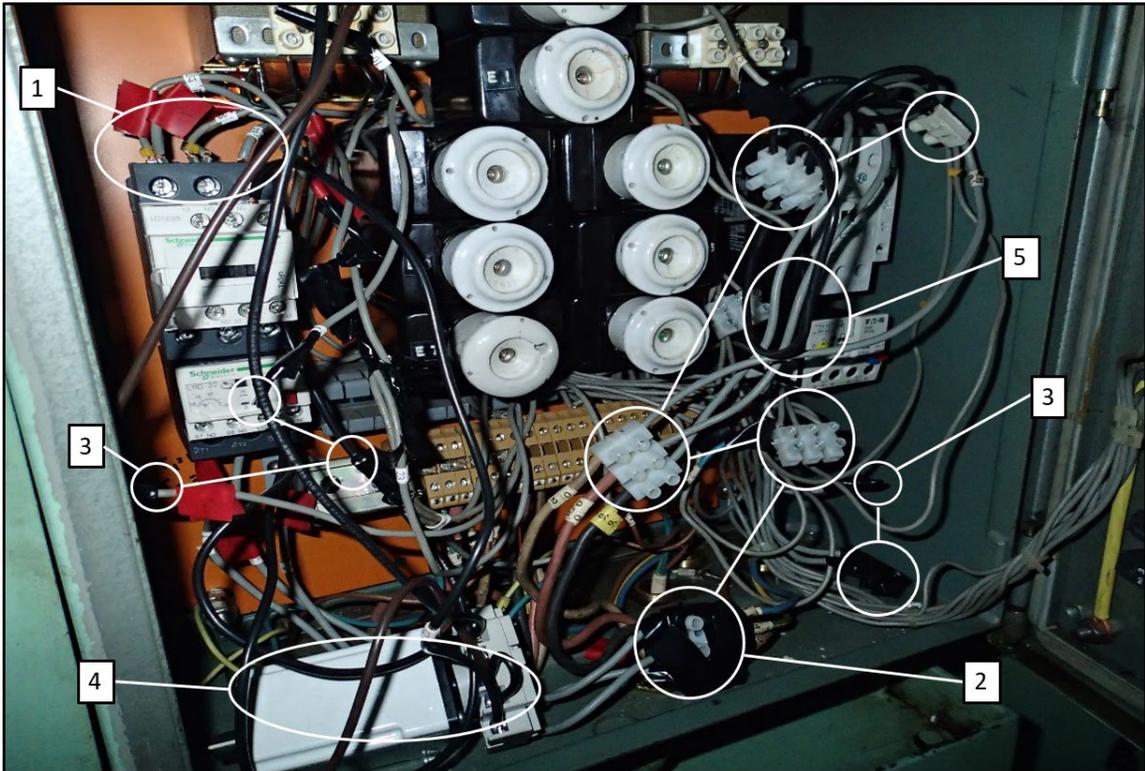
- In the control panel used to operate the hydraulic sliding doors, the electrical wiring did not meet the requirements of TP 127 - Ships Electrical Standards.⁹⁹ With reference to (Figure G29), the following was noted:
 - Multiple wires connected to a single terminal (1)
 - Suspended terminal blocks (2)
 - Multiple free-ended wires (3)
 - An unsecured relay box (4)
 - Connections between wires of different gauges (5)

Figure G29. Electrical wiring inside the watertight door power unit control panel (Source: TSB)

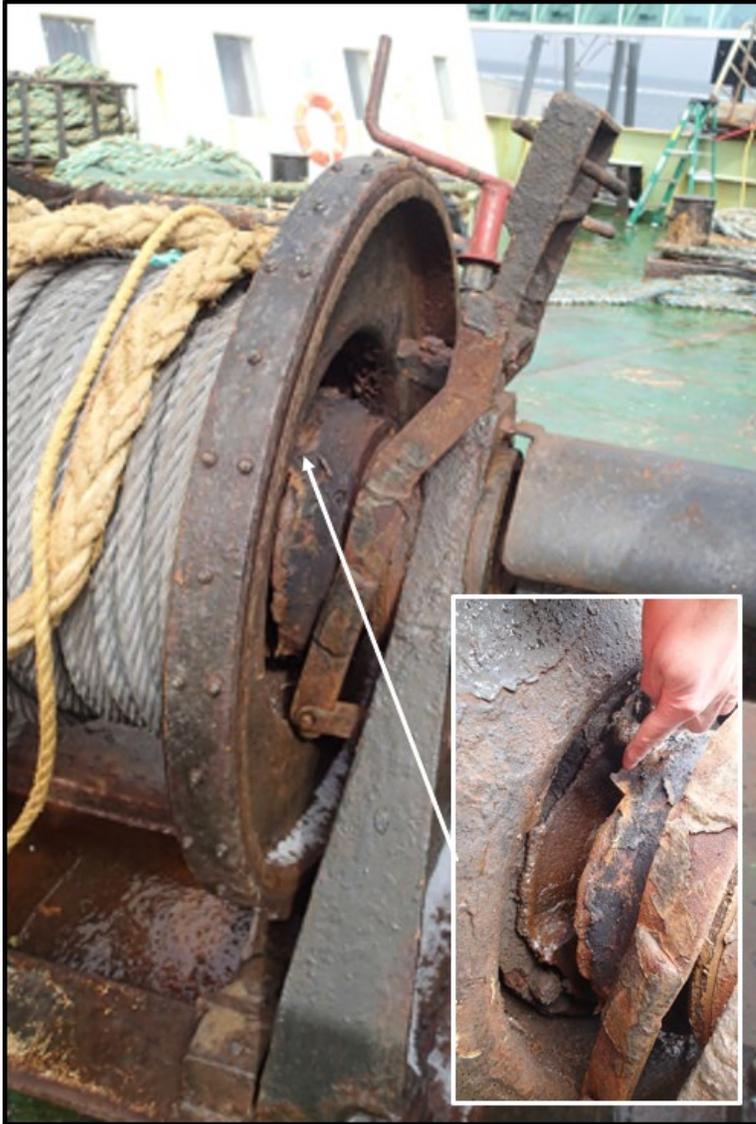
Figure G30. Starboard side mooring winch gear (Source: TSB)

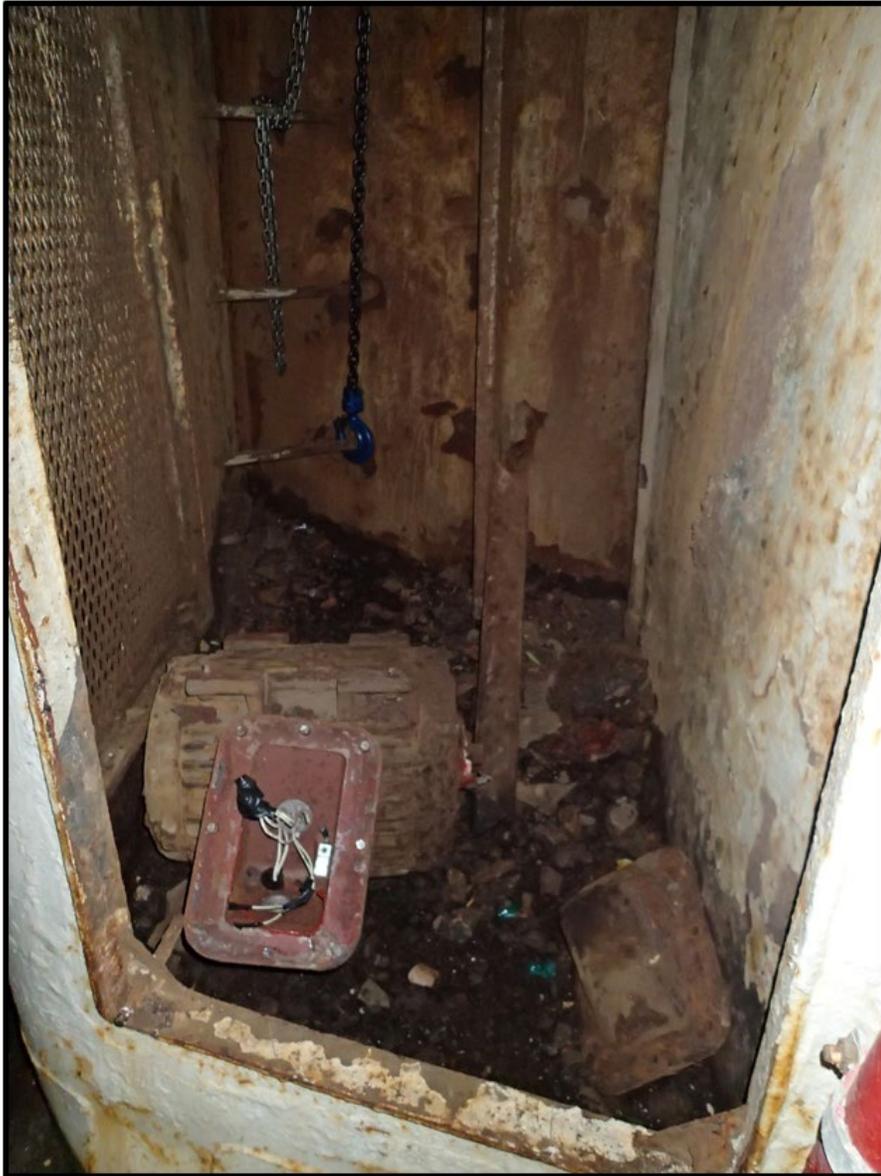
- The extraction fans used to remove carbon monoxide produced by vehicle exhaust on the car deck were inoperative (Figure G31).

Figure G31. Inoperative extraction fan (Source: TSB)

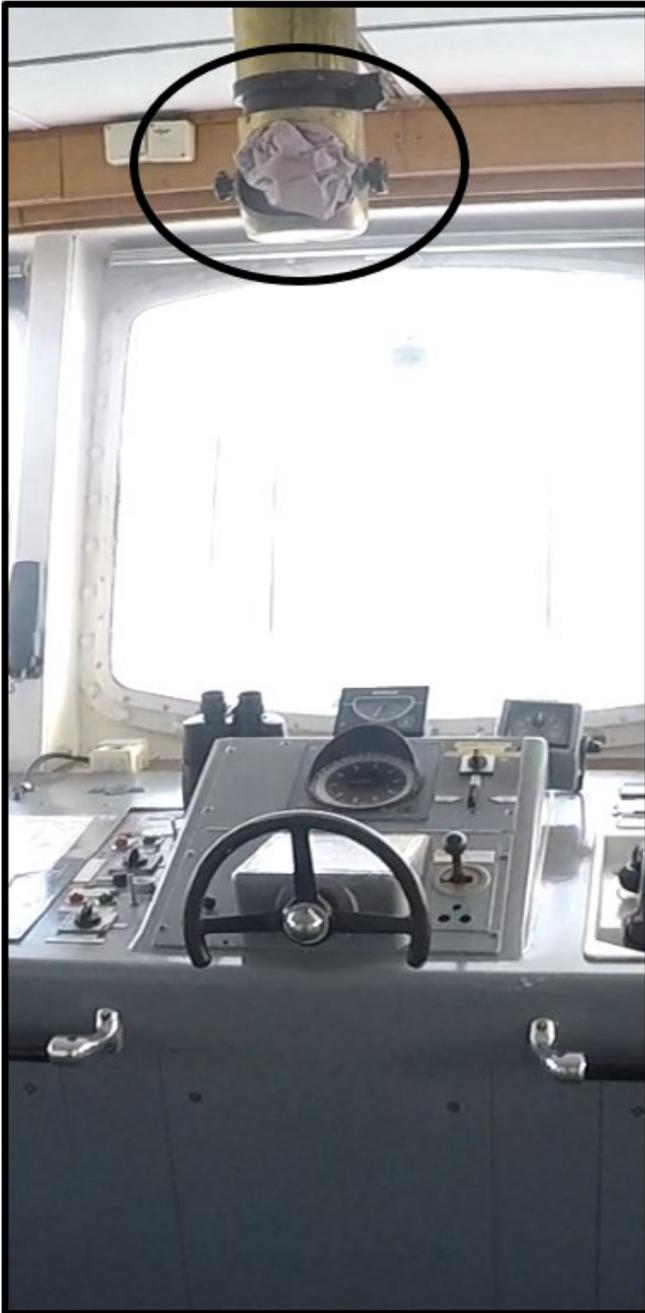
- The periscope tube for the vessel's magnetic compass, which reflects the heading of the magnetic compass onto the bridge, had a rag stuffed into it (Figure G32).

Figure G32. Rag stuffed into the magnetic compass periscope tube (Source: TSB)
