MARINE TRANSPORTATION SAFETY INVESTIGATION REPORT M21A0315

SINKING AND LOSS OF LIFE

Unregistered fishing vessel known as *Island Lady*
Labrador Sea, Newfoundland and Labrador
17 September 2021

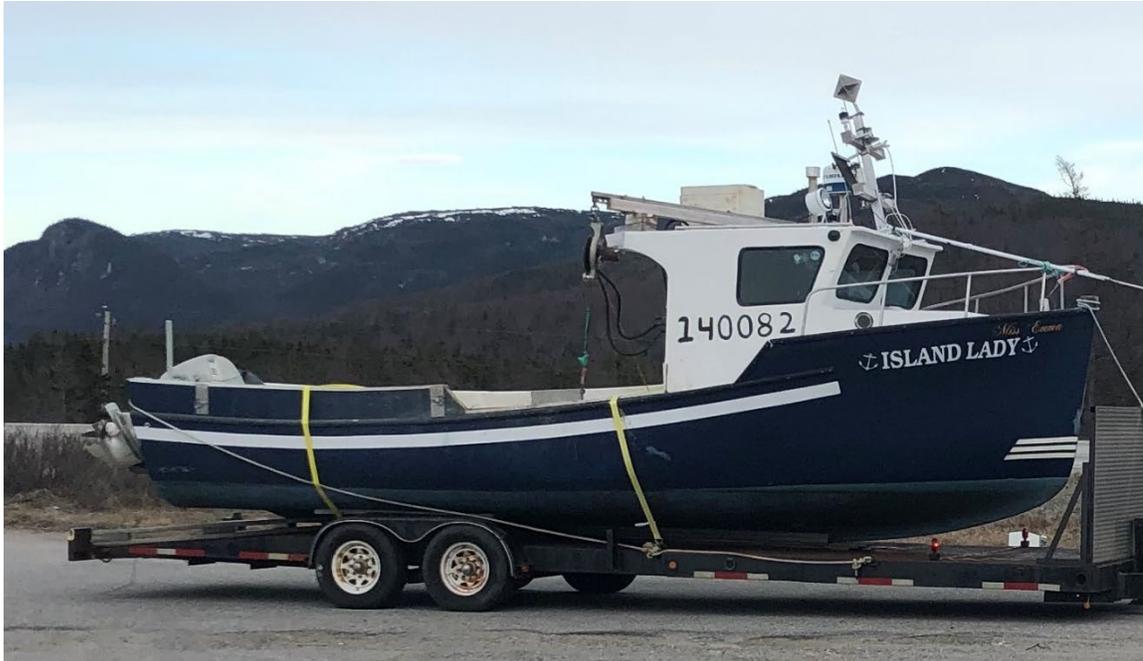
The occurrence vessel, commonly known as the *Island Lady*, was a fibreglass fishing vessel of open construction (Figure 1) that was not registered with Transport Canada (TC). The *Island Lady* was approximately 8.5 m long, and powered by 2 independent gasoline outboard motors (90 hp each). A hydraulic gillnet hauler was located on the starboard side amidships. The hydraulic pump for this hauler was powered by a gasoline engine installed on the port side on the top of the cabin.

Figure 1. The *Island Lady* (Source: Transport Canada)

The *Island Lady* had never been formally assessed for stability, so the vessel's inherent stability limits were unknown, and the crew was unaware of the vessel's safe operating limits.

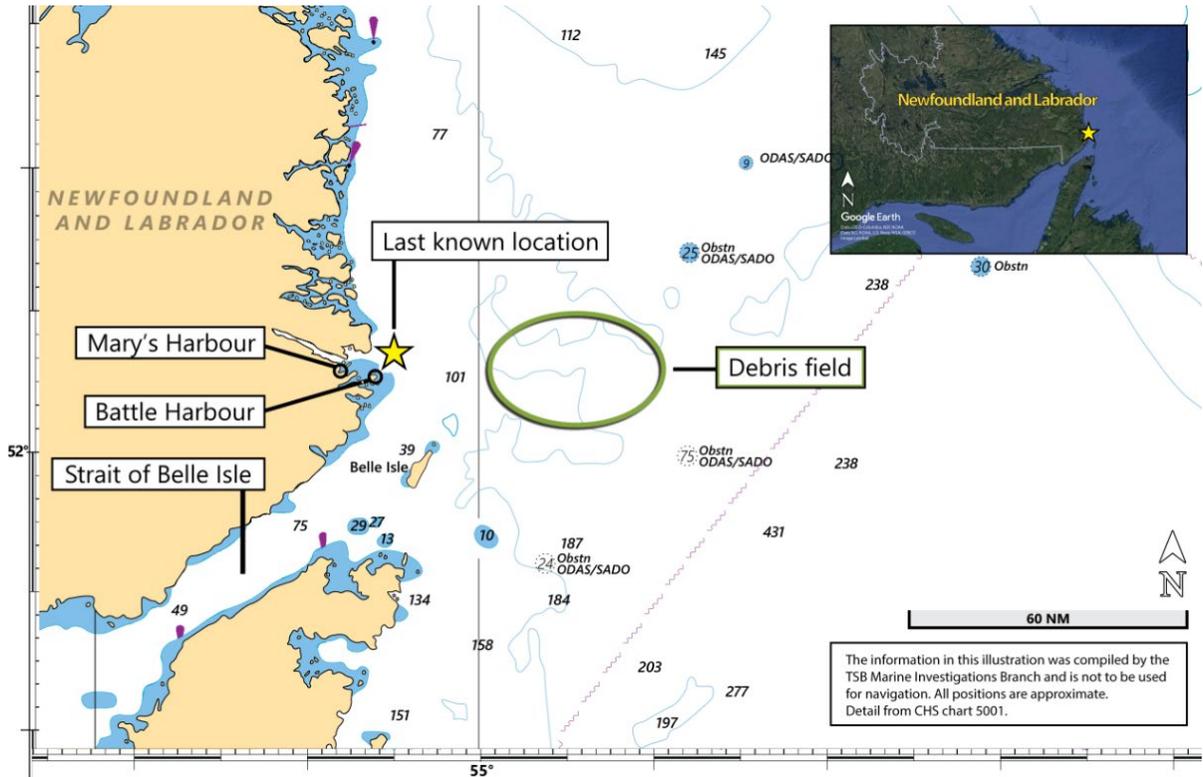
The investigation into this occurrence could not determine with certainty the cause of the disappearance of the *Island Lady*. However, it is likely that the vessel sank and that both crew entered the water unexpectedly, without life-saving appliances for flotation and protection from environmental conditions, and without being able to successfully make a distress call.

Figure 2. Chart of the occurrence area indicating the last known location of the *Island Lady* and the location where debris was recovered (Source of main image: Canadian Hydrographic Service, Chart 5001; source of inset image: Google Earth, with TSB annotations)
