# MARINE TRANSPORTATION SAFETY INVESTIGATION REPORT M22C0338

## BOTTOM CONTACT

Oil and chemical tanker *Kivalliq W.*  
Chesterfield Narrows  
Baker Lake, Nunavut  
18 October 2022

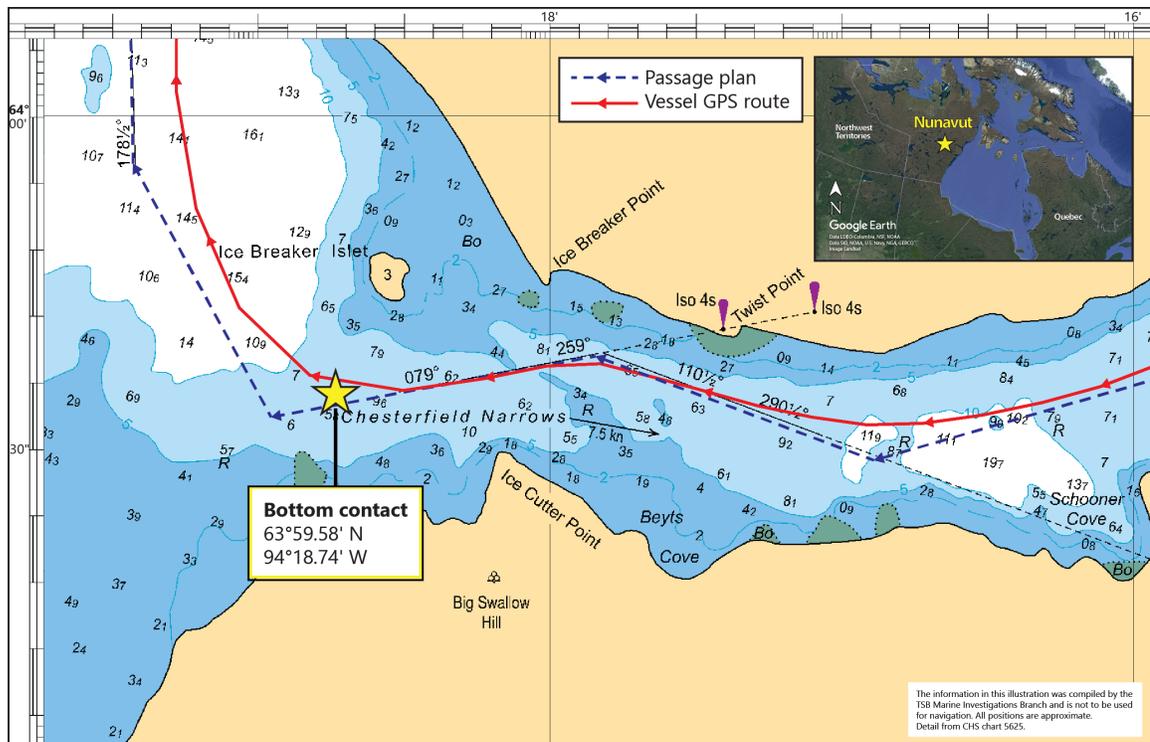
At approximately 0450, as the vessel turned to exit Chesterfield Narrows (Figure 2), an abnormal vibration was felt throughout the vessel, and the vessel was slower to respond to helm orders. Shortly thereafter, the master sent the officer of the watch to the cargo control room to check the instruments for possible water ingress, and initiated emergency procedures. It was suspected that

the vessel had made bottom contact with an uncharted submerged object. The master directed the vessel toward a nearby anchorage and ordered the crew to assemble at the muster stations.

**Figure 2. Electronic chart display showing the Kivalliq W's passage plan, track, and position where the bottom contact occurred (Source: Canadian Hydrographic Service Chart 5625, with TSB annotations)**

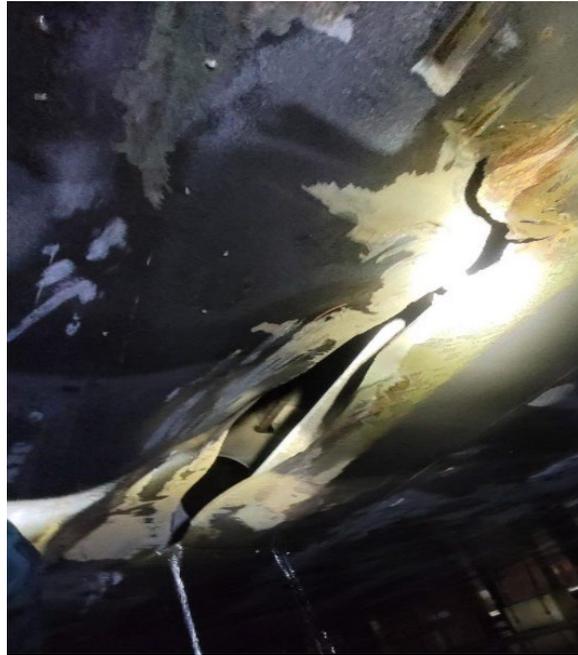
As a result of bottom contact, the *Kivalliq W.* sustained a hull breach below the waterline. The damage was limited to the bottom shell plating of the No. 3 starboard ballast water tank, between frames 105 and 108. The breach, which caused the ingress of water, was approximately 3 m in length (figures 3 and 4).

Figure 3. Damage to the vessel, viewed from the exterior (Source: Coastal Shipping Limited)

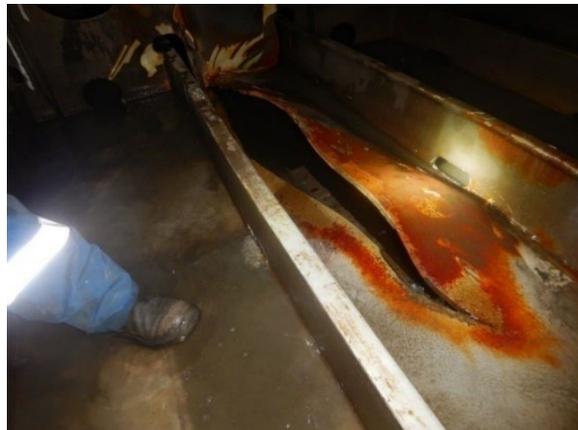
As the vessel listed to starboard, water was found in the No. 3 starboard ballast water tank. Before the occurrence voyage, this tank was empty; the presence of water in the tank confirmed to the crew that the vessel had made bottom contact and that the hull had been breached. All other tanks appeared intact, including those in the engine room spaces.

Figure 4. Damage to the vessel, viewed from inside No. 3 starboard ballast water tank (Source: Coastal Shipping Limited)

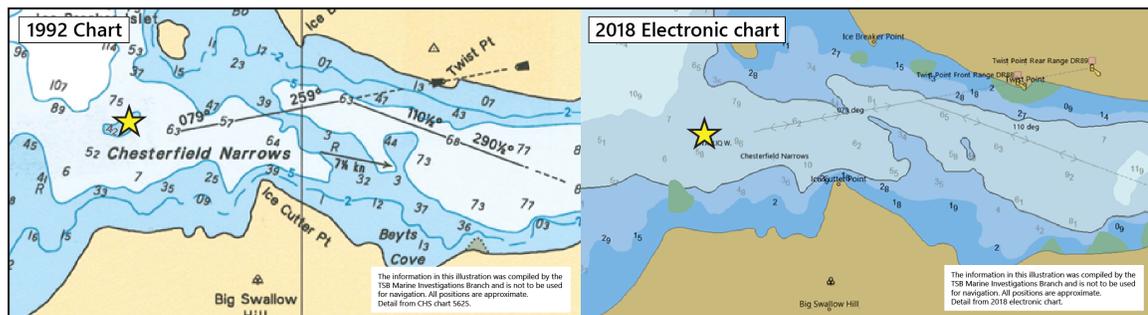
Figure 5. Canadian Hydrographic Service Chart 5625 – Schooner Harbour to Baker Lake, comparison between the 1992 and 2018 versions (Source: Canadian Hydrographic Service, with TSB annotations)

The 1992 edition of Chart 5625 shows a depth of 4.2 m at the occurrence position (Figure 5). The 2018 edition of the chart, which was used in this occurrence, does not show the same shallow depth at this position. Six years elapsed between the hydrographic survey used for the 2018 edition of the chart and the occurrence involving the *Kivalliq W*.

Following the occurrence, the CHS reviewed the data collected from the 2016 hydrographic survey, and on 31 March 2023, the CHS published a chart correction to indicate depths of 5.1 m in the area of the occurrence.<sup>18</sup> This cancelled the second navigational warning.
