RAILWAY INVESTIGATION REPORT R13E0069

MAIN TRACK DERAILMENT

**CANADIAN PACIFIC RAILWAY
FREIGHT TRAIN 679-101
MILE 80.70 HARDISTY SUBDIVISION
PROVOST, ALBERTA
28 APRIL 2013**

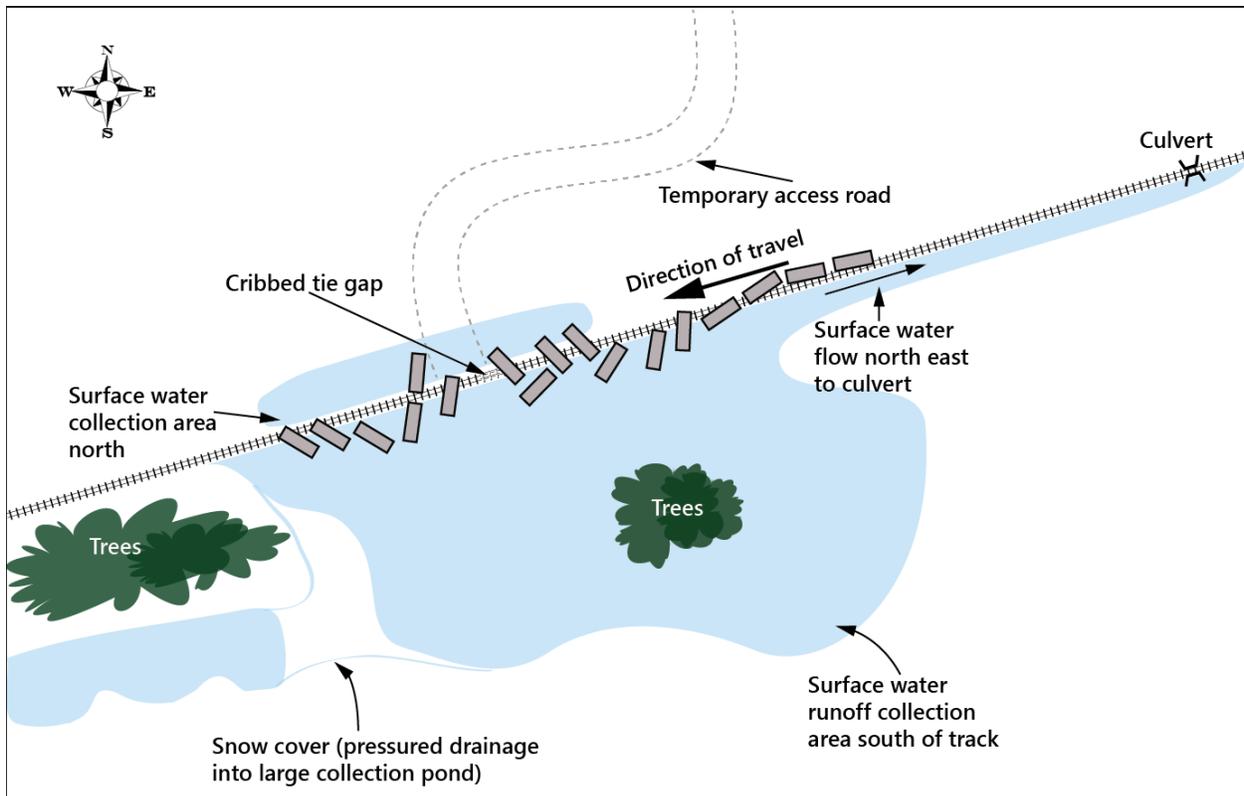
Figure 2. Derailed site diagram

The derailment occurred in a rural area with no crossings or sidings in the vicinity. The point of derailment (POD) was determined to be at Mile 80.7 on tangent track. The first 4 cars had derailed to the south side of the track and had rolled down the bank into standing water. The remaining derailed cars came to rest on top of the track and on both sides (Figure 2). The track roadbed at this location was elevated above ground level (Photo 1). The standing water on the north side of the track was approximately 2 feet deep and 6 feet below the level of the rail. The standing water on the south side of the track was significantly deeper and was within 3 feet of the level of the rail (Photo 2).

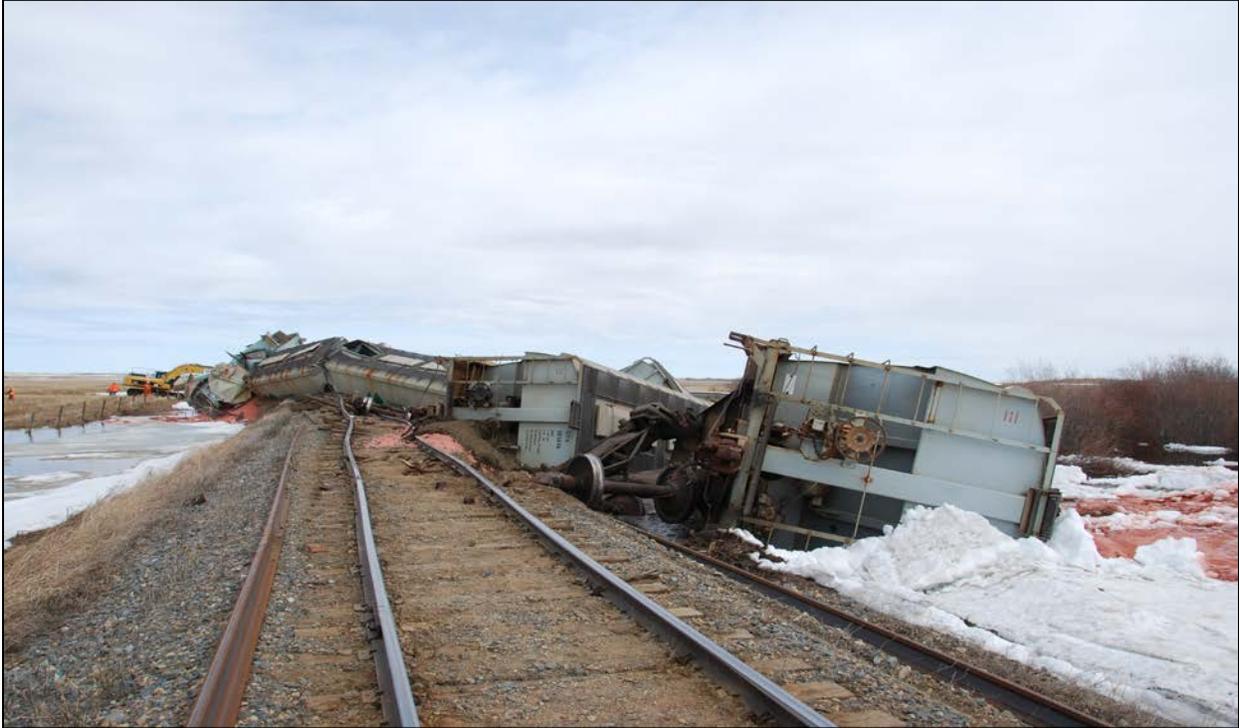
Photo 1. View of derailment looking east

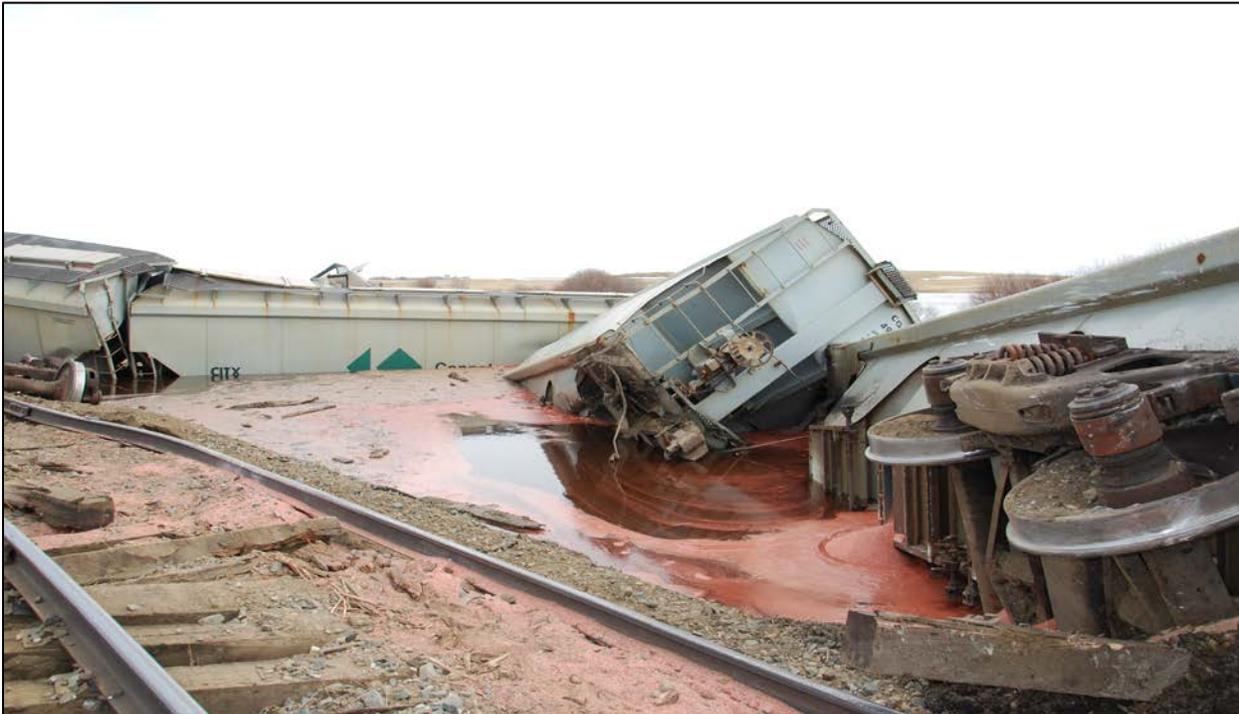
Photo 2. View of derailment looking southeast - high standing water at the south side of the track

In the 4 days prior to the occurrence, daytime temperatures had been abnormally warm followed by cooler nights, which had resulted in a steadily increasing seasonal run-off water volume from the melting snow. The natural drainage at this location was from the west. Excess water would normally pass through a culvert east of the POD to the north side of the track. However, ice in the south ditch restricted the flow of the high volume of run-off water from the rapidly melting snow, allowing the water to back up in the ditch. It is also possible that the culvert itself was partially iced up. Due to the limited capacity of the drainage system and the southern exposure, the water level remained higher on the south side of the track relative to the north side, resulting in above normal water level infiltration and saturation of the track subgrade.

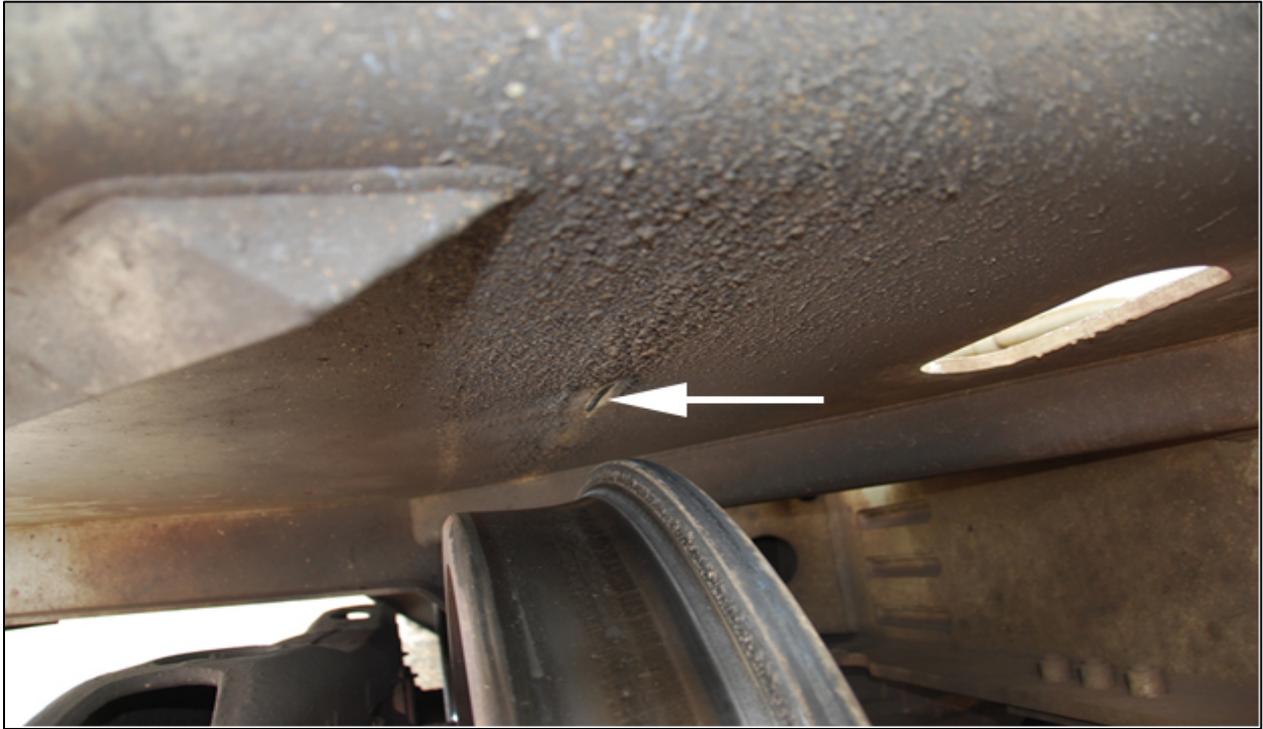
The front of the train (i.e., 16 cars and 2 locomotives that were ahead of the derailment) was inspected. Impact marks were observed on the deck plates² of the first 16 cars, indicating that they had been struck from beneath by the leading wheelset on each of the cars (Photo 3).

Photo 3. Impact marks where the wheel struck the deck plate

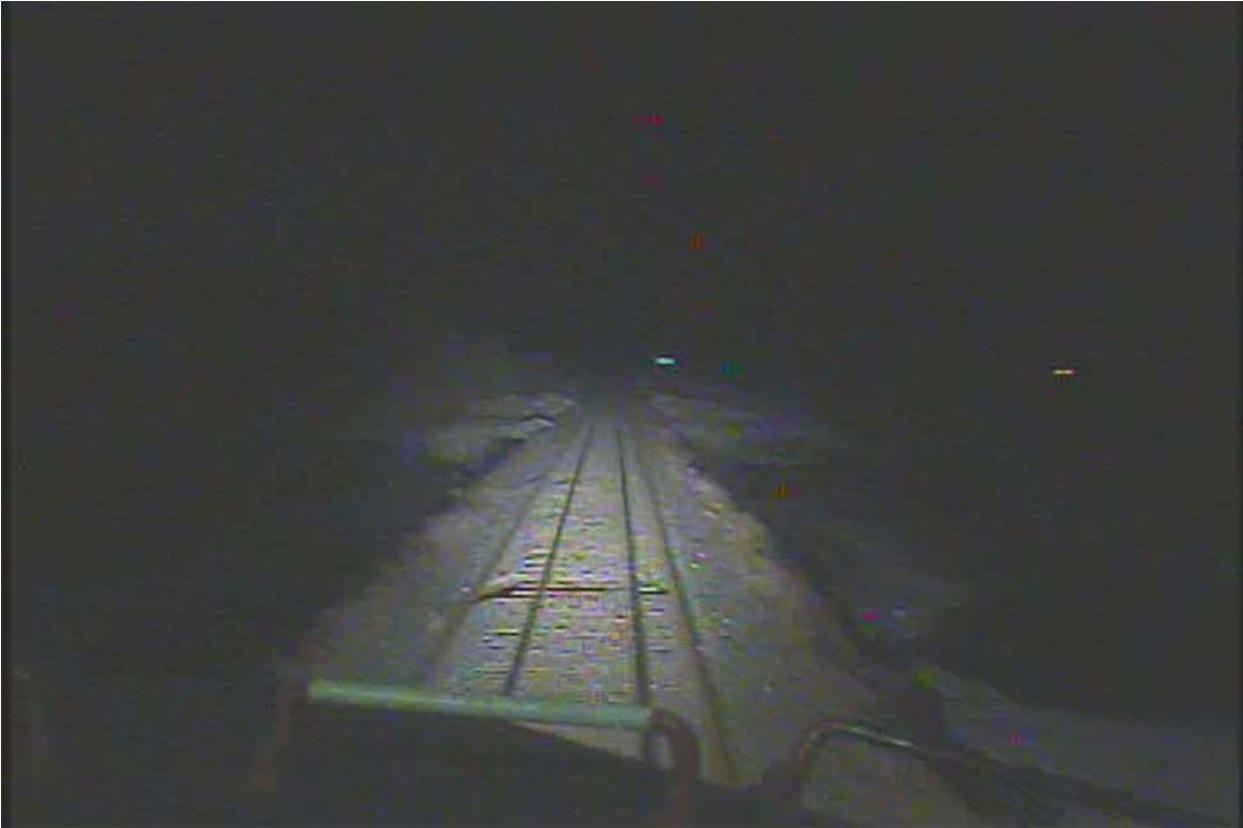
A forward facing video camera had been installed on the lead locomotive. The recorded video indicated that 3 cribbed³ ties were clearly visible as the train approached the POD (Photo 4).

Photo 4. Still frame from forward facing video camera on CP locomotive 8913.

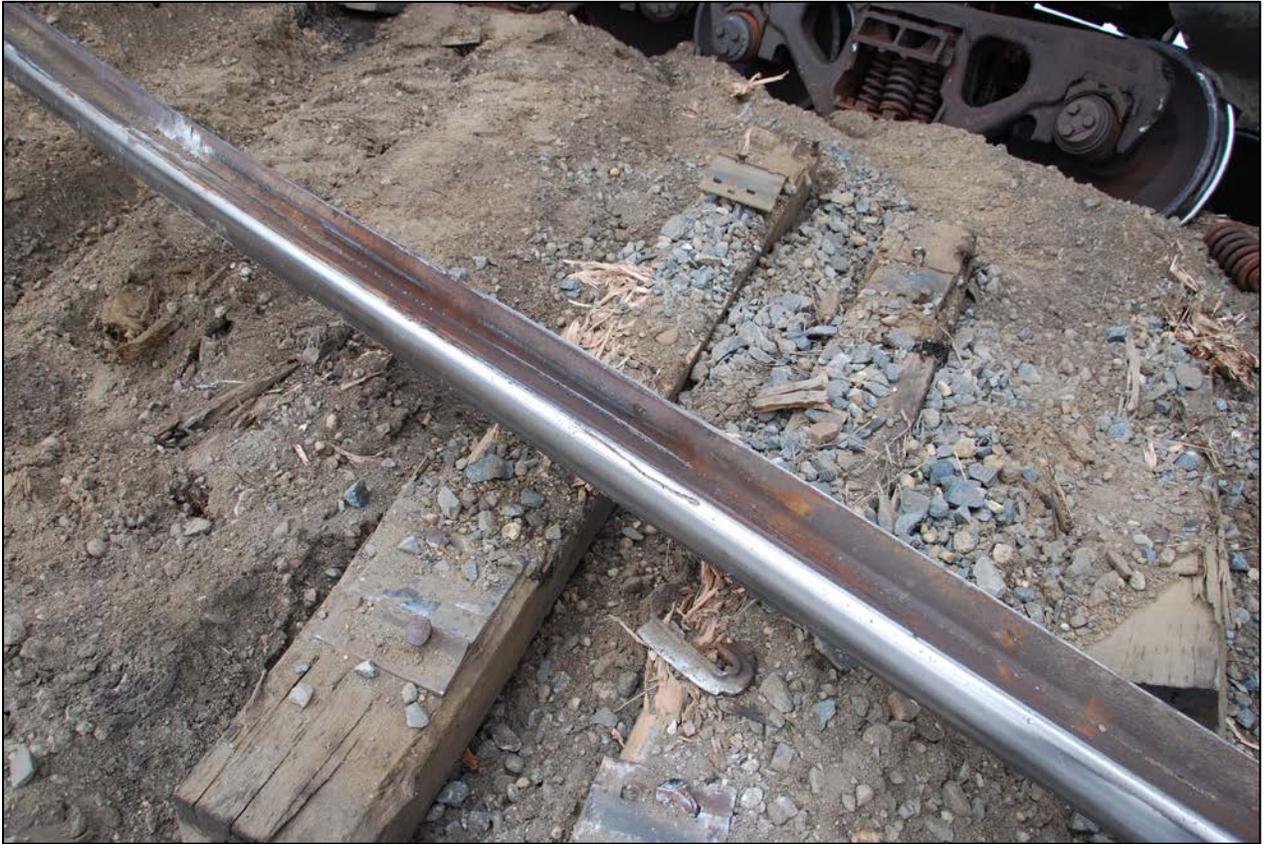
The track leading up to the derailment location was lying on a 0.4% ascending grade, transitioning to level track. The rail in the area of the derailment was 100-pound jointed rail manufactured by Algoma in 1929. The ties were 8 foot, treated No. 1 softwood ties. The tie plates were single shoulder with 2 spikes per plate. The condition of the tie plates was generally poor with broken plates at some rail joints. FAIR⁴ rail anchors were installed to every second tie. The rail anchors displayed evidence of rail movement. The ties and spikes were in fair condition. Ballast consisted of a surface sprinkling of grade 3 ballast (i.e., mainly sand and gravel less than 2 inches) and was fouled (Photo 5).

Photo 5. Subgrade and ballast conditions near the POD

The daily temperature variations resulted in freeze and thaw cycles that produced excess free water in the track subgrade. This excess water decreased the normal internal soil friction, leading to reduced cohesion, stability, and bearing support. This sustained infiltration created elevated water pressures (pore pressure) that resulted in surface water migration through the railway embankment from the south to the north. This water flow through the subgrade created a void below track level as ballast and subgrade material were lost from between and beneath the ties, reducing the capacity of the track to support the passing train.
