RAIL TRANSPORTATION SAFETY INVESTIGATION REPORT R18W0237

MAIN-TRACK TRAIN DERAILMENT

Hudson Bay Railway
Freight train 995-15
Mile 99.59, Wekusko Subdivision
Ponton, Manitoba
15 September 2018

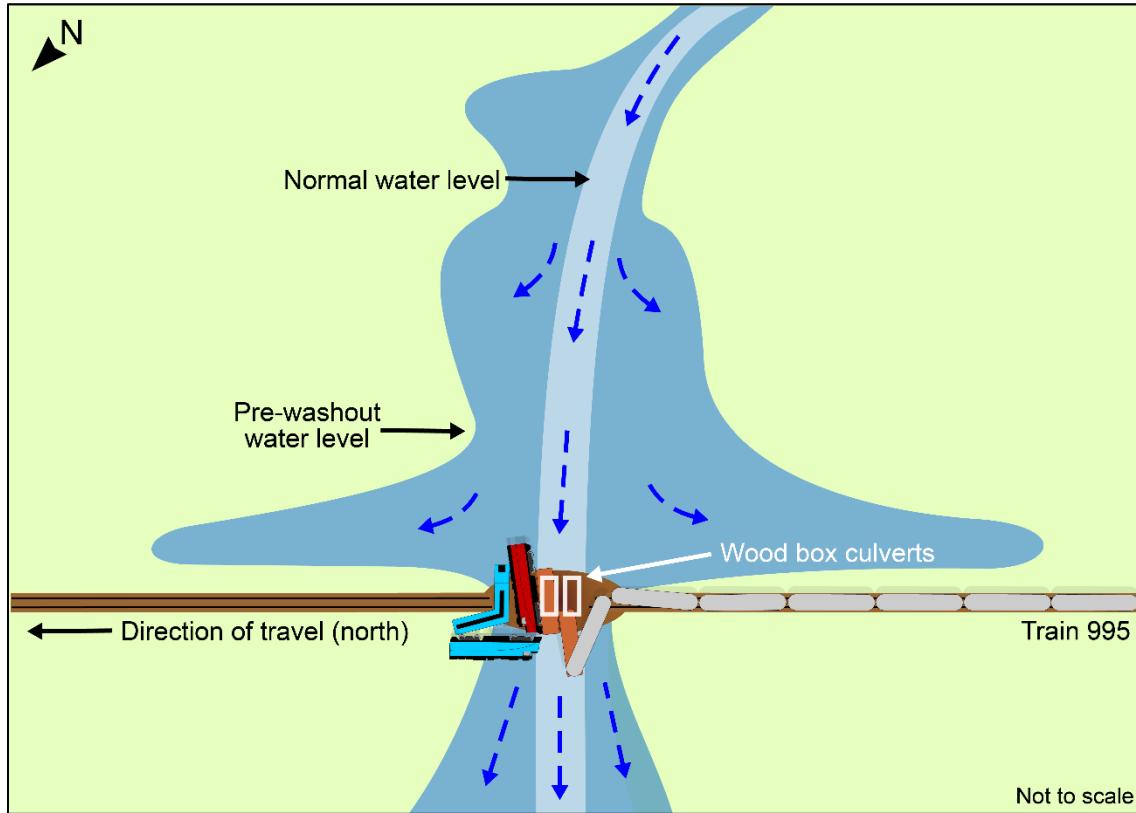
Figure 2. Schematic of derailment site showing the water levels under normal conditions and before the washout (Source: TSB)

At 1632, as the train was proceeding northward at 25 mph on a raised portion of track, the train crew observed a void in the roadbed surface ahead at Mile 99.59. The rails appeared to be in place, so it was not immediately apparent that there was a significant washout.⁵ Consequently, the train entered the washout location without the crew initiating an emergency brake application. The train proceeded on to the unsupported section of track, the track collapsed, and the head end of the train struck the opposite side of the washout. The 3 head-end locomotives, 2 empty gondola air dump ballast cars, and 2 tank cars loaded with LPG derailed (Figure 2).

A subgrade failure and washout measuring about 50 feet long and 15 feet deep had left the rails and ties unsupported and hanging.

The derailment occurred when the train encountered an unsupported section of track due to a washout and subgrade failure that had occurred at Mile 99.59 before the train's arrival.

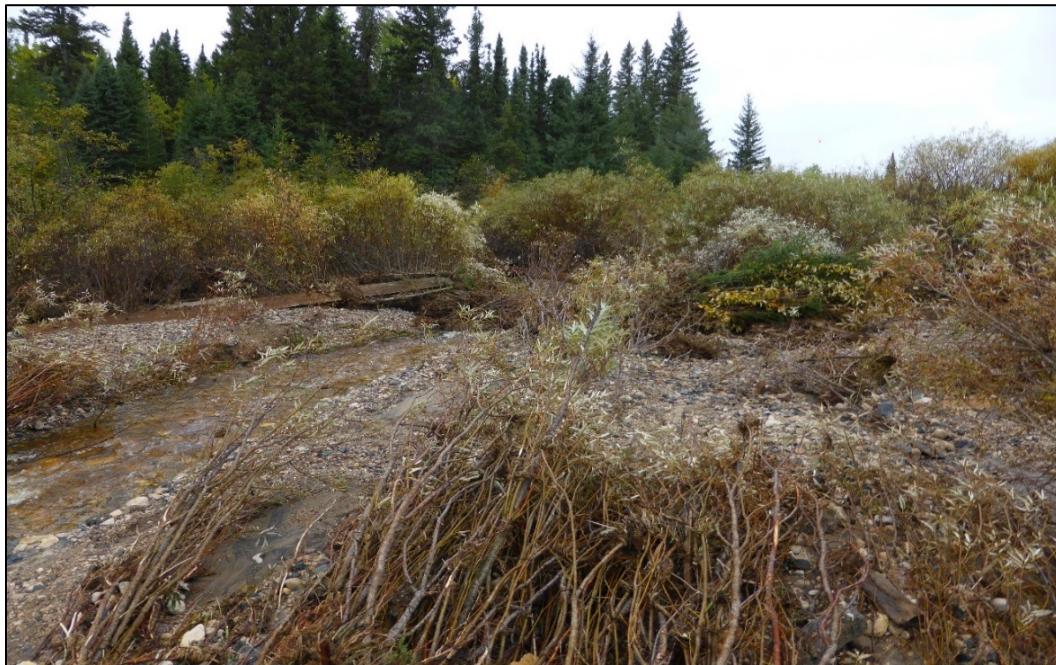
Figure 4. Site photo downstream showing culvert timbers and flattened streambed plants
(Source: TSB)

Culvert timbers and flattened streambed plants were observed as far as 1000 feet downstream, north of the washout (Figure 4).

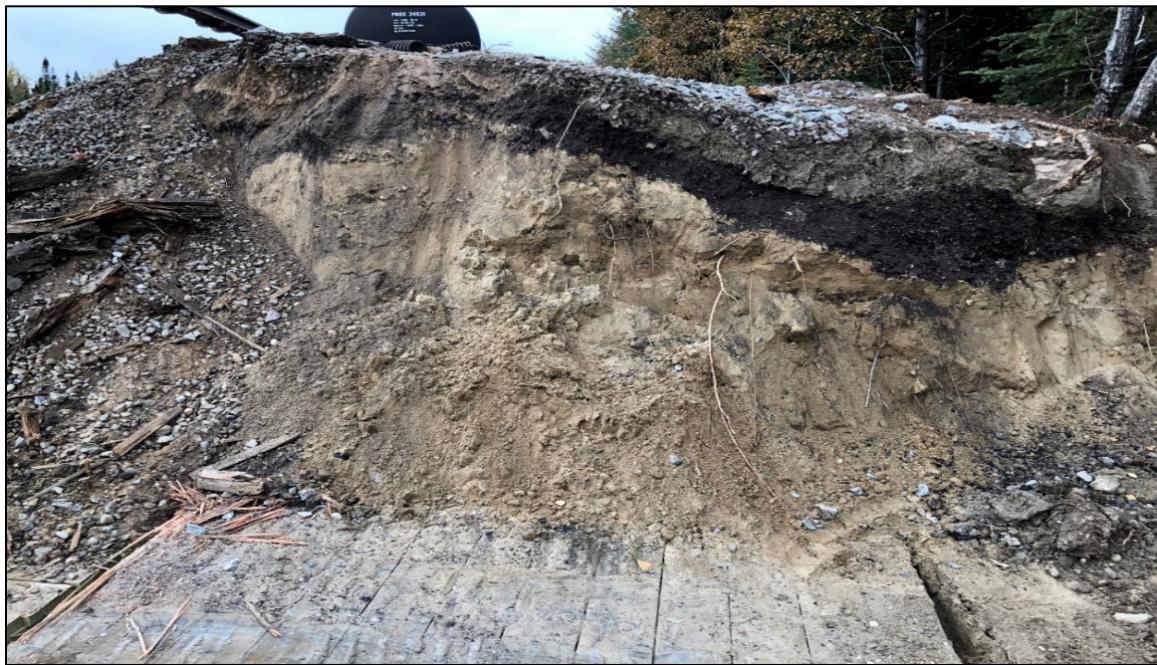
Figure 5. Cross-section of grade and subgrade at the derailment site (Source: Hudson Bay Railway)

The roadbed was about 12 feet above the local terrain. At the derailment site, the subgrade was mainly sand (Figure 5).

A trestle bridge had previously traversed the creek at this location and provided drainage to the local area. At some point, the bridge was replaced with 2 wood box culverts and sand fill. The subgrade had been compacted over the years by the passage of trains. However, it remained susceptible to water infiltration, particularly during periods of high water in the local area.

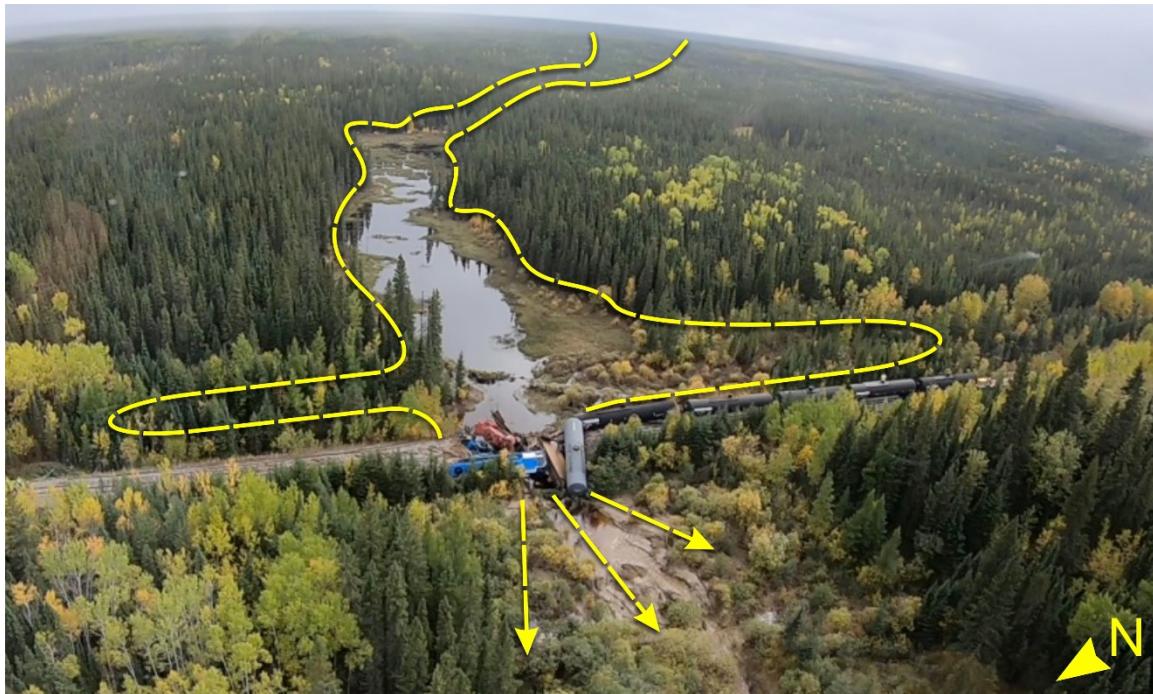
Figure 6. Aerial view looking east. The visible shoreline high-water marks are outlined east of the rail line. Arrows identify the westward flow of water. (Source: TSB)

At Mile 99.59, water passed through the wood box culverts installed 12 feet below the rail. However, as a result of the high water volumes, the water had been backing up and forming a large pool of water east (upstream) of the rail line. Aerial examination following the derailment showed the recent high-water levels east of the rail line, as visible shoreline water markings were present (Figure 6).
