Rail Transportation Safety Investigation Report R19D0117

MAIN-TRACK TRAIN DERAILMENT

Central Maine & Quebec Railway
Freight train 630
Mile 103.73, Sherbrooke Subdivision
Bolton-Ouest, Quebec
16 November 2019

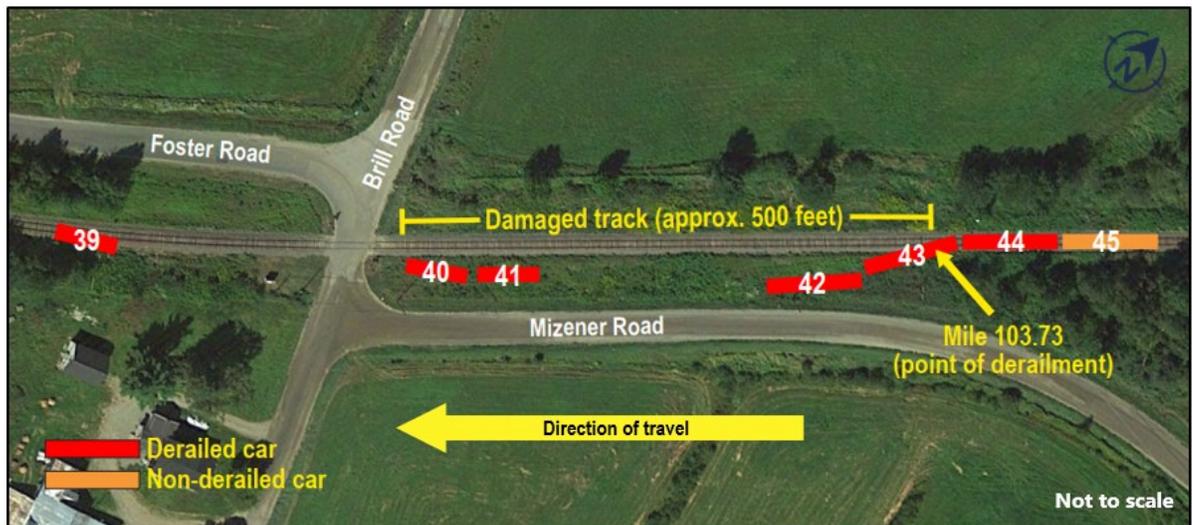
Figure 2. Schematic of the derailment site (Mile 103.73 of the Sherbrooke Subdivision) (Source: Google Earth, with TSB annotations)

The 39th car was the first to derail. It was upright, still partly on the track, approximately 225 feet west of the Brill Road crossing. The 40th and 41st cars were lying on their sides, approximately 50 feet from the east side of the crossing. The 42nd car was lying on its side, below the right-of-way. The 43rd car was standing across the track and was still coupled to the next car (the 44th car), which was upright on the track. The 45th car, the last car of the train, was upright and had not derailed (Figure 2). The first 3 cars that derailed were boxcars loaded with rolls of paper, and the last 3 cars were centerbeam flat cars loaded with lumber.

The paved surface of the Brill Road crossing at Mile 103.87 was damaged and deeply marked by the first derailed car.

East of this railway crossing, approximately 500 feet of track was destroyed. The north rail was still in place for most of that distance, but the south portion of the roadbed had been swept away by the scraping effect of the derailed cars, including the south rail and a large majority of the wood ties.

The damage extended to the location of the 43rd car. Eastward beyond this point, the track was intact. The south rail had broken at the point of derailment, at Mile 103.73.

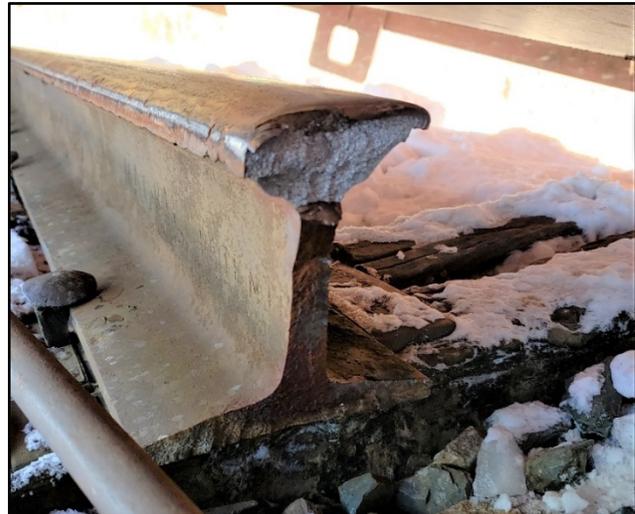
Figure 3. Broken, partly worn rail at Mile 103.73 (Source: TSB)

An ultrasonic rail test to detect possible internal rail defects was conducted on this section of track on 18 October 2019. At Mile 103.73, the south rail (left side of a westward train) could not be examined due to the shelling of the running surface of the rail. Therefore, on 14 November 2019, this rail had been replaced with a partly worn rail⁵ measuring 39 feet long (Figure 3).

The broken rail was 100-pound RE-HF rail manufactured in 1947 by Algoma Steel of Canada.⁶ A first section of the broken rail, measuring approximately 34 feet 8 inches long, was still in track. A second section, approximately 9 inches long, was found among the debris, still bolted to a pair of joint bars. Between these 2 sections, a 43-inch rail length was missing and could not be found. On the remaining section of the south rail, no markings were observed on the sides, other than the raised markings from the original manufacturing process.

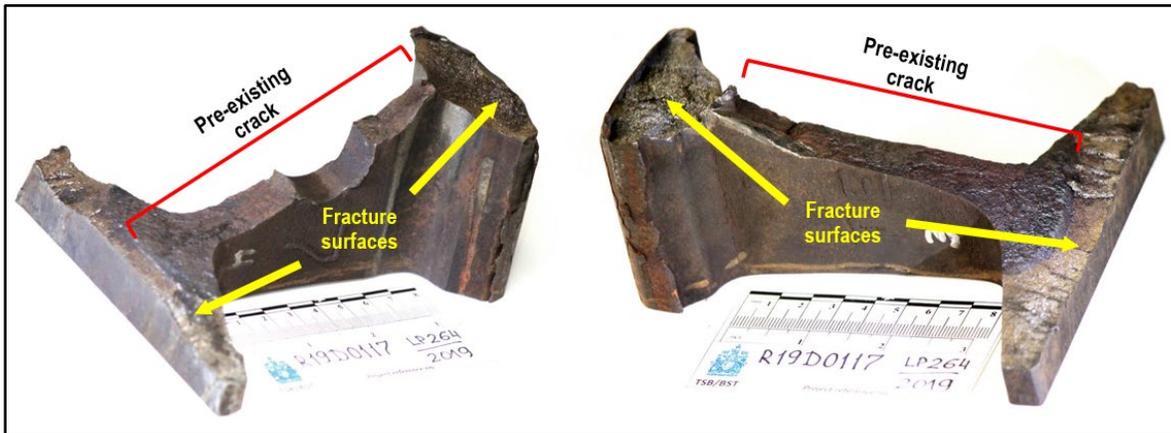
Figure 4. Fracture surfaces of the rail (Source: TSB)

The laboratory examination (TSB Laboratory Report LP264/2019) revealed that the broken rail showed signs of advanced fatigue. It had longitudinal cracks at the head-web junction and, in many other locations, it had pre-existing internal transverse cracks in the rail web. Over time, these transverse cracks gradually extended to the lower portion of the rail head and the upper portion of the base (Figure 4), until they led to catastrophic rail failure as the train rolled over it.

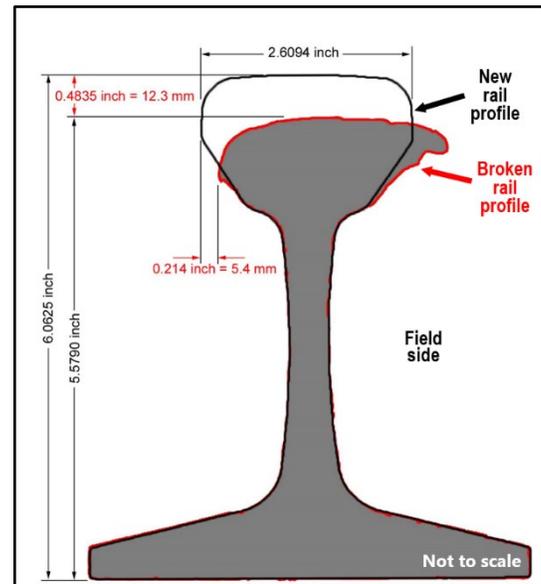
Figure 5. Compared profiles (Source: TSB)

In addition to internal cracks, the broken rail exhibited severe lateral plastic deformation and significant wear of the rail head. These conditions are associated with the repeated passage of heavy loads over a long period of time (Figure 5).

Canadian Pacific Railway (CP)⁹ sets wear limits for rail in service from a combination of lateral and vertical measurements. With respect to wear on the running surface of 100-pound RE-HF rail, given a

lateral wear measurement of 5.4 mm (as indicated in Figure 5), the allowed vertical wear limit would be set at 8.7 mm. When there is no gauge face wear, the maximum vertical rail wear limit would be set at 11.1 mm.

In this occurrence, the vertical wear on the running surface of the broken rail was 12.3 mm. Furthermore, there was no marking on the rail identifying the date of the last ultrasonic test. Given this level of wear, this section of rail should have been identified as scrap rail unfit for reuse.¹⁰

Under the TSR, each railway company must establish adequate standards applicable to each type of rail in service to ensure that the structural integrity of the rail is not compromised. When evaluating rail for subsequent reuse, these standards must be applied consistently to ensure that defective rail is not inadvertently placed into service.
