# RAIL TRANSPORTATION SAFETY INVESTIGATION REPORT R20D0088

## COLLISION BETWEEN A TRAIN AND A TRACK UNIT

VIA Rail Canada Inc. passenger train VIA 68 and  
STL 099285 hi-rail vehicle  
Mile 30.5, Canadian National Railway Company Kingston Subdivision  
Les Cèdres, Quebec  
06 December 2020

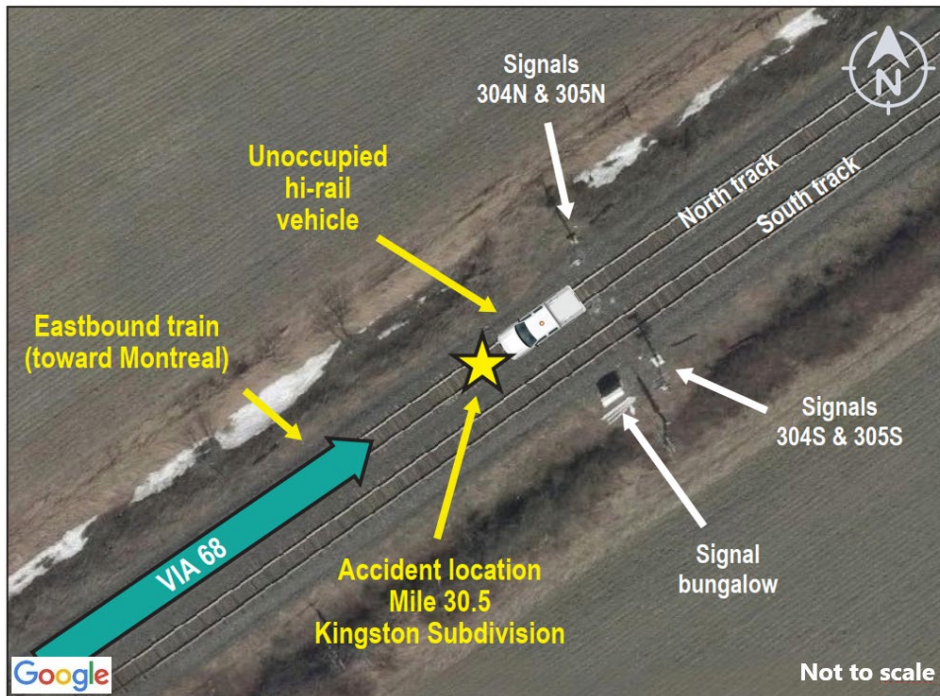
Figure 2. Diagram of the collision site (Source: Google Maps, with TSB annotations)

At the time of the collision, the hi-rail track unit was unoccupied<sup>2</sup> and stationary on the north track, just west of intermediate signals 304N and 305N (Figure 2). Its headlights, fog lights, and strobe lights were on, in accordance with CN requirements,<sup>3</sup> and its engine was running.

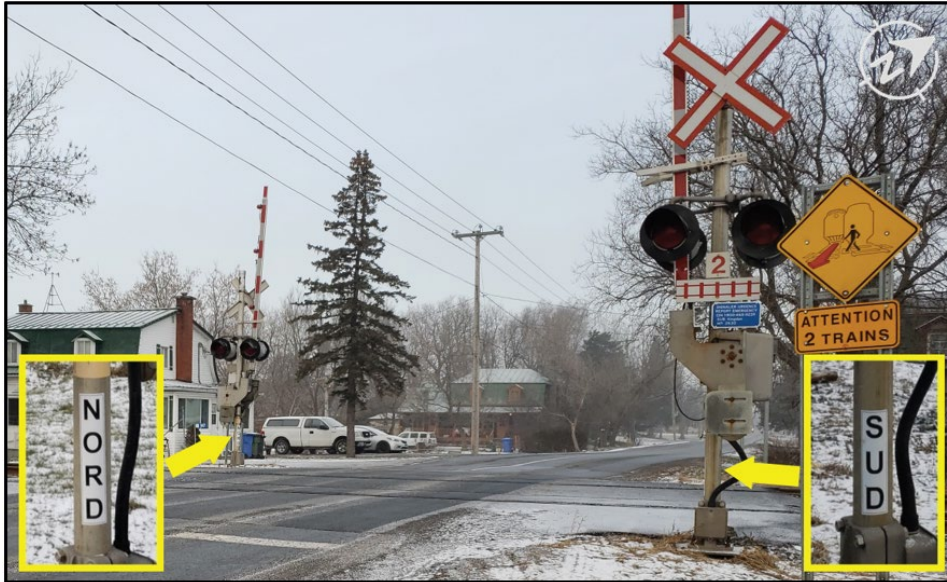
Figure 3. Saint-Féréol Road grade crossing, with inserted images showing the “NORD” and “SUD” stickers (Source: TSB)

Around 2100, the maintainer went to the Saint-Féréol Road grade crossing. The grade crossing is equipped with automatic warning devices.<sup>8</sup> The 2 tracks are identified by "NORD" and "SUD" stickers on the signal masts (Figure 3).<sup>9</sup> The volume of road traffic on this secondary road is considered low.

It was dark, and the area was lit only by a street lamp just over 50 feet southwest of the grade crossing. The signal maintainer intended to put his vehicle on the south track and move westward, but inadvertently positioned the vehicle on the north track and exited, lowering the front and rear guide wheels of the hi-rail system. Once the vehicle was positioned on the track, the signal maintainer moved westward to the signal bungalow, located just over a mile away. During this time, the signal maintainer did not notice the “NORD” and “SUD” stickers on the signal masts. These stickers are used to indicate to hi-rail track unit operators which track they are travelling on.
