RAIL TRANSPORTATION SAFETY INVESTIGATION REPORT R21C0070

FIRE ON RIGHT-OF-WAY

Canadian National Railway Company
Yard assignment YCYS61-16
Mile 124.95, Three Hills Subdivision
Calgary, Alberta
17 July 2021

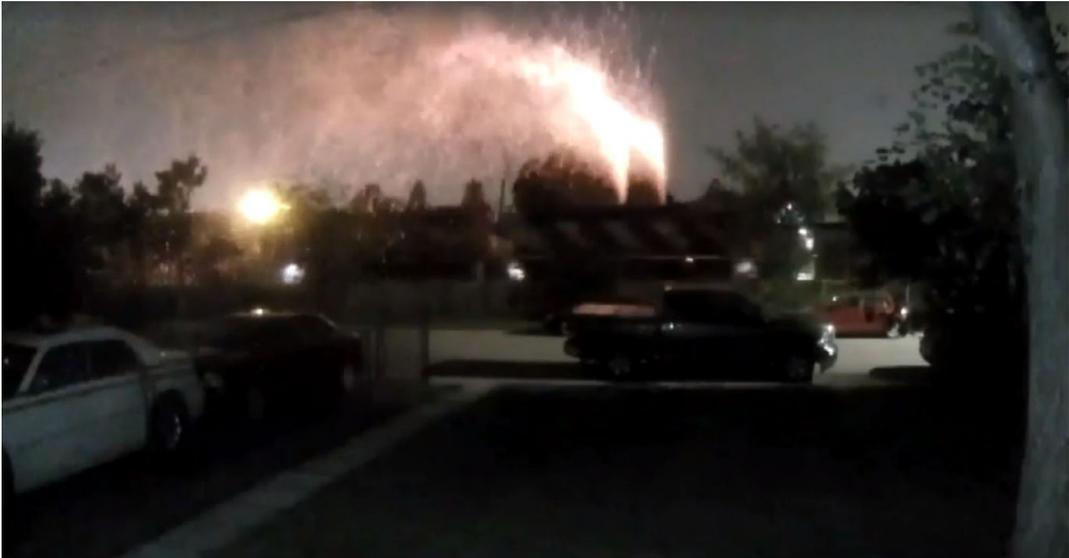
Figure 1. Flames emitting from locomotive CN 7524 (Source: Global News)

Compression testing was also performed by CN on all power assemblies, and the result indicated that the No. 11 power assembly had no compression and the No. 3 power assembly had low compression. As diesel engines rely on compression to create heat and to ignite the diesel fuel, the diesel fuel injected into the No. 11 power assembly and possibly the No. 3 power assembly was not igniting. As a result, during the exhaust cycle, unburned diesel fuel was being expelled into the exhaust system. Once in the exhaust system, the diesel fuel ignited, causing a fire in the locomotive exhaust stack.

Unburned fuel can result in a buildup of carbon deposits in the exhaust system. It is likely that some of the carbon deposits present at the time of the occurrence ignited, creating embers that were expelled from the locomotive exhaust stack before the flames were noticed by the crew. Embers migrated to the right-of-way, igniting grass fires.

The 2 power assemblies were replaced. No further examination was performed on the failed power assemblies to determine the cause of the failure.

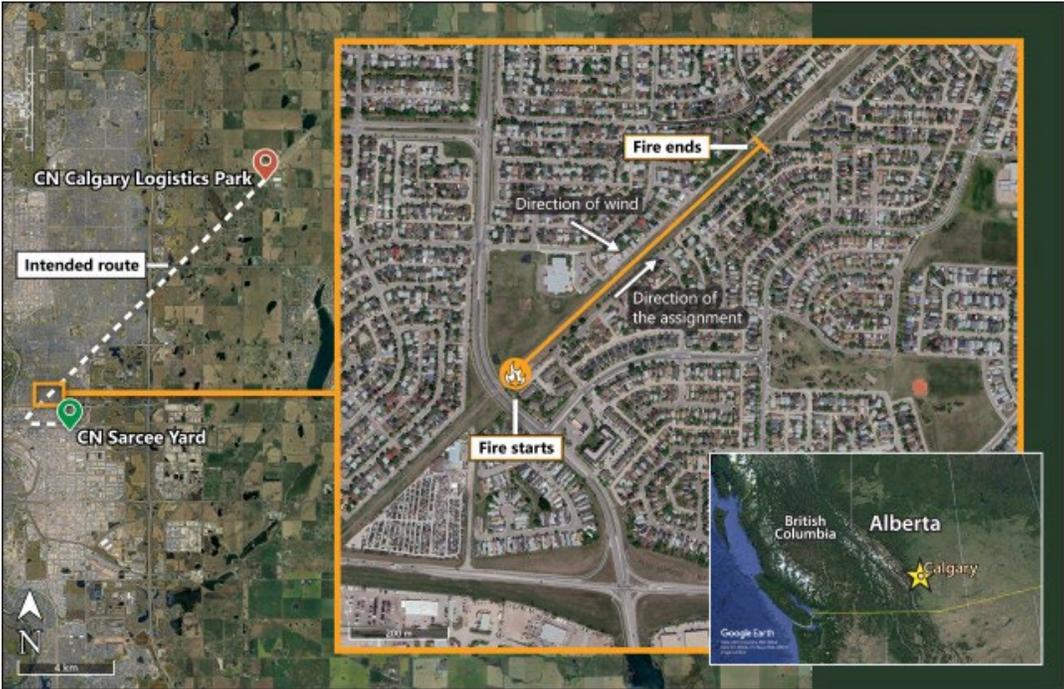
It was later determined that the grass fires extended along the right-of-way for approximately 2376 feet, from 36 Street SE to Erin Mount Crescent pedestrian crossing (Figure 2). They were contained between the track and a wire fence on the east side of the track.
