RAIL TRANSPORTATION SAFETY INVESTIGATION REPORT R22T0045

UNCONTROLLED MOVEMENT AND DERAILMENT

Canadian Pacific Railway Company
Cut of cars
Mile 196.7, Belleville Subdivision
Toronto Yard
Toronto, Ontario
13 March 2022

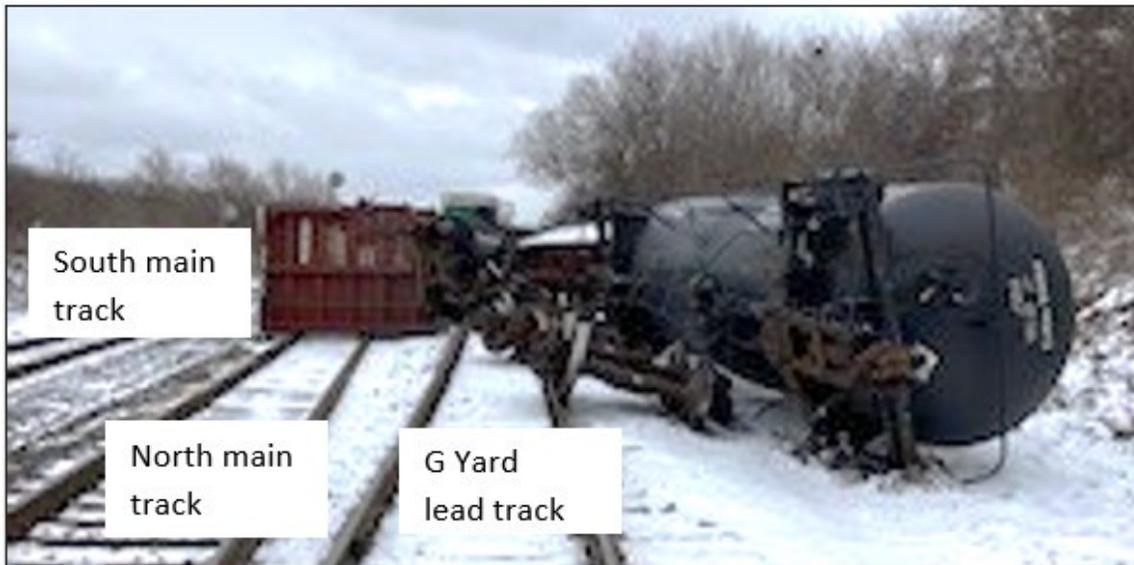
The first car to derail, a tank car loaded with sulphuric acid (UN1830), came to rest on its side. The next car, a box car loaded with drywall, also came to rest on its side, foul of the north main track (Figure 3). The remaining 5 cars—2 tank cars loaded with sulphuric acid, 2 residue cars last carrying sulphuric acid, and 1 car loaded with wood pulp—derailed upright. There were no leaks of dangerous goods, and no one was injured.

Figure 3. Occurrence location, looking west, showing the first 2 derailed cars at the split switch derail, including a box car foul of the main track (Source: Canadian Pacific, with TSB annotations)
