AIR TRANSPORTATION SAFETY INVESTIGATION REPORT A23F0062

RUNWAY EXCURSION ON TAKEOFF

WestJet Airlines Ltd.

Boeing 737-7CT, C-GWCN

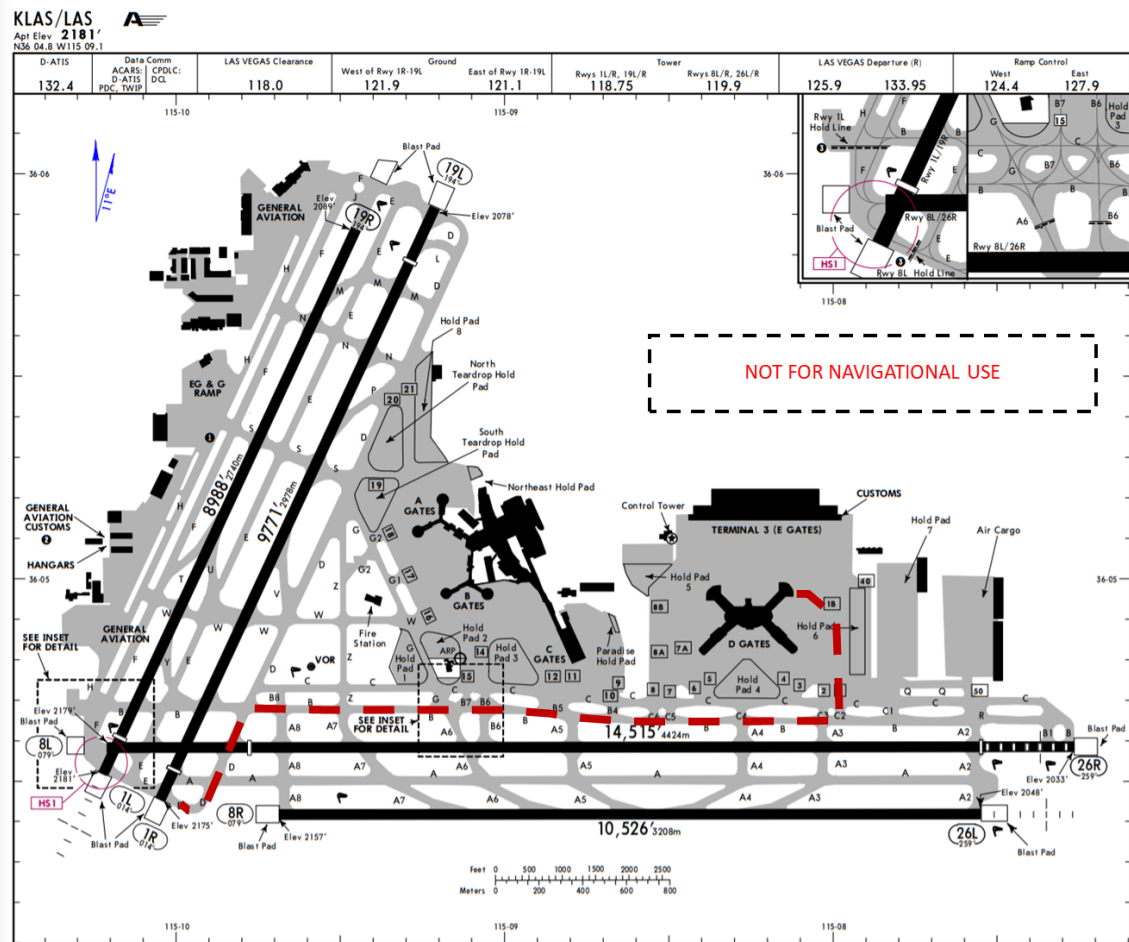
Before passengers boarded, the flight crew conducted a departure briefing and discussed known threats and challenges associated with the procedure to be flown. The captain had been the pilot flying (PF) from CYWG to KLAS, and it was planned that the first officer (FO) would be the PF for the occurrence flight. The FO was seated in the right seat. After 109 passengers had boarded and the aircraft had been loaded with fuel, the aircraft pushed back from the gate at 1814 and, at 1817, the captain taxied the aircraft onto Taxiway B with a clearance to turn onto Taxiway D from B and cross Runway 08L/26R to hold short of Runway 01R, the active runway (Figure 1).

Figure 1. Diagram of Harry Reid International Airport showing occurrence aircraft's taxi route onto Runway 01R (dashed line) (Source: Jeppesen, with TSB annotations)

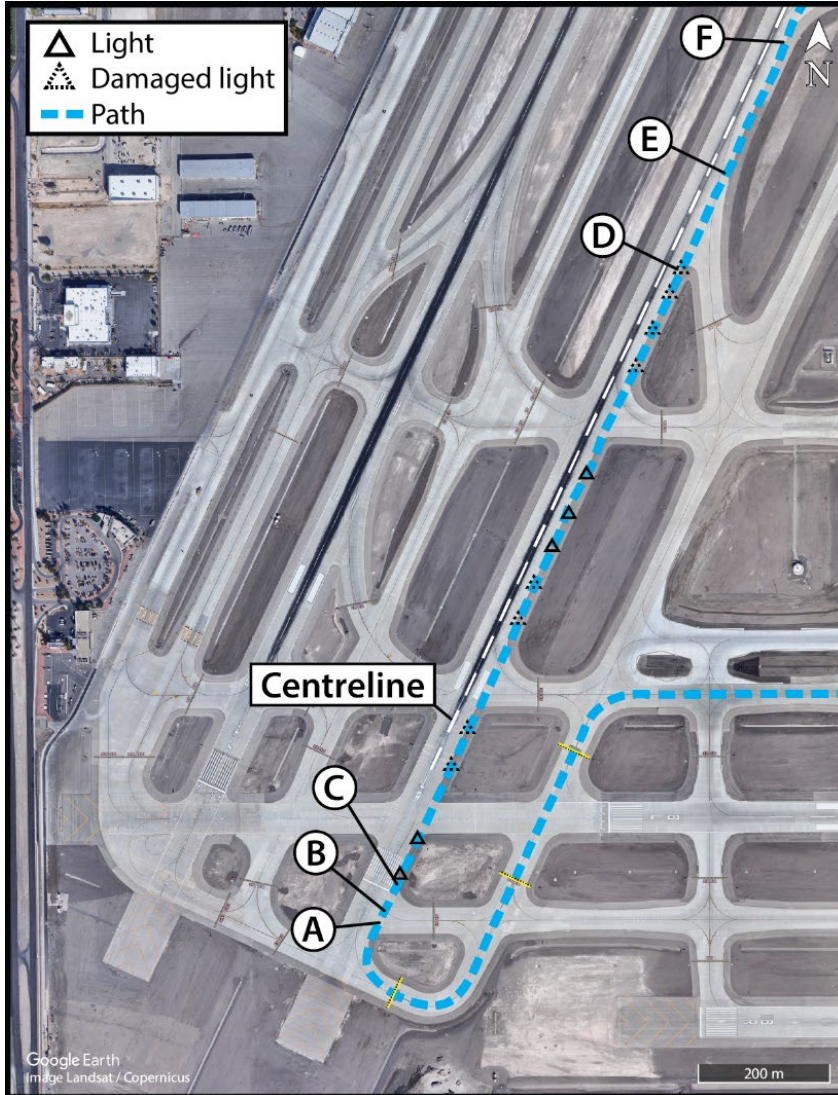
The airport operator determined that 8 runway edge lights on the right side of Runway 01R had been struck: 7 lights were damaged and the 8th light had its lens knocked off. The distance from the 1st damaged light to the 8th damaged light was approximately 2680 feet (Figure 2).

Figure 2. Occurrence aircraft's take-off path, based on quick access recorder data and automatic dependent surveillance - broadcast data. Runway edge light positions are indicated, along with the locations (labelled A to F and listed in Table 1) at which the flight crew performed significant actions during the take-off sequence (Source: Google Earth, with TSB annotations)

The debris was contained and located just outside of the runway edge markings. Airport electricians replaced the 7 damaged lights and repaired the 8th light. There was no indication of any impact on airport operations from the damaged lights.

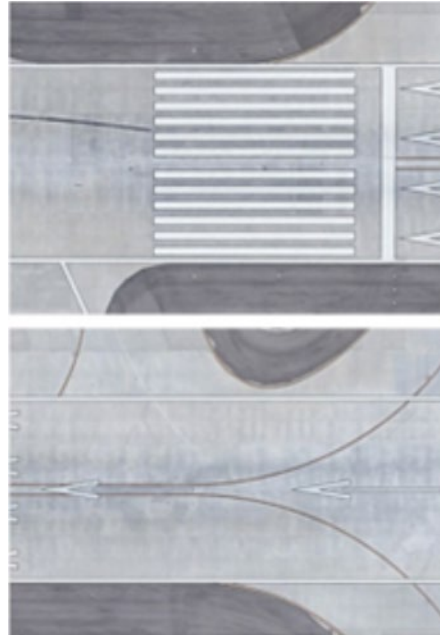
Figure 4. Runway threshold (top) and displaced threshold area (bottom) at Harry Reid International Airport (Source: Google Earth)

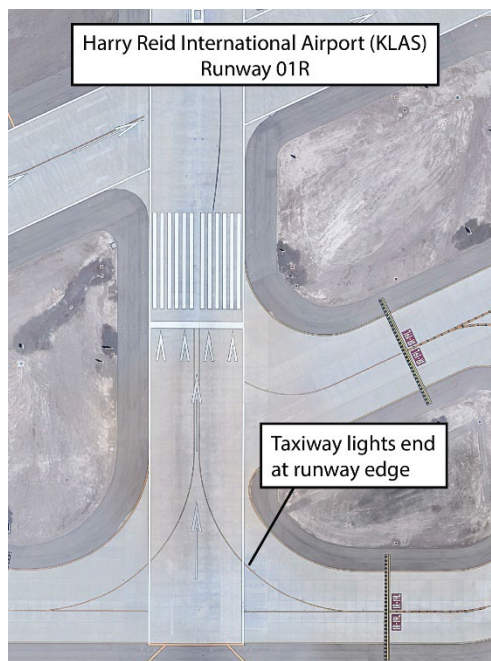
In this occurrence, the aircraft entered Runway 01R from Taxiway D, on which taxiway centreline markings extended to the centre of the runway; however, the lighting stopped at the runway edge markings, as required by the standard.

Figure 5. Taxiway lighting at intersection with Runway 01R at Harry Reid International Airport (Source: Google Earth, with TSB annotations)

The standard differs from that which applies to Canadian airports, where taxiway centreline lighting can continue onto runways even if they are not certified for low-visibility operations. Although the intention of the U.S. standard is to reduce excessive lighting in the runway area, in this occurrence, it created a potential hazard by stopping a key visual indicator partway to the aircraft's intended destination, ending it instead at the runway edge markings. The termination of these lights at the runway edge markings reduces their salience during nighttime operations and made it more likely that the occurrence crew would have had to rely on other cues to align the aircraft properly.

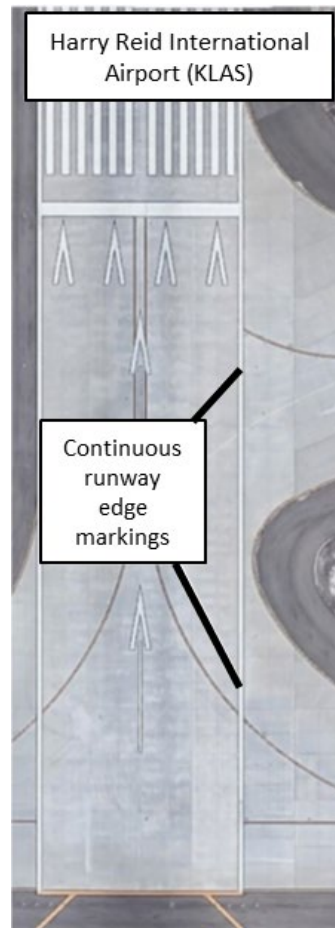
between a runway and a taxiway.¹⁴¹⁵ By contrast, the U.S. standard¹⁶ for runway edge markings specifies that runways shall have uninterrupted edge markings (figures 7 and 8).

Figure 8. Runway edge markings at Harry Reid International Airport (Source: Google Earth, with TSB annotations)

In this occurrence, the aircraft entered Runway 01R from Taxiway D, crossing over a continuous runway edge marking.

One of the strongest visual cues available to the captain while he was taxiing the aircraft onto the runway was likely the runway edge marking, given that it is white and thicker than the taxiway centreline, which is a yellow line with a black border. A white line such as this was also what the captain was expecting to see, which would have indicated that they had reached the centre of the runway. In this case, however, the white line, compared to the markings used at Canadian airports, was located in an unexpected place. With good weather conditions present and having already received the take-off clearance, the captain did not want to delay the departure and so his attention was primarily focused within the cockpit to monitor the FO.
