RAIL TRANSPORTATION SAFETY INVESTIGATION REPORT R23H0006

MOVEMENT EXCEEDS LIMITS OF AUTHORITY

Canadian National Railway Company
Freight train M 37231-13
Mile 69.4, Kingston Subdivision
Near Cornwall, Ontario
13 April 2023

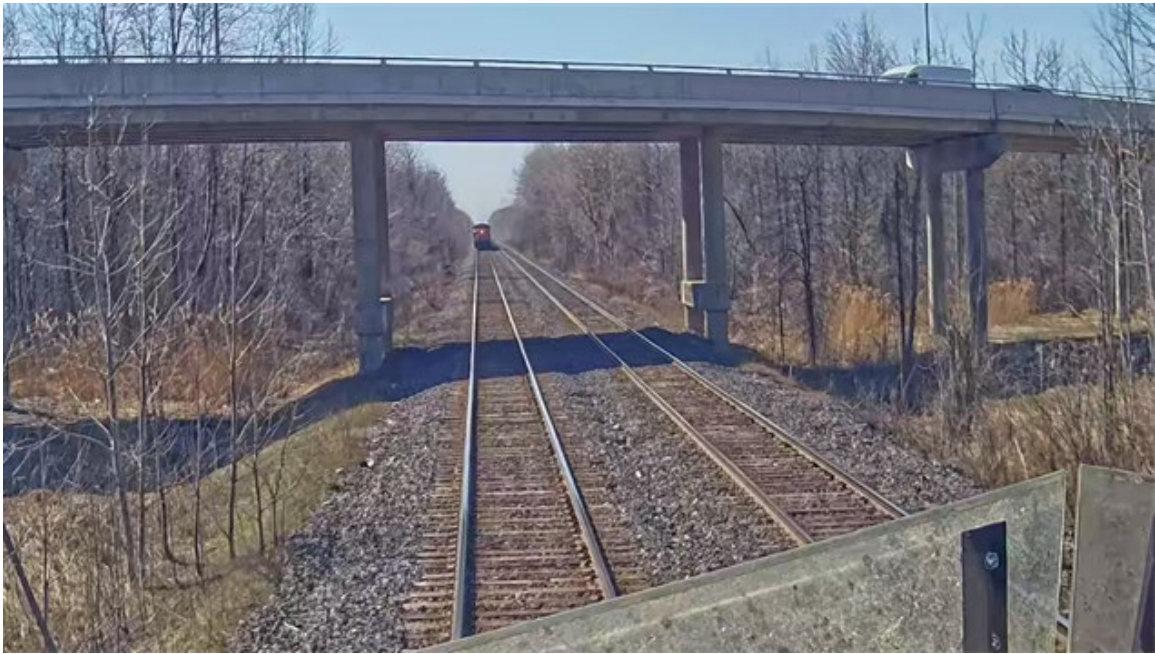
about 1450, while travelling at 45 mph, VIA 67 approached Wesco, where it was to cross over to the north track. At about 1451, upon hearing the emergency radio broadcast from the crew of CN 372, the LE at the controls of VIA 67 brought his train to a controlled stop. VIA 67 came to rest with the head end at approximately Mile 68.9, 1100 feet east of the head end of CN 372 (Figure 2). There were no injuries to either crew or to the passengers.

Figure 2. Head end of train CN 372, as seen from the locomotive on train VIA 67, after both trains had stopped (Source: VIA Rail Canada Inc.)

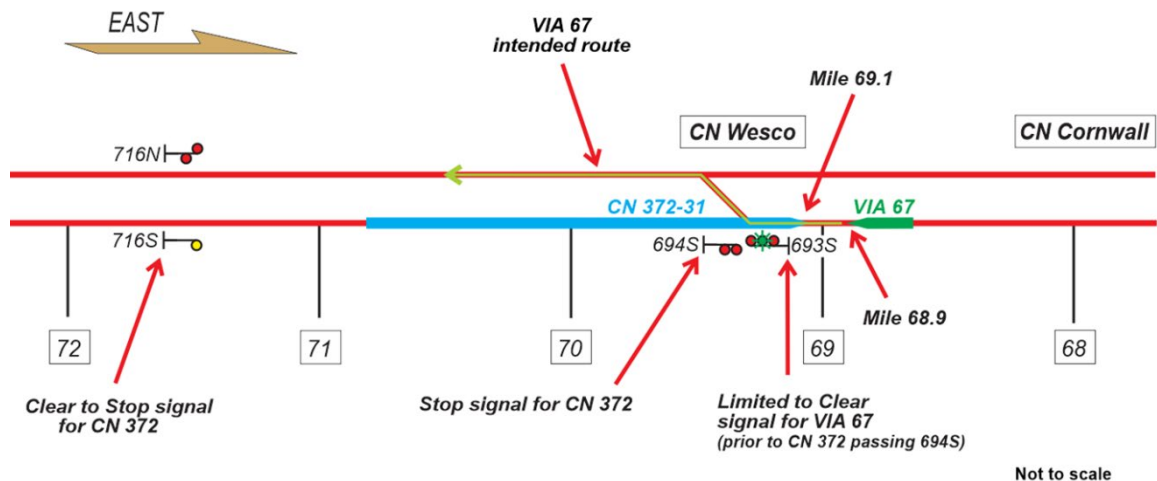
Figure 3 shows the location of the relevant signals, and the relative position of the stopped trains in relation to these signals and to each other.

Figure 3. Schematic of the track near the occurrence location (Source: TSB)

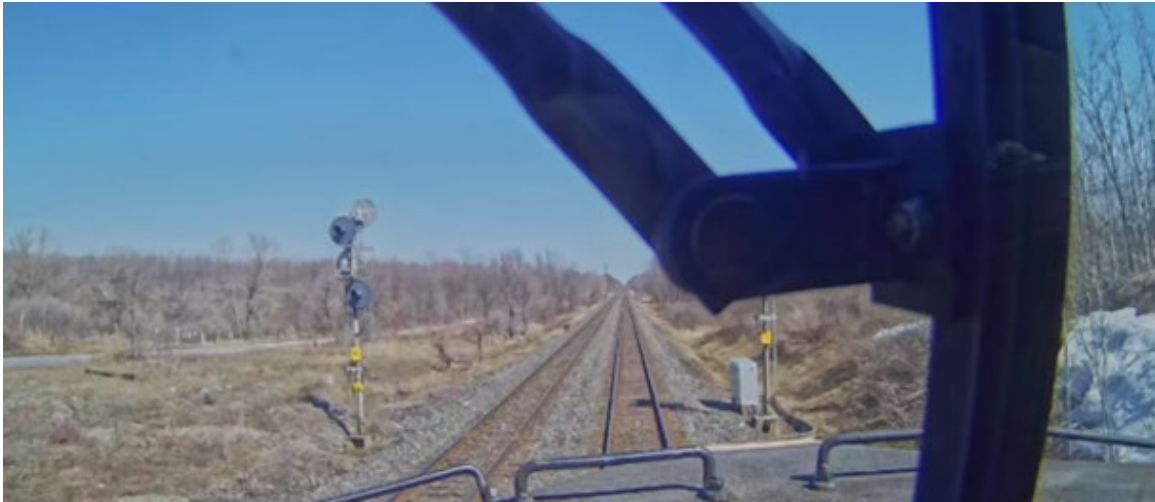
While playing back the data from the forward-facing video camera, the TSB observed that a windshield wiper was obstructing the view from the camera (Figure 4). During daylight operations, the signal views from the camera are limited by the camera resolution, which results in a limited opportunity to identify the signal indication. In this occurrence, this did not impede the crew's ability to positively identify the signal.

Figure 4. View from the forward-facing camera on train CN 372, showing that the view is obstructed by a windshield wiper (Source: Canadian National)

A forward-facing video camera is a useful tool in an accident investigation; however, in this occurrence, the view from train CN 372's locomotive camera was partially obstructed by a windshield wiper, resulting in a limited opportunity to identify the signal indication.

CN requires that crews ensure the view from forward-facing cameras remains unobstructed at all times.¹⁰
