AIR TRANSPORTATION SAFETY INVESTIGATION REPORT A23C0081

RUNWAY OVERRUN

Superior Airways Limited
Cessna 208B, C-FYMK
Pikangikum Airport, Ontario
12 September 2023

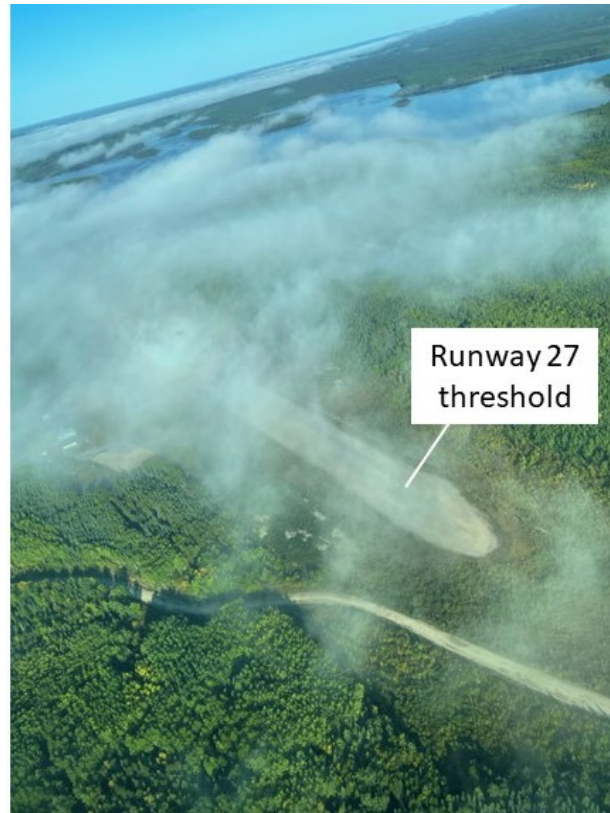
The take-off, climb, and cruise portions of the flight from CYRL to CYPM were conducted in visual meteorological conditions. As the occurrence aircraft approached CYPM, the pilot noticed fog over the airport (Figure 1) and the community of Pikangikum. The pilot activated the aircraft radio control of aerodrome lighting and was able to see the east end and threshold of Runway 27. The pilot continued the visual approach to Runway 27 with an approach speed of approximately 115 knots indicated airspeed and flaps set to 20°.

At 0840, the aircraft touched down approximately 1850 feet from the threshold of Runway 27 at approximately 90 knots. While the aircraft was in the flare for landing, visibility was reduced significantly in a fog layer. During the rollout, the pilot could not see the end of the runway owing to the fog. He applied the brakes and selected the power lever to the beta range,² but he did not use reverse. As the aircraft was slowing, the pilot observed the runway end lights go by, and the aircraft overran the end of the runway at approximately 35 knots.

Figure 1. Photo of Runway 27 and fog, taken shortly after the occurrence by another aircraft following behind the occurrence aircraft on the same route (Source: Superior Airways Limited, with TSB annotations)

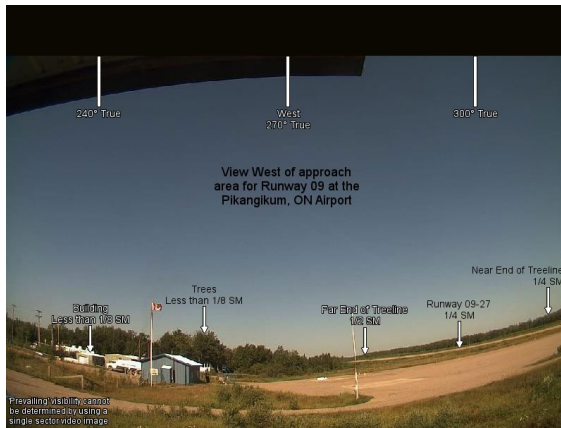
Figure 2. Reference image for weather conditions at Pikangikum Airport (CYPM)
(Source: NAV CANADA)

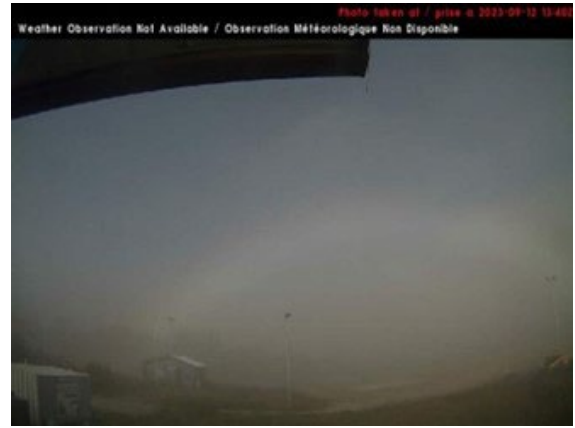
NAV CANADA has a camera site at CYPM, which takes periodic pictures of the weather conditions and makes them publicly available on its flight planning website along with a reference image (Figure 2). An image depicting the weather conditions at CYPM was captured at 0840 (Figure 3).

Figure 3. Weather conditions at Pikangikum Airport (CYPM) at 0840 on the day of the occurrence (Source: NAV CANADA)

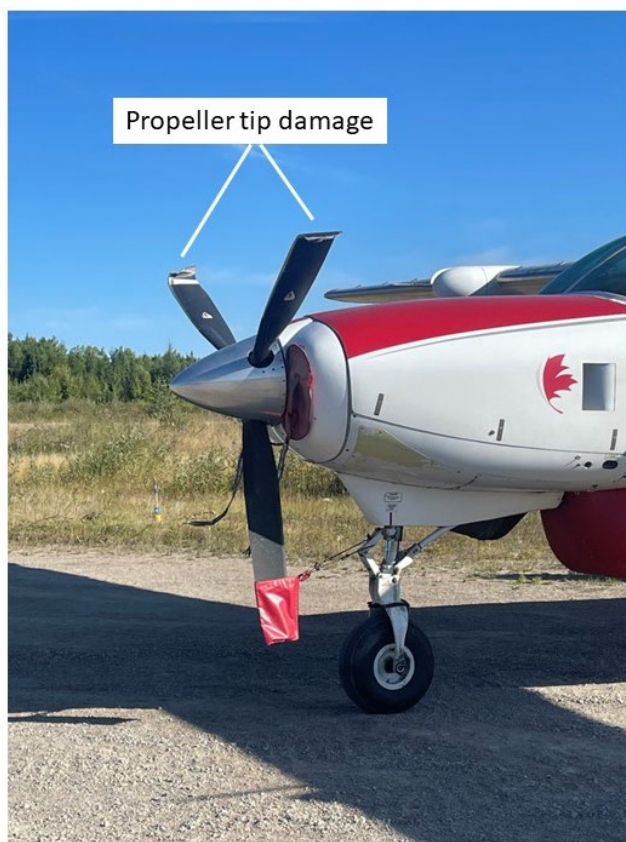
The investigation determined that the aircraft's centre of gravity was within the manufacturer's prescribed limits, and its weight at takeoff was 8012 pounds and at landing approximately 7850 pounds. The aircraft had no known deficiencies, and there was no indication of an aircraft system malfunction contributing to this occurrence. The aircraft sustained minor damage during the event, including damage to the propeller blade tips (Figure 4).

Figure 4. Damage to the propeller blade tips (Source: Superior Airways Limited, with TSB annotations)
