# AIR TRANSPORTATION SAFETY INVESTIGATION REPORT A23C0105

## RUNWAY OVERRUN

North Star Air Ltd.  
Pilatus Aircraft Ltd. PC-12/45, C-GEOW  
Kasabonika Airport (CYAQ), Ontario  
21 November 2023

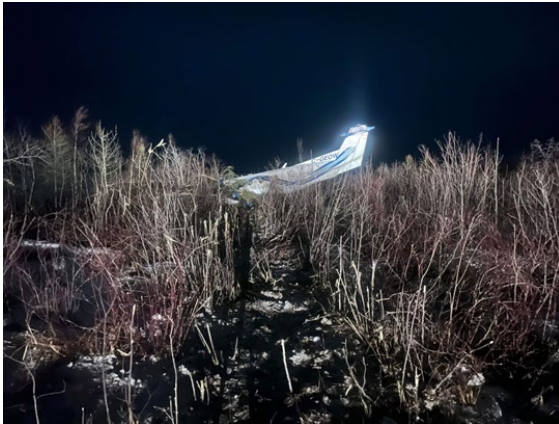
aircraft touched down approximately 1200 feet beyond the threshold of Runway 03 at 102 knots ground speed. During the landing roll, the captain applied reverse thrust momentarily, which resulted in a slight yawing motion of the aircraft. The reverse thrust was returned to the idle position, and directional control was restored. The captain then fully applied the brakes; however, at 1938, the aircraft skidded and overshot the end of the runway. The aircraft came to rest approximately 350 feet beyond the runway surface (Figure 1). The aircraft cabin remained upright and intact (Figure 2). The passengers and crew were not injured and were able to egress through the main cabin door. The aircraft's emergency locator transmitter activated.

**Figure 1. Occurrence aircraft at rest beyond end of runway** (Source: Ministry of Transportation of Ontario, with permission)

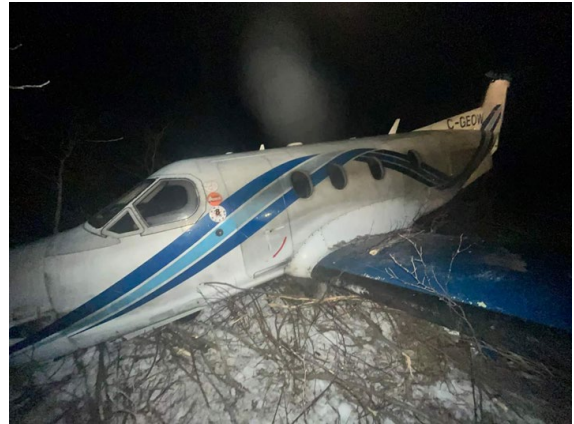
**Figure 2. Occurrence aircraft in upright position** (Source: Ministry of Transportation of Ontario, with permission)

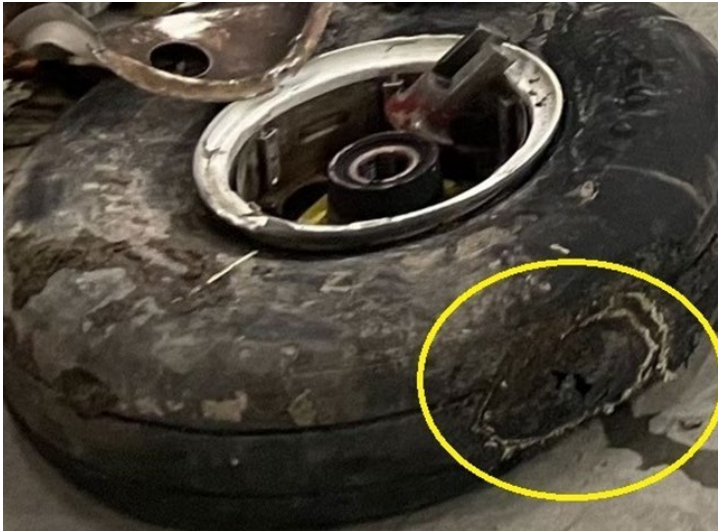
The landing gear collapsed, and the propeller, engine, and cowling were substantially damaged. The fuselage was buckled, and the wings, ailerons, and flaps sustained extensive damage. The main landing gear tires were blown, with damage indicative of heavy skidding (Figure 3).

**Figure 3. One of the main landing gear tires with damage from the heavy skidding (Source: North Star Air Ltd., with permission)**

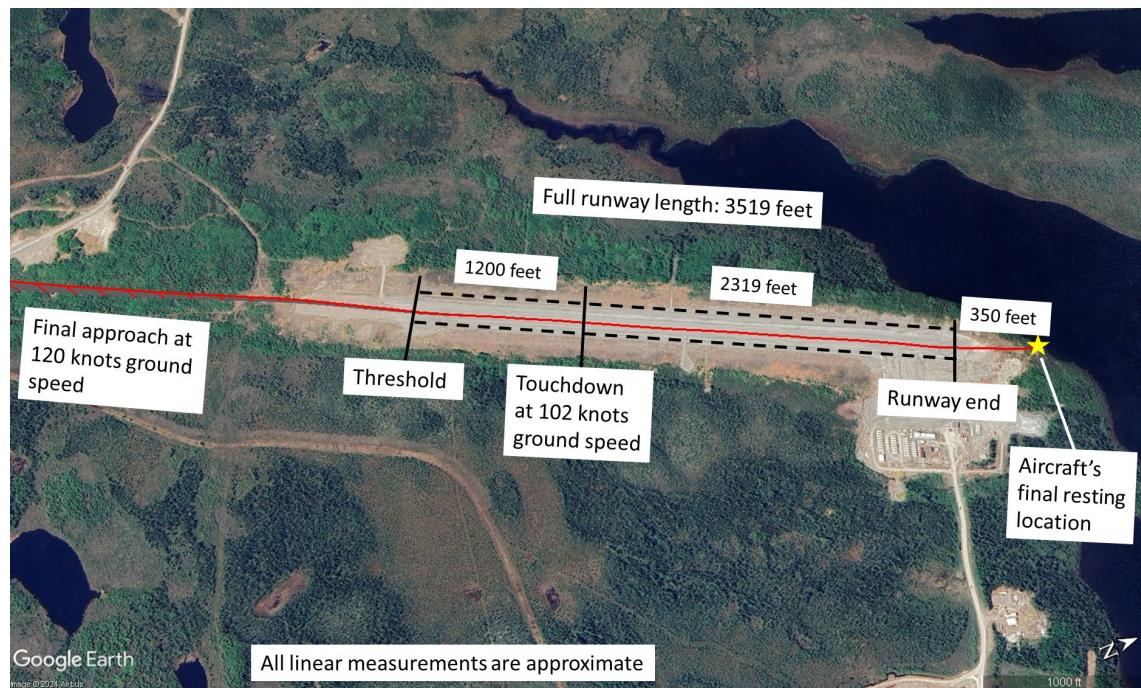
The weather conditions present and forecast during the occurrence showed winds moving westerly to become favourable for takeoffs and landings on Runway 21. The final approach was 120 knots ground speed during the last 500 feet of the approach. The aircraft crossed the threshold at 110 knots ground speed and touched down approximately 1200 feet beyond the threshold at 102 knots ground speed (Figure 4).

Figure 4. Aerial view of Runway 03 showing the occurrence aircraft's trajectory, touchdown point, landing roll, and its final resting location (Source: Google Earth, with TSB annotations, based on GPS data)

After the occurrence, North Star Air revised its SOPs to include cross-checking of ground speed to indicated airspeed on final approaches.
