AIR TRANSPORTATION SAFETY INVESTIGATION REPORT A22Q0025

RUNWAY OVERRUN

Skyservice Business Aviation Inc.
Honda Aircraft Company, LLC, HondaJet HA-420, C-FJJT
Montréal/St-Hubert Airport (CYHU), Quebec
07 March 2022

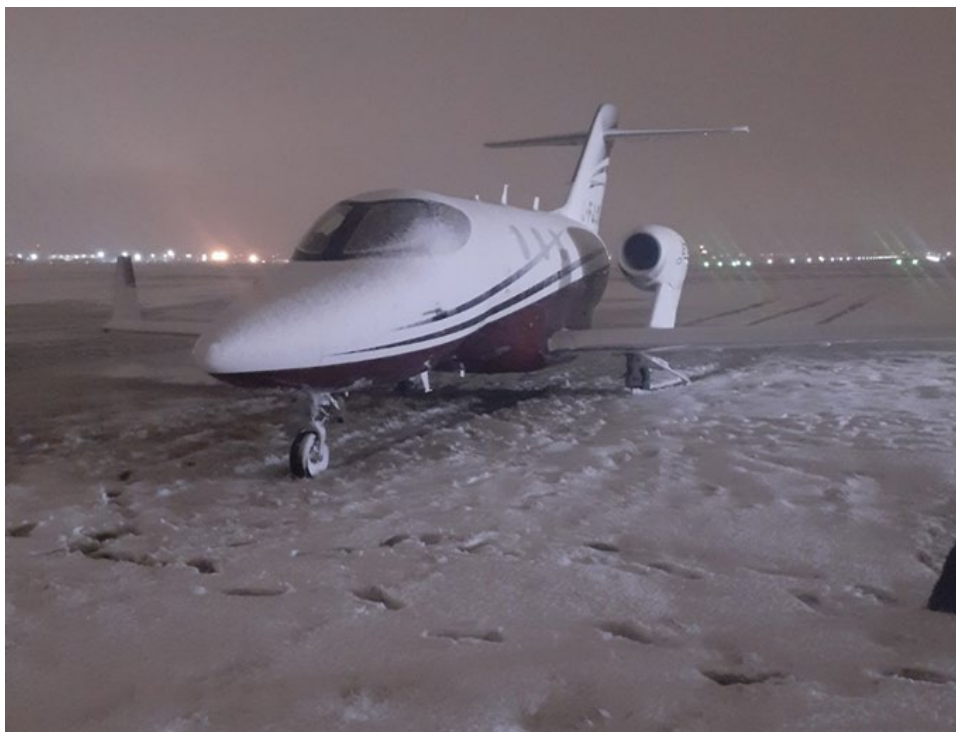
Figure 1. Aircraft at rest after the runway overrun (Source: Third party, with permission)

A runway end light was damaged.

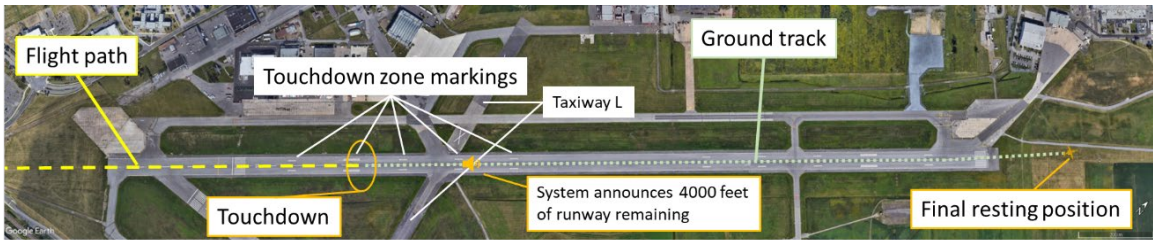
Figure 2. Image showing the touchdown zone markings as well as the aircraft's flight path (dashed line), the touchdown point, the location of the announcement of 4000 feet of runway remaining, the aircraft's ground track (dotted line), and its final resting position (Source: Google Earth, with TSB annotations)

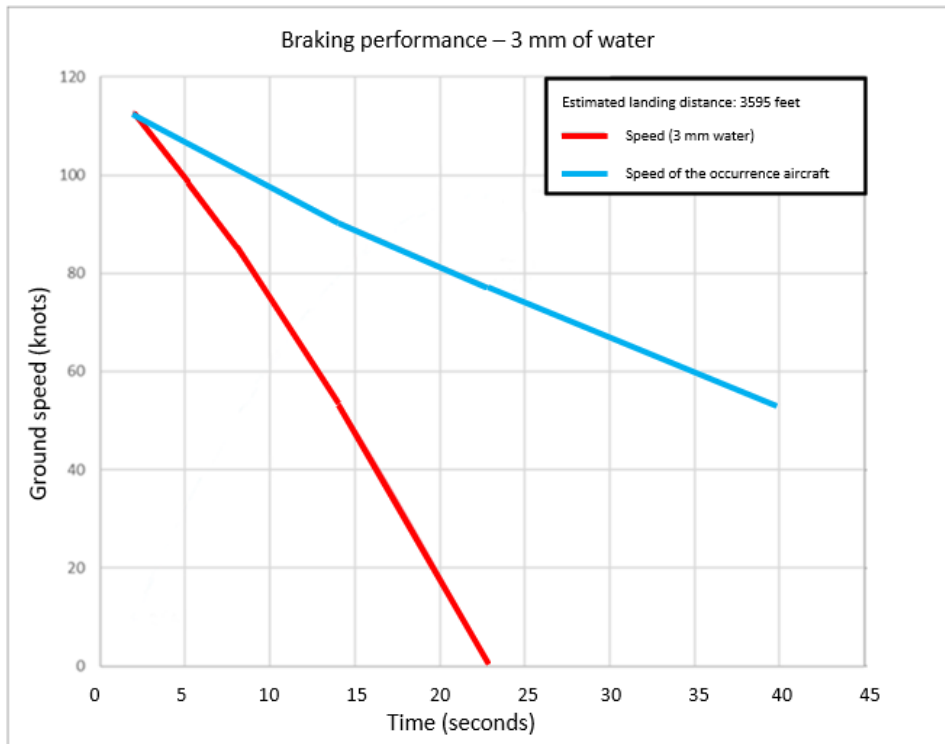
Figure 3. Graph showing the predicted braking performance of a HondaJet on a runway contaminated with 3 mm of water, and the braking performance of the occurrence aircraft – Scenario 2 (Source: TSB)

This scenario is representative of the runway conditions reported shortly before the occurrence.

In scenarios 2, 3, and 4, there is a large disparity when comparing the simulated results to the actual speed profile of the occurrence aircraft. Therefore, it is unlikely that the conditions depicted in these scenarios are representative of the actual conditions during the occurrence.

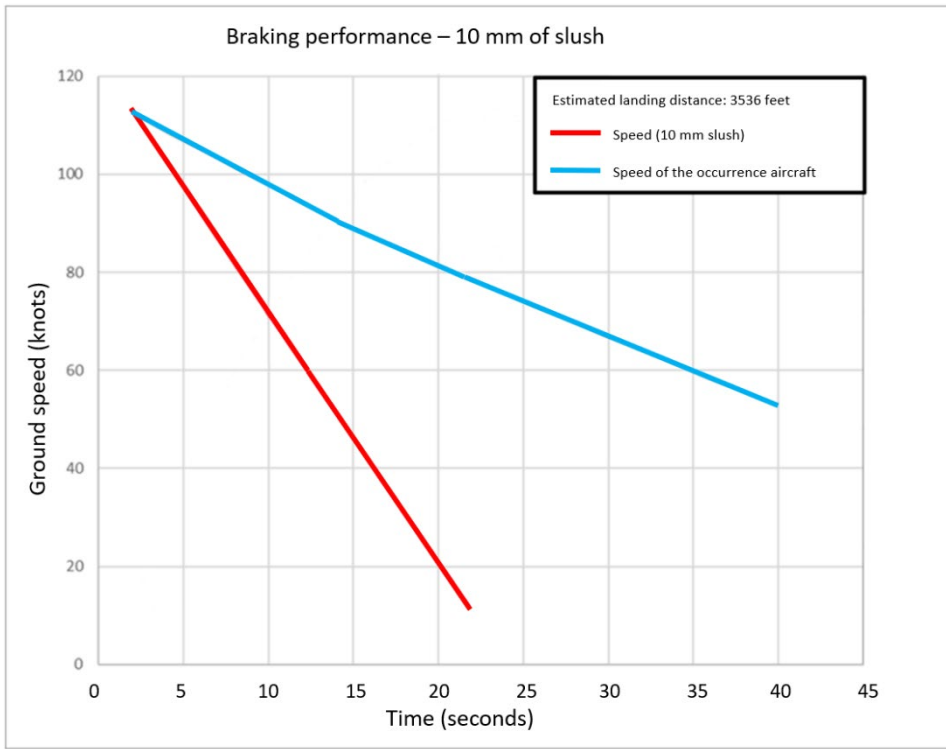
Figure 4. Graph showing the predicted braking performance of a HondaJet on a runway contaminated with 10 mm of slush, and the braking performance of the occurrence aircraft – Scenario 3 (Source: TSB)

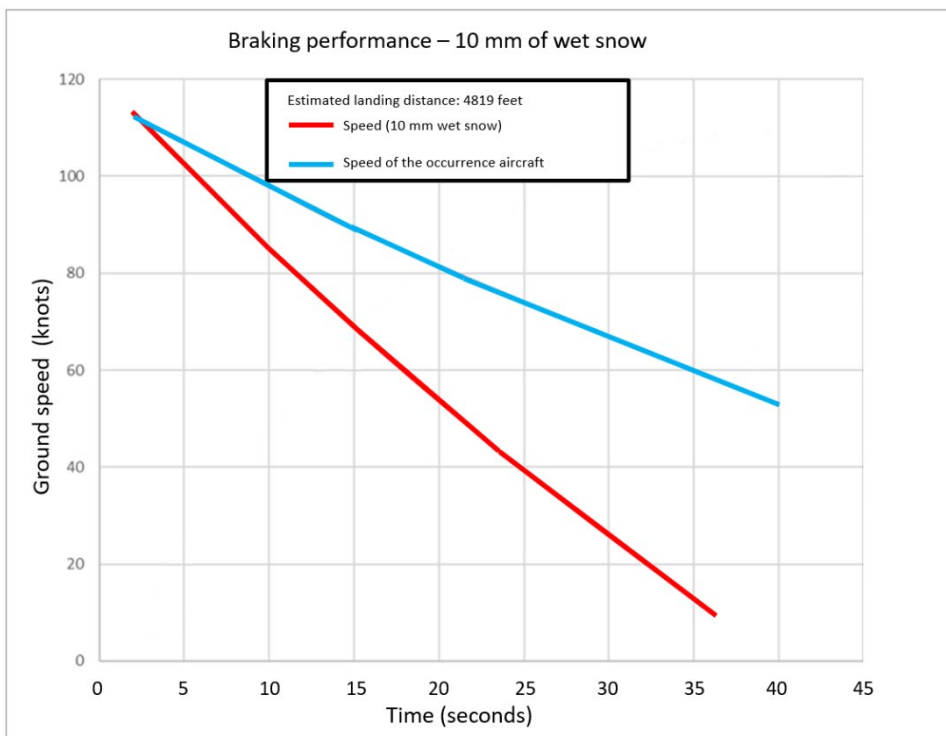
Figure 5. Graph showing the predicted braking performance of a HondaJet on a runway contaminated with 10 mm of wet snow, and the braking performance of the occurrence aircraft – Scenario 4 (Source: TSB)

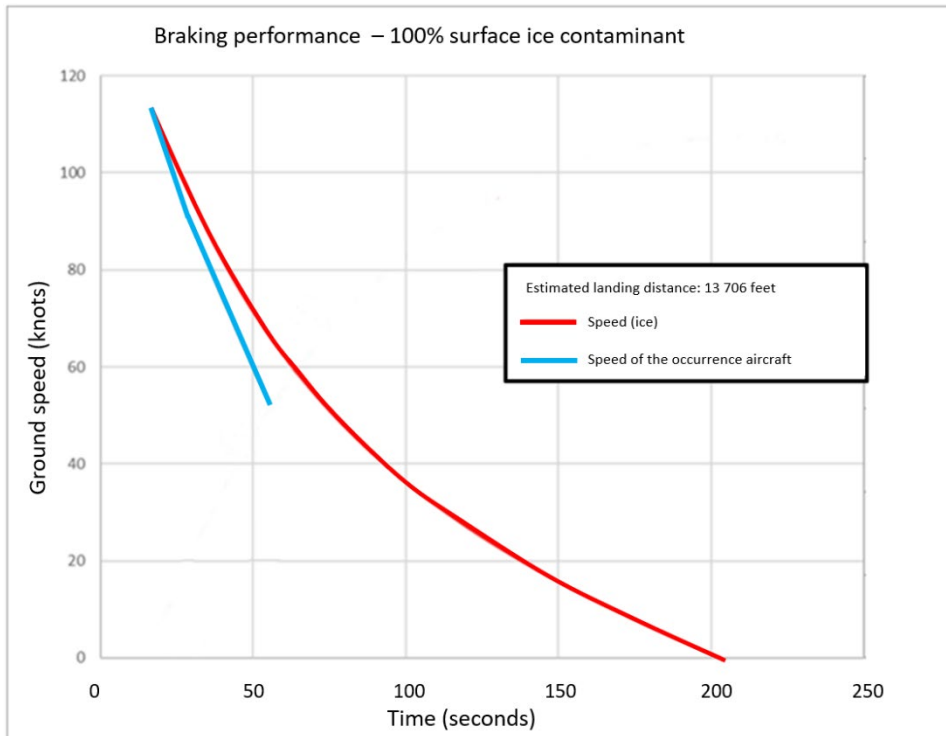
Figure 6. Graph showing the predicted braking performance of a HondaJet on a runway contaminated with 100% surface ice, and the braking performance of the occurrence aircraft – Scenario 5 (Source: TSB)

There is a higher degree of correlation between the simulated results of scenario 5 and the actual speed profile of the occurrence landing than with the results of the other scenarios.

Based on witness statements gathered, the weather conditions at the time of the occurrence, and the analysis carried out by Environment and Climate Change Canada, the investigation concluded that there was no ice on the surface of the runway at the time of the occurrence.
