AIR TRANSPORTATION SAFETY INVESTIGATION REPORT A24W0059

STALL, SPIN, AND COLLISION WITH TERRAIN

Privately registered
Sportinè Aviacija ir Ko LAK-17B FES (glider), C-FMXC
Black Diamond/Cu Nim Aerodrome, Alberta, 1.8 NM SE
29 May 2024

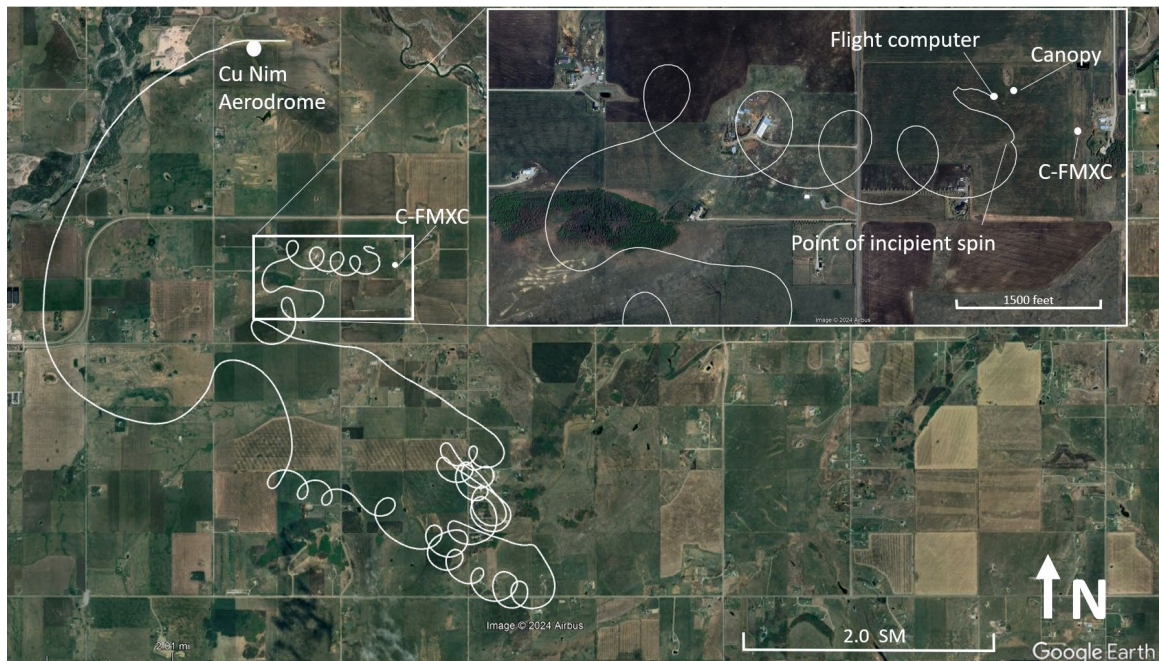
For the next 23 minutes, the occurrence pilot attempted to gain altitude by thermaling a few miles south of CEH2 (Figure 1); however, he only gained a few hundred feet in total. He then turned toward the aerodrome, and while on the left downwind leg for Runway 25, he attempted to gain more altitude and conducted 5 turns to the left.

Figure 1. Occurrence flight path, with a close-up view of the 5 left turns and incipient spin in inset (Source of main and inset images: Google Earth, with TSB annotations based on data from the Naviter Oudie N and LXNAV FlarmMouse devices on board the occurrence glider)

The glider averaged a height of 1350 feet AGL during the turns and gained some altitude but not a significant amount. While in the 5th turn to the left, the glider stalled at an indicated airspeed of 74.7 km/h² and entered an incipient spin to the right (Figure 1, inset). The flight data show a loss of about 200 feet³ and a subsequent increase of indicated airspeed to about 185 km/h. The glider recovered from the incipient spin and gained about 10 feet in altitude before its canopy was ejected.
