# AIR TRANSPORTATION SAFETY INVESTIGATION REPORT A23Q0145

## LATERAL RUNWAY EXCURSION

Propair Inc.  
Beech King Air A100, C-GJJF  
Wemindji Airport (CYNC), Quebec  
04 November 2023

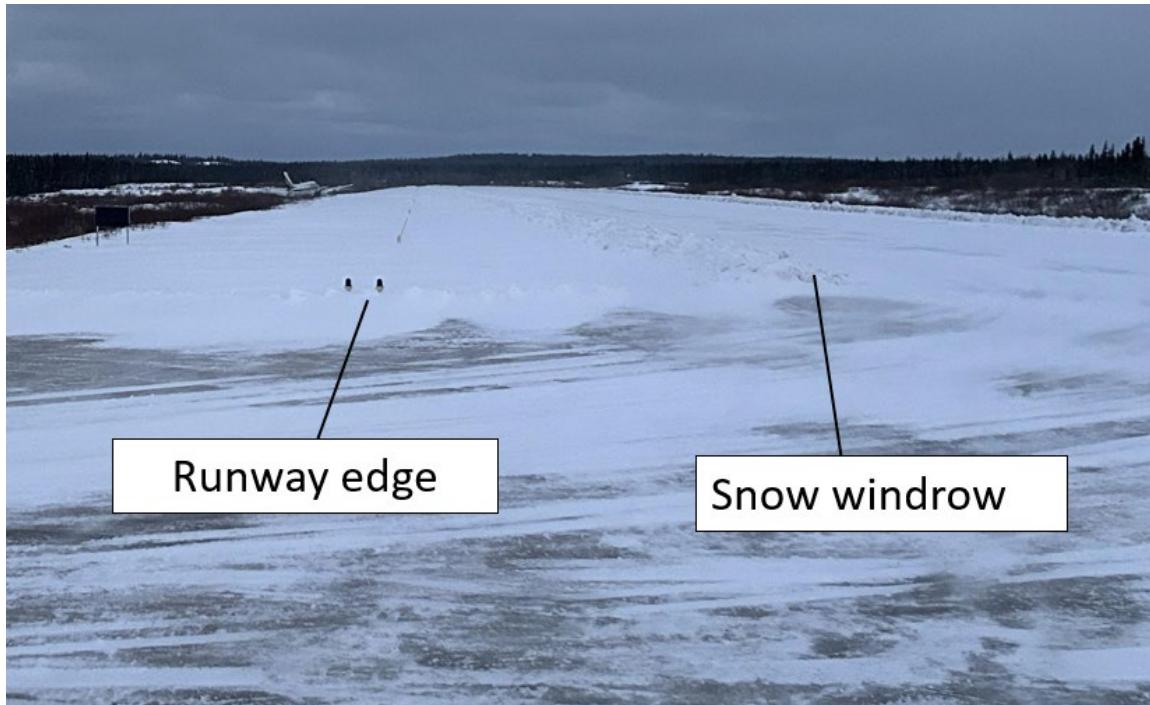
The approach was conducted in accordance with the criteria set out in the company's standard operating procedures (SOPs) and the pilot's operating manual (POM). The aircraft crossed the runway threshold at a height of approximately 30 feet and touched down on the runway about 400 feet beyond the threshold at 0227, slightly to the left of the normal runway centreline, but within lateral boundaries of the runway. Shortly after touchdown, the left main landing gear and propeller struck a snow windrow that was on the runway and extended along the entire length of the runway (Figure 1).

Figure 1. Snow windrow on the left side of Runway 28 at Wemindji Airport (Source: Propair, with TSB annotations)

The vehicle operator found himself completing tasks and making decisions for which he had not been trained and did not have the necessary experience or knowledge. He therefore partially removed the snow from the runway, leaving snow windrows that reduced the

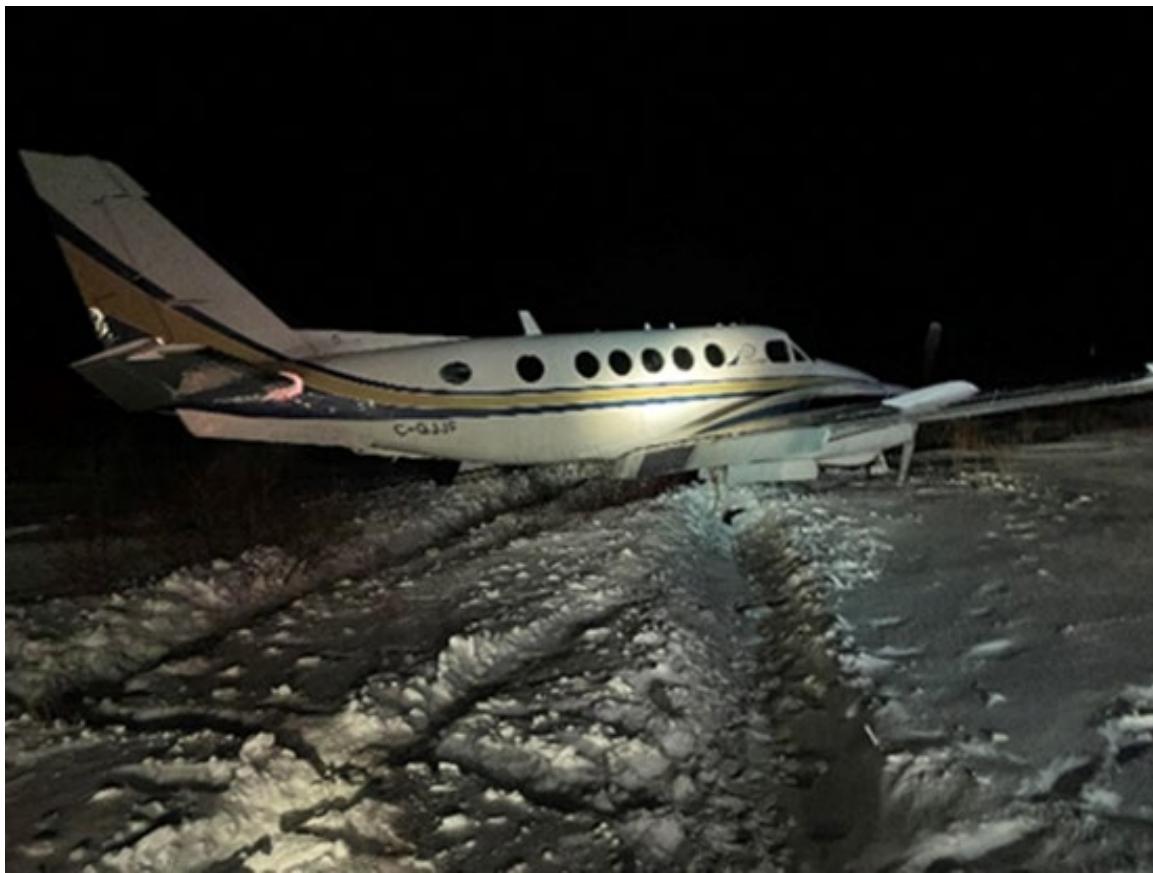
The aircraft then swerved to the left and exited the runway. It came to rest in the snow approximately 45 feet from the left edge of the runway (Figure 2).

Figure 2. Occurrence aircraft after the lateral runway excursion (Source: Propair)

The left propeller and engine, as well as the flaps on both sides, were slightly damaged by the impact with the snow windrow.
